**6th Annual Aboveground Storage Tank Conference & Trade Show
Houston, Texas | September 19, 2013**

**“Pictures” the Emissions of Storage Tanks
with the Use of Infrared Cameras**

The Sniffers nv, Belgium

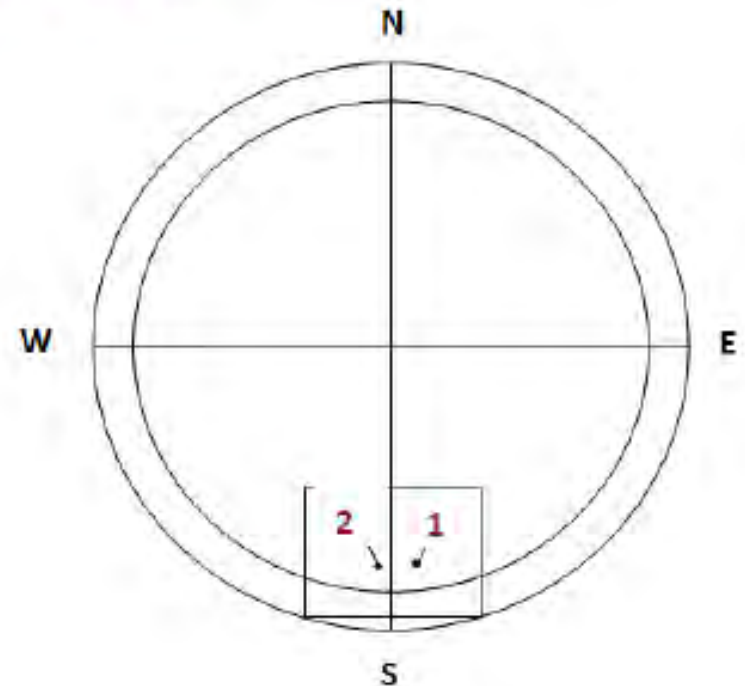
Figure 3-3: Scheme tank FB-753

*. 2 emission locations were found at on the roof, at the breather valves

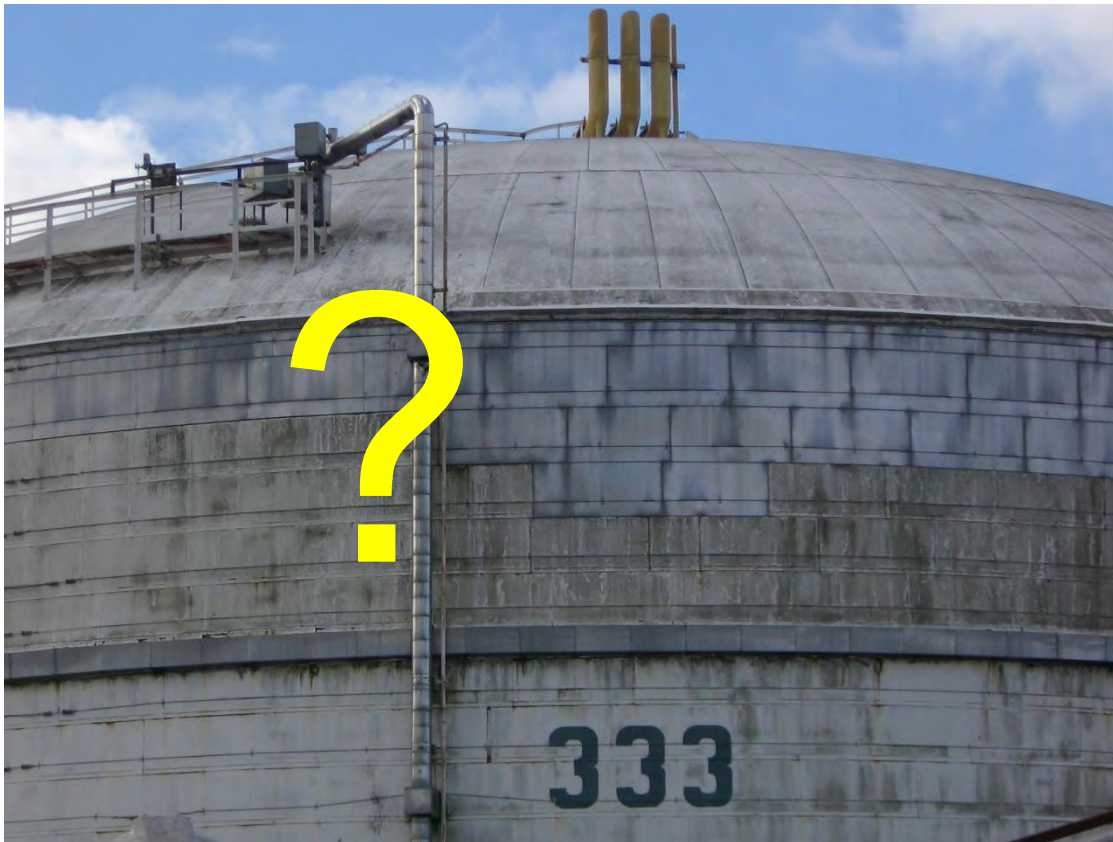
Leak invisible with the naked eye!!

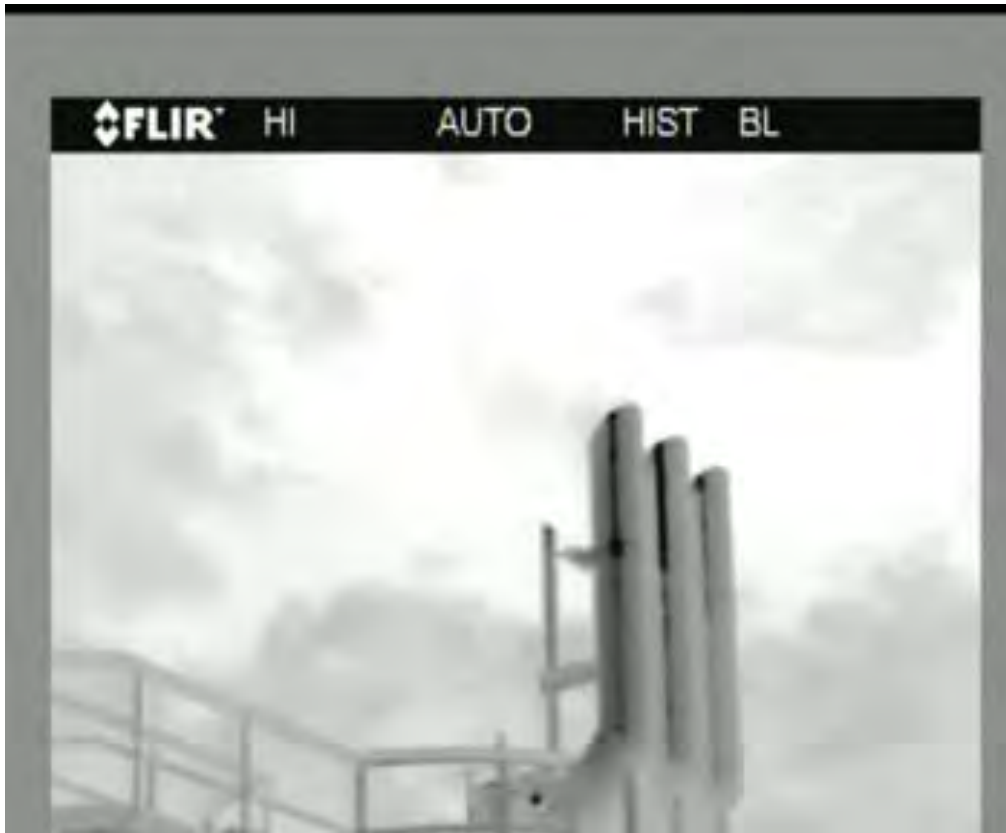
But with an
infrared leak
camera ...

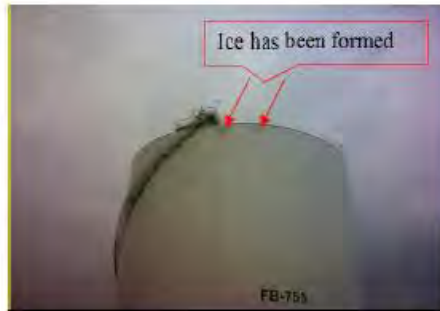
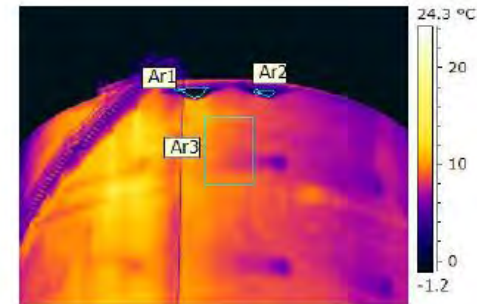
Location:	
Equipment:	Tank
Type:	FB-753
Product:	Ethylene
Position:	Pos 3
Deviation	(1)
Recommendation	Follow up – Plan a new inspection

Object Distance:	15.0 m
Atmospheric Temperature:	4.5 °C
Emissivity:	0.90
Reflected Temperature:	-5.2 °C
Ar1 Average Temperature:	-1.1°C
Ar2 Average Temperature:	-0.4 °C
Ar3 Average Temperature:	9.0 °C

- The average temperature of Ar1 en Ar2 is 10.0°C lower than the connected wall (Ar3). Ice is formed on the wall of the tank. Deviation

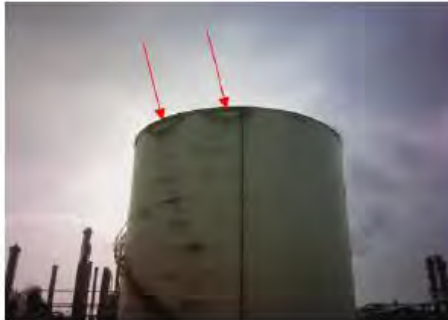
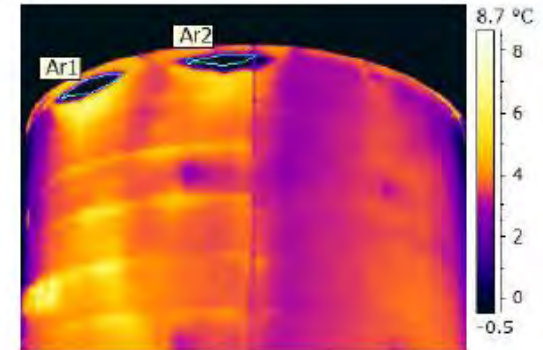
Location:	I
Equipment:	Tank
Type:	FB-752
Product:	Ethylene
Position:	Pos 8
Deviation	(1)
Recommendation	Follow up – Plan a new inspection

Object Distance:	15.0 m
Atmospheric Temperature:	4.5 °C
Emissivity:	0.90
Reflected Temperature:	-7.4 °C
Sp1 Average Temperature:	-0.9 °C
Sp2 Average Temperature:	-2.1 °C

- The average temperature of Ar1 is ca. -0.9°C and the average temperature of Ar2 is ca. -2.1°C . It is recommended to follow up these locations and to plan a new inspection. Deviation

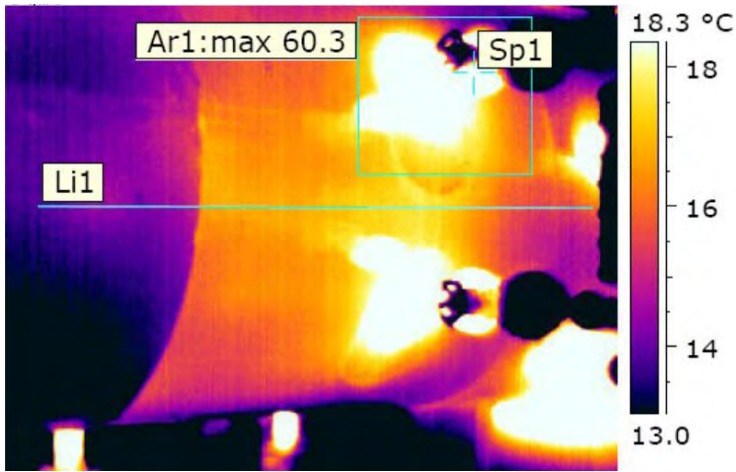
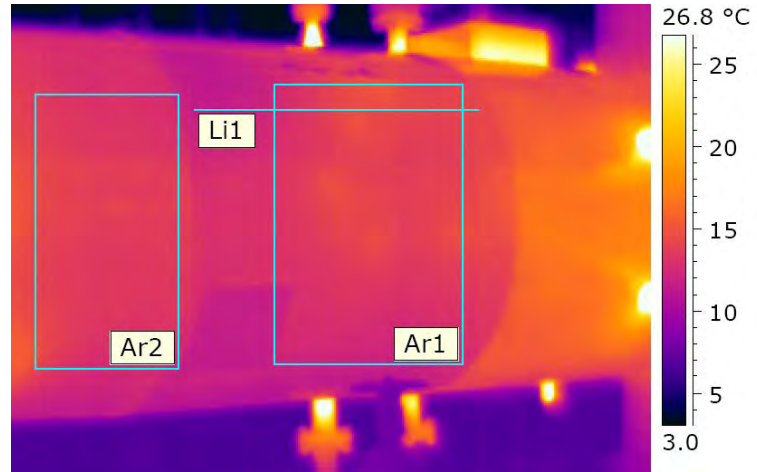
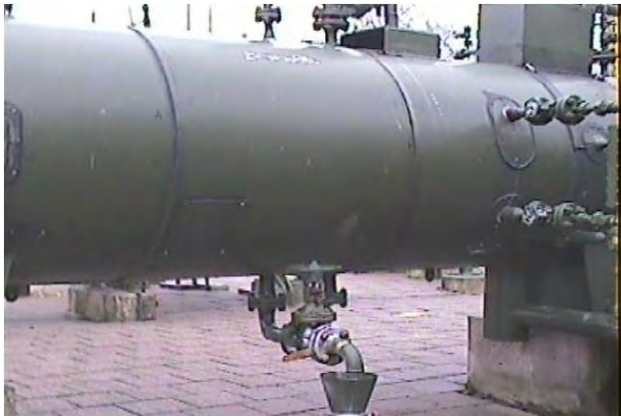
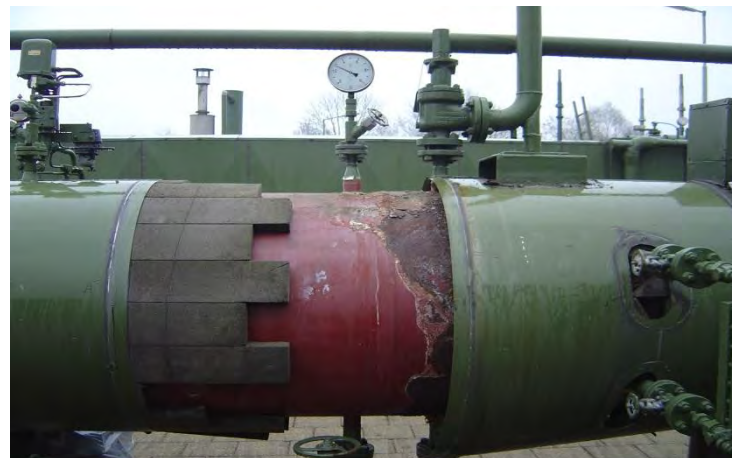
- example Corrosion under insulation

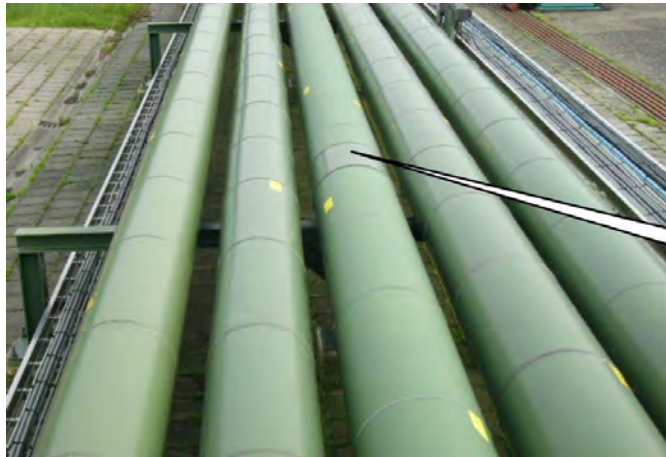
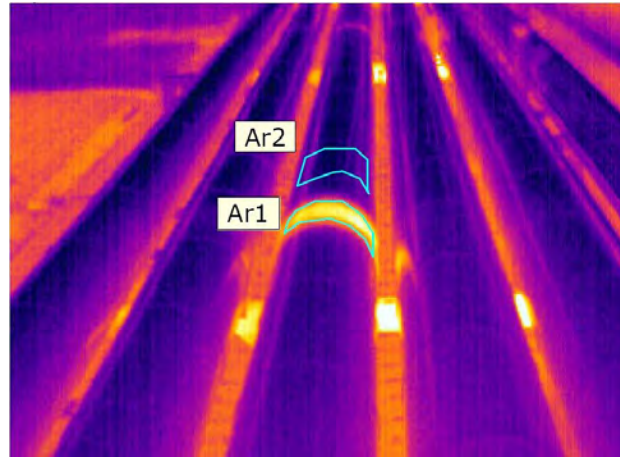
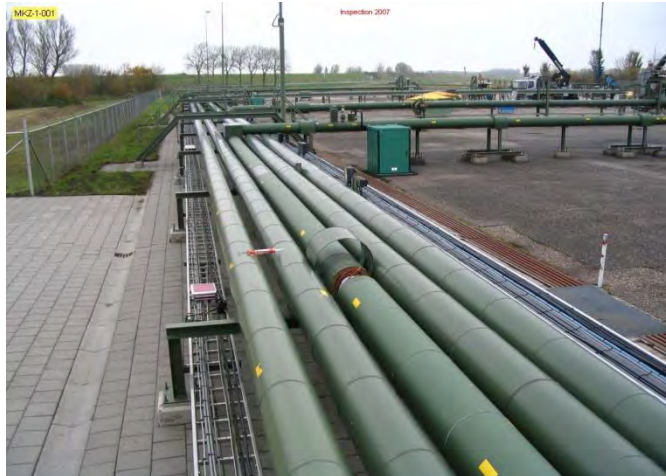
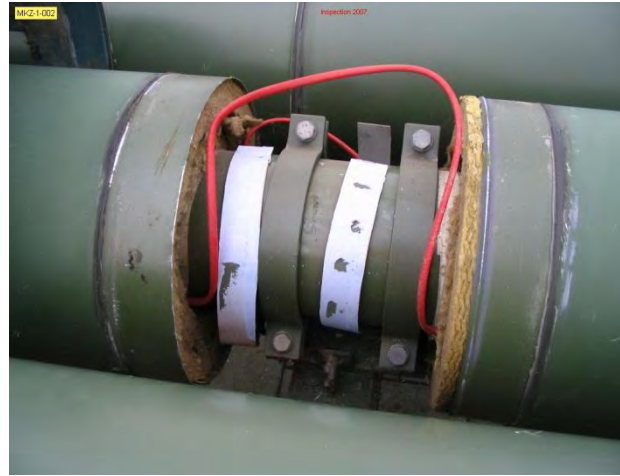
- Example: Insulation forgotten after maintenance

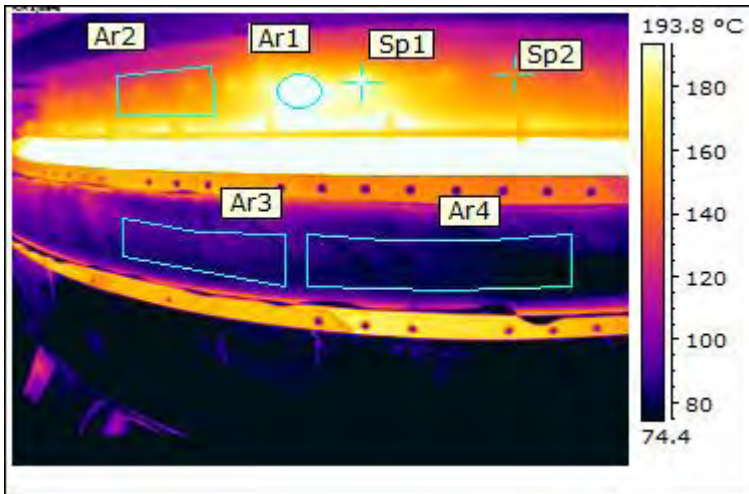
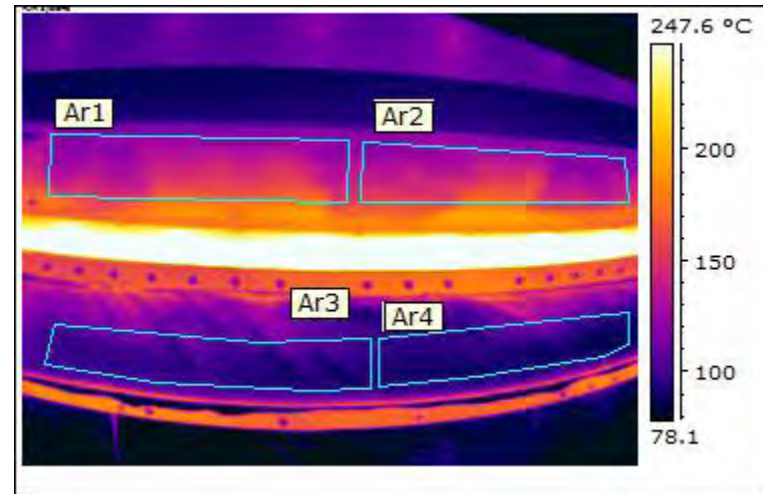
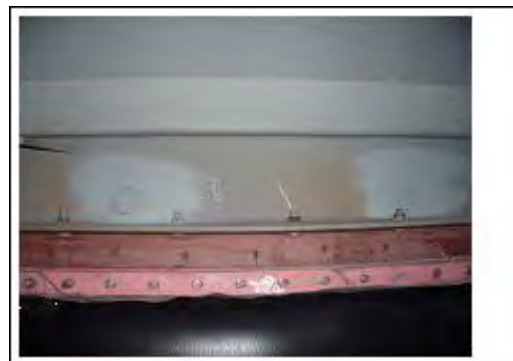
- 'BEFORE' AND 'AFTER' INSPECTION OF INSULATING COMPOUND APPLICATION
