Corrosion in Systems Storing and Dispensing Ultra Low Sulfur Diesel (ULSD)

> Lorri Grainawi Director of Technical Services STI/SPFA June 17, 2014

#### **Corrosion Related to ULSD**

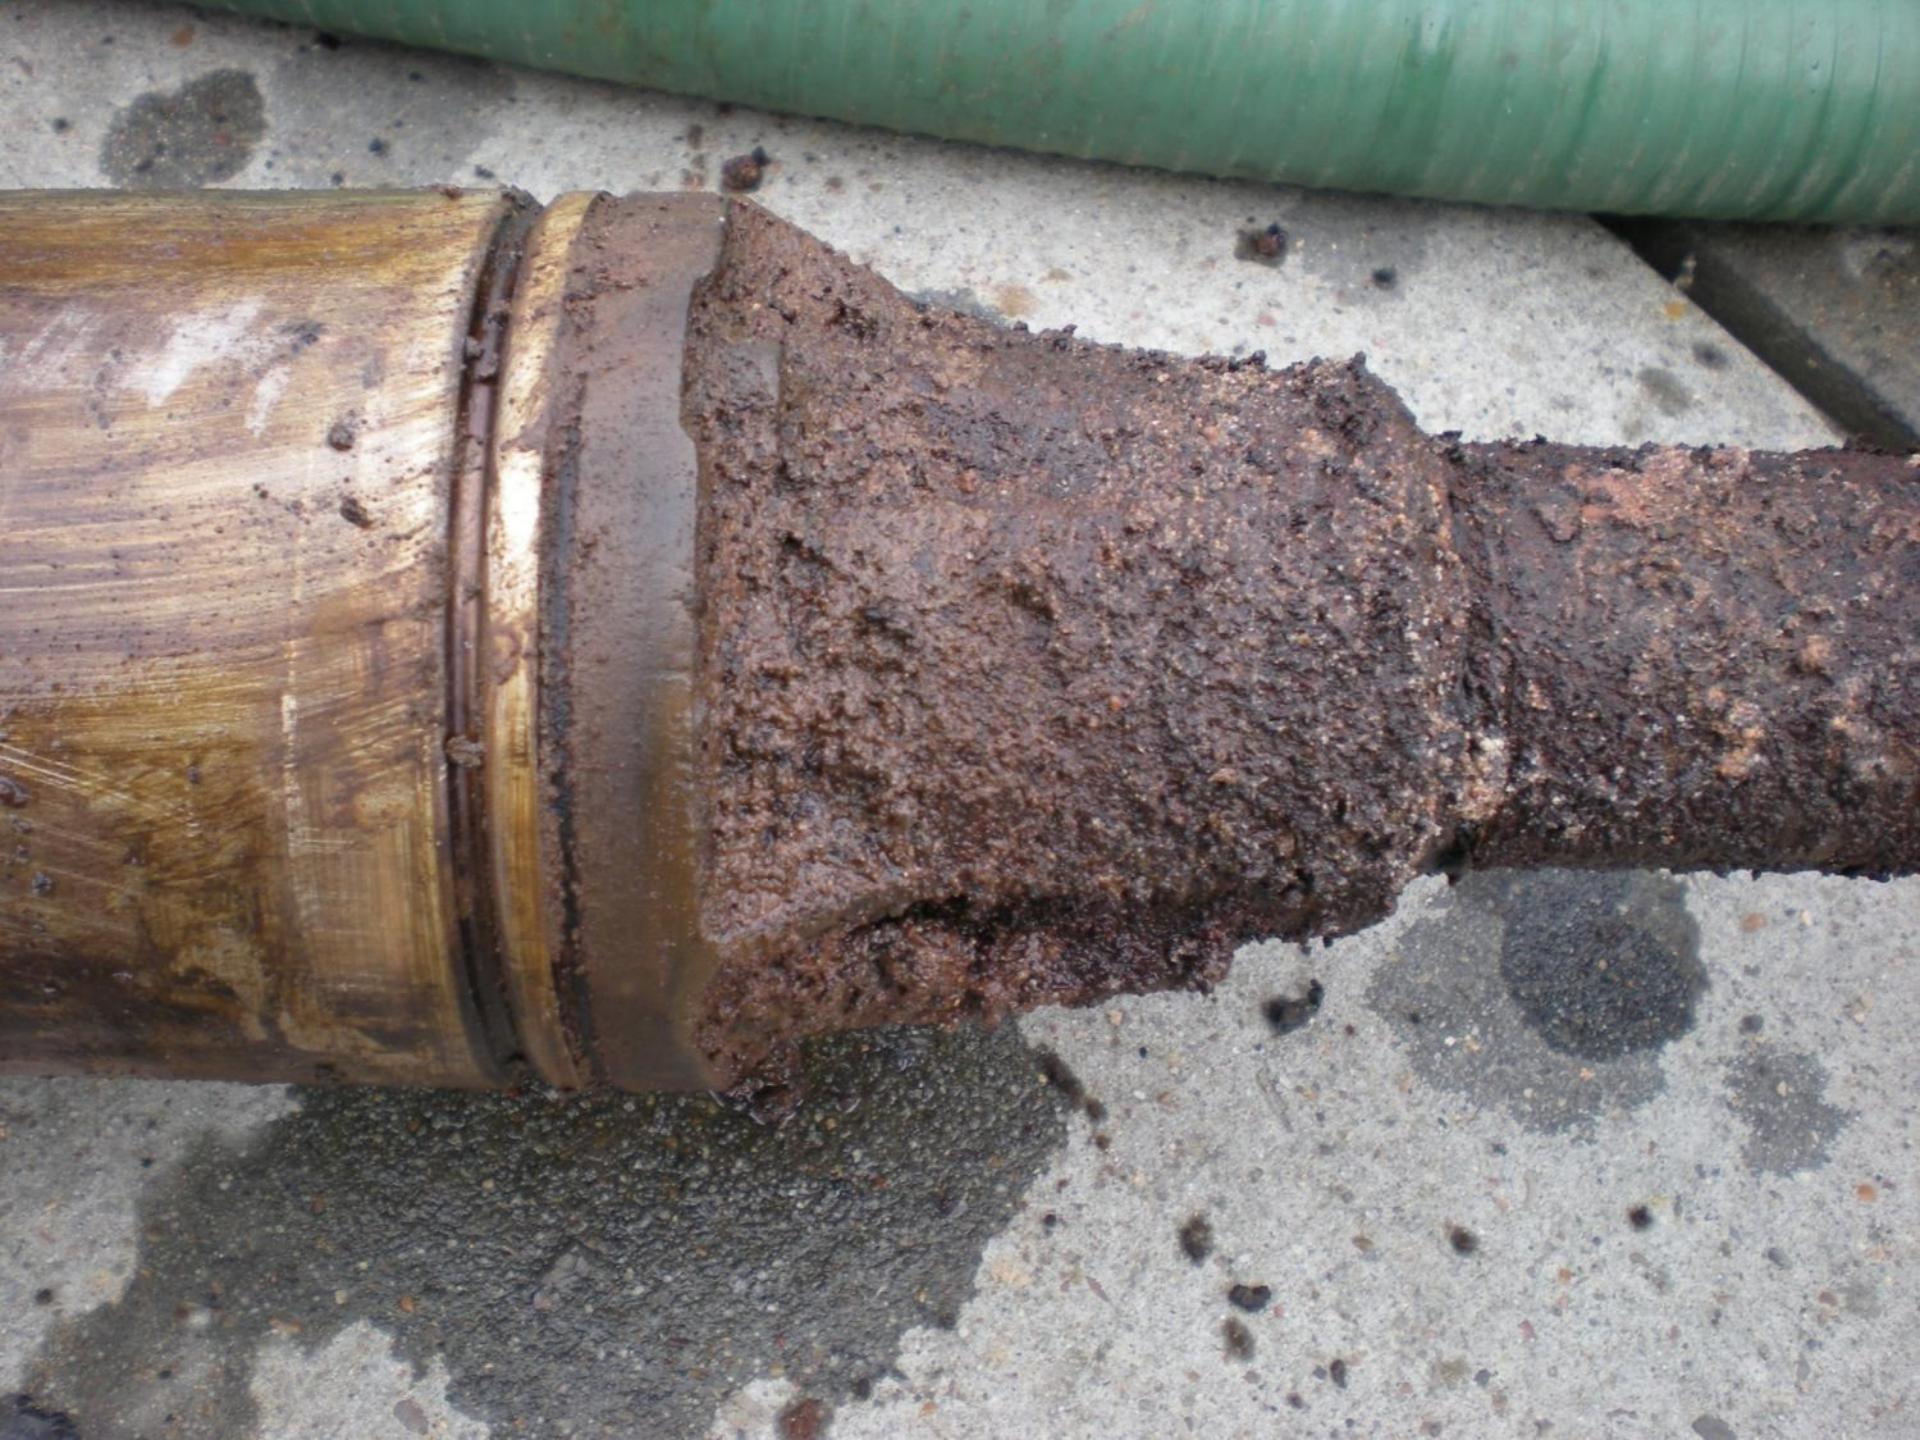
#### STP column pipe inside FRP tank

Upper section of STP – vapor only

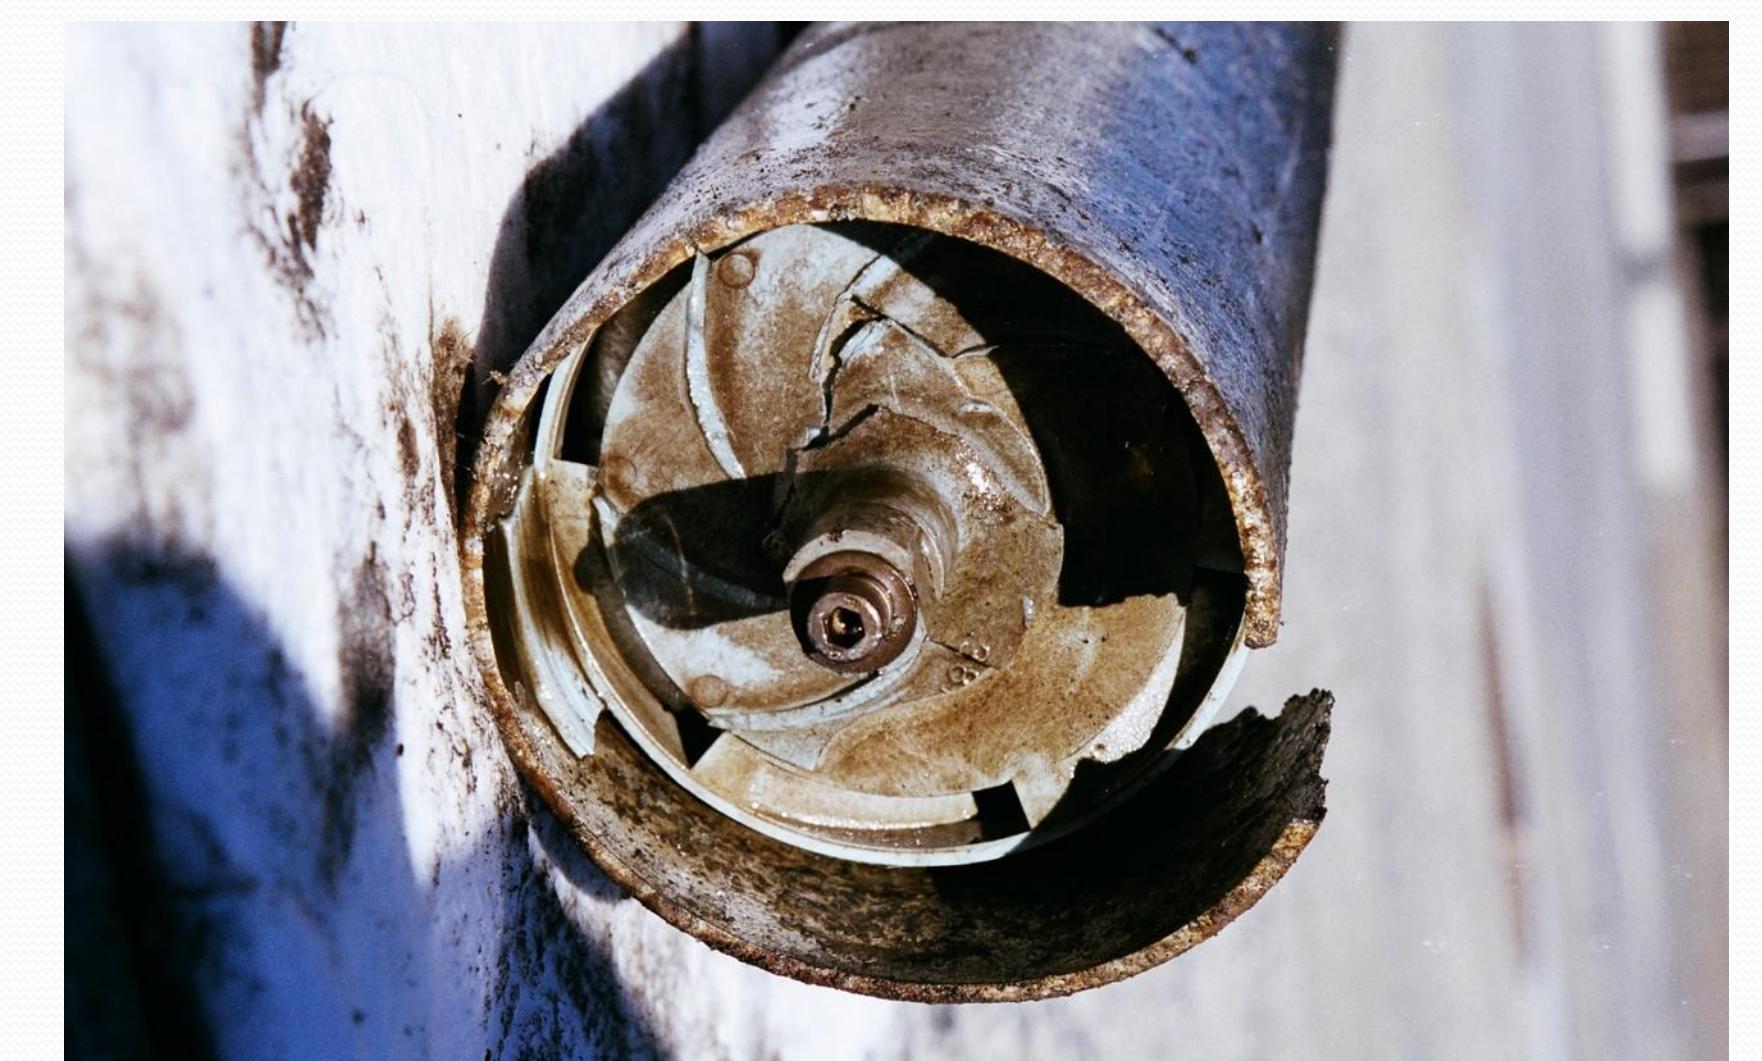
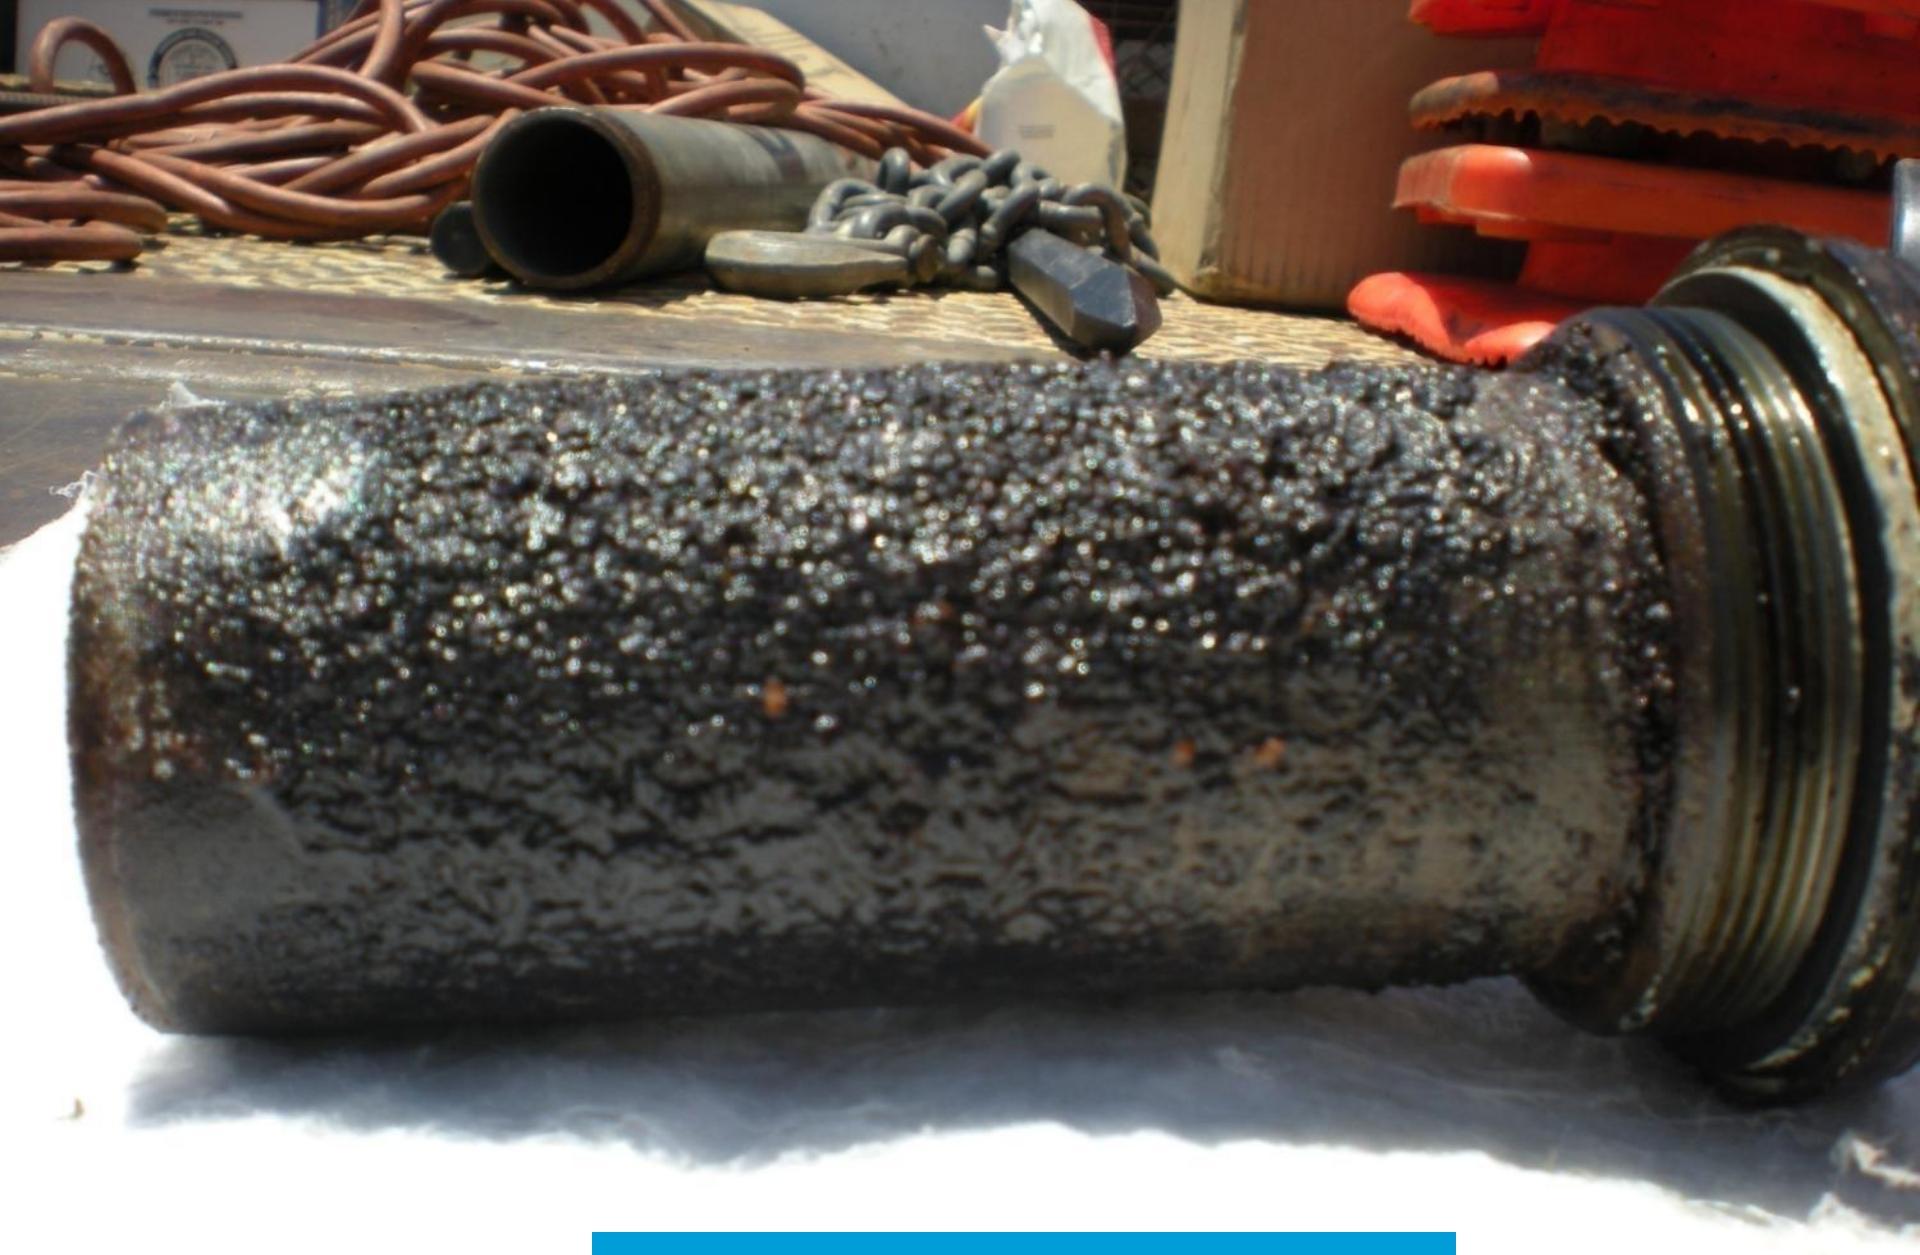
#### Pump connection corroded thru

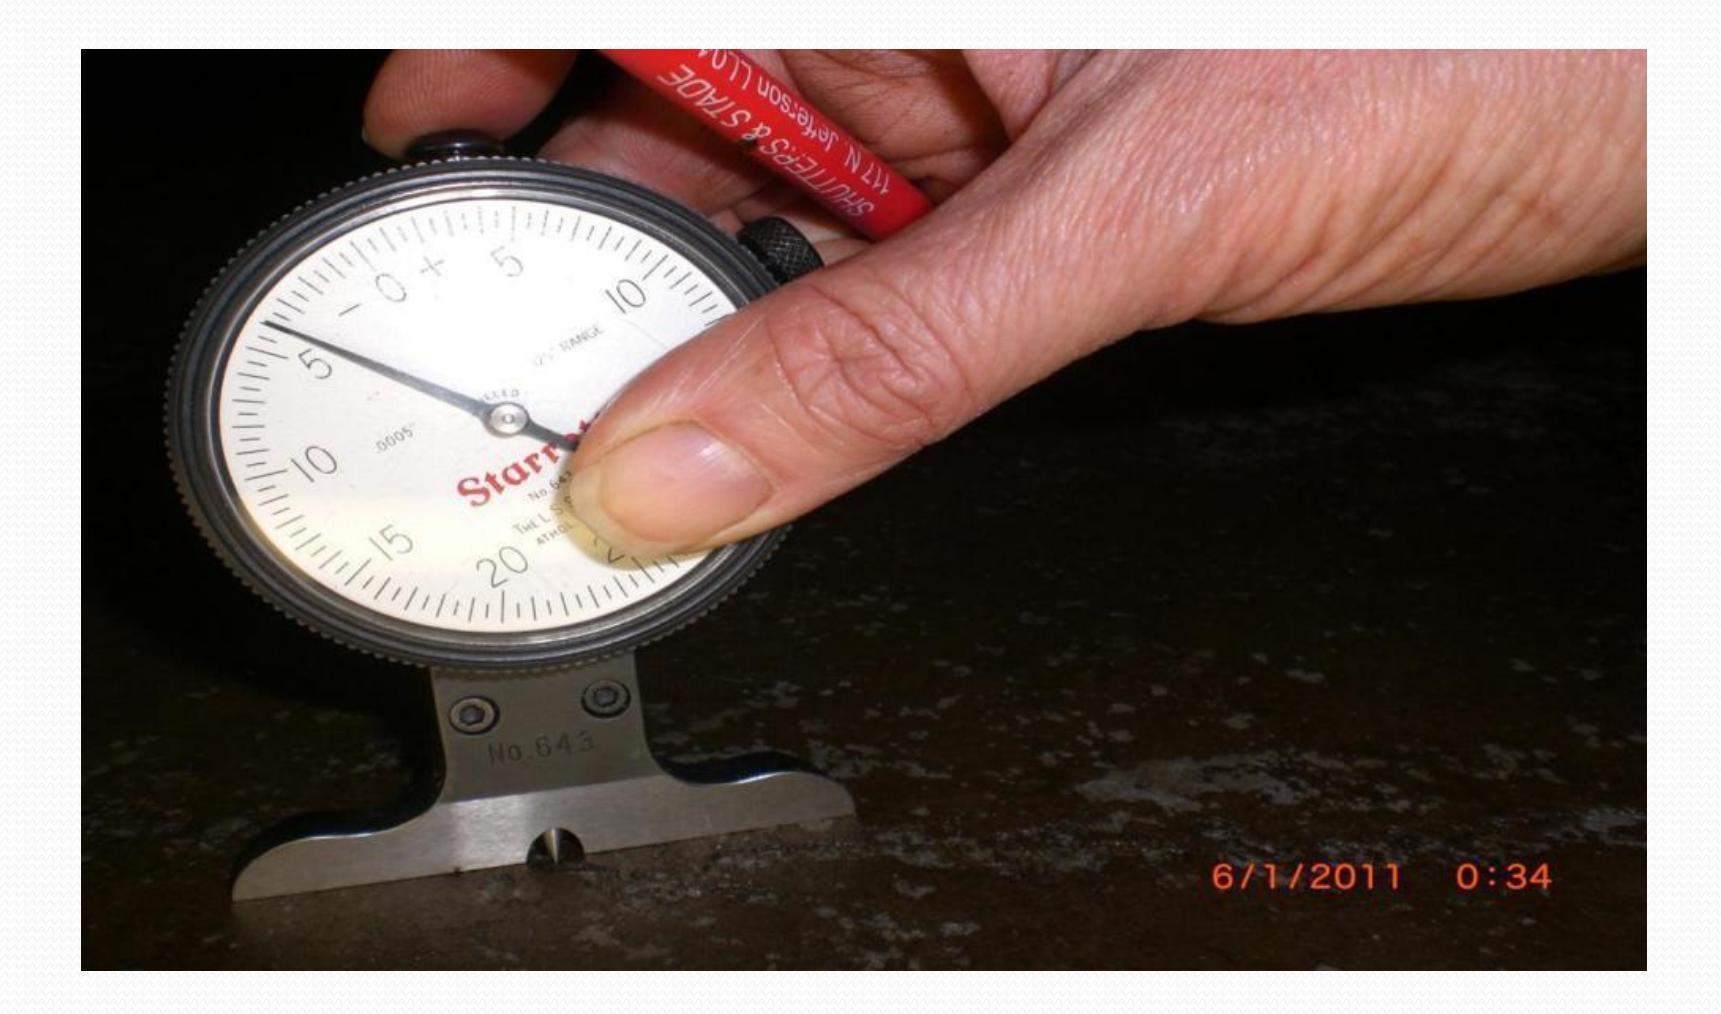
#### Steel Tanks – Different issues

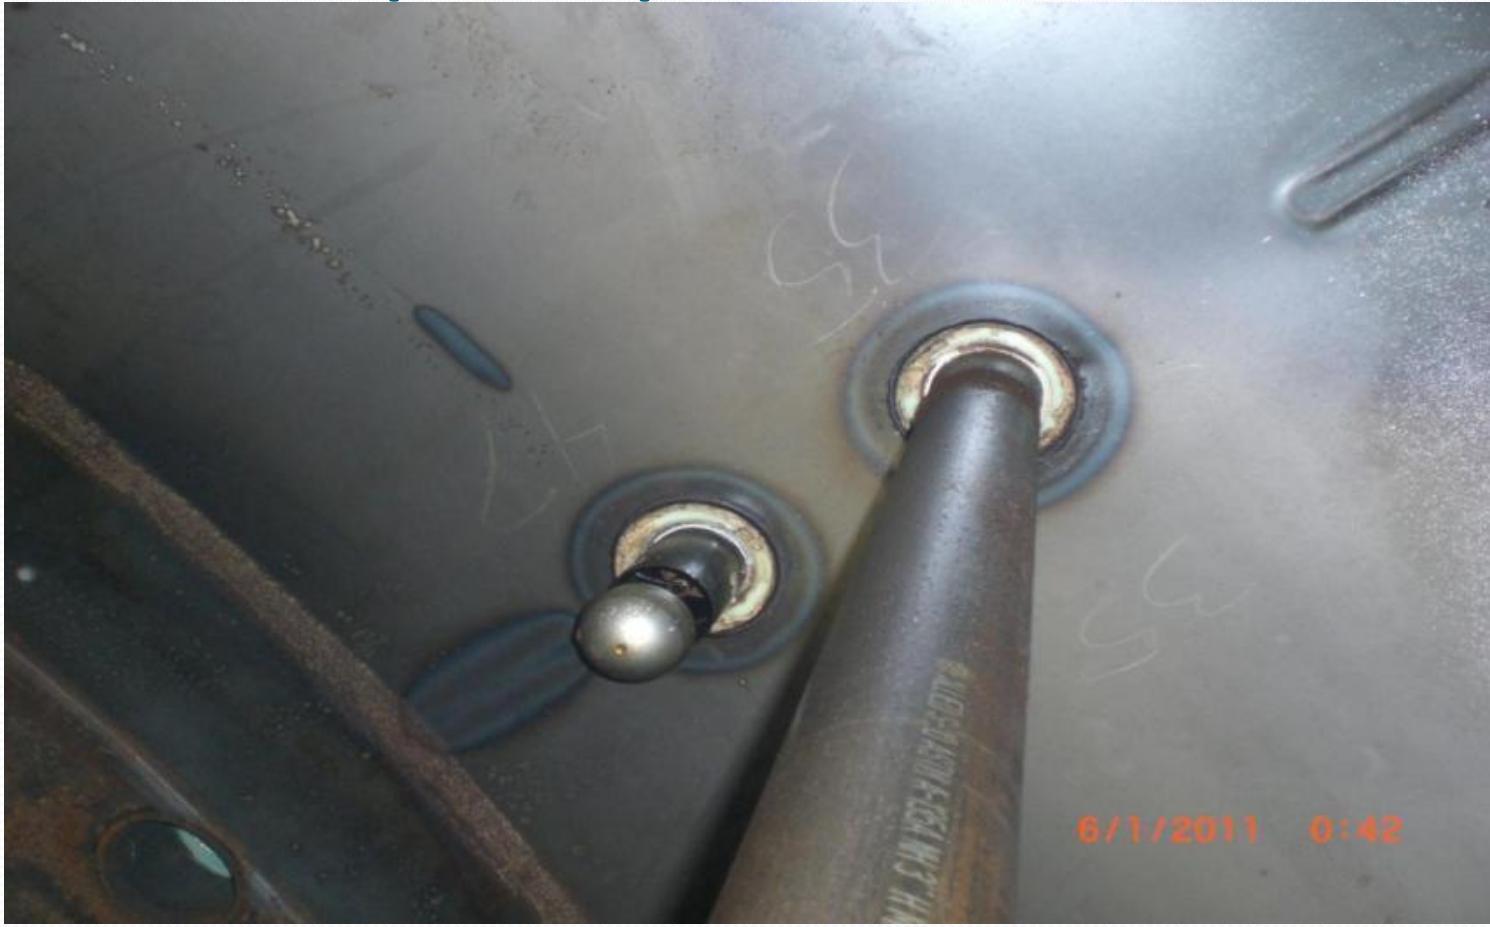
#### Steel Tank Top Vapor Space is Clean

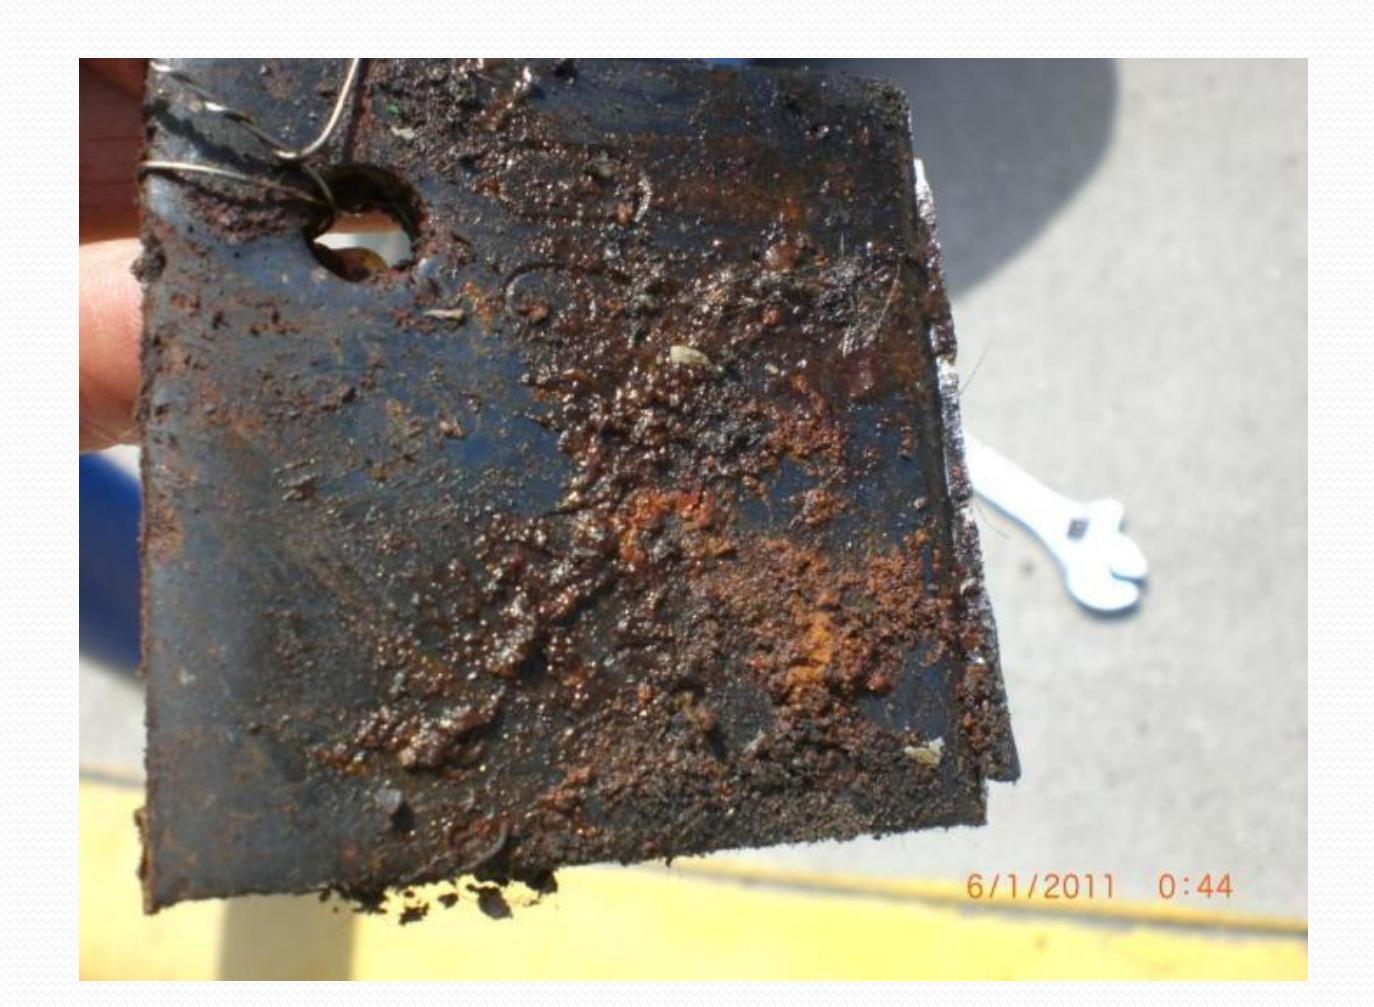
#### **Steel Coupon in Tank Bottom**

Some sludge is evident, but no corrosion pits.

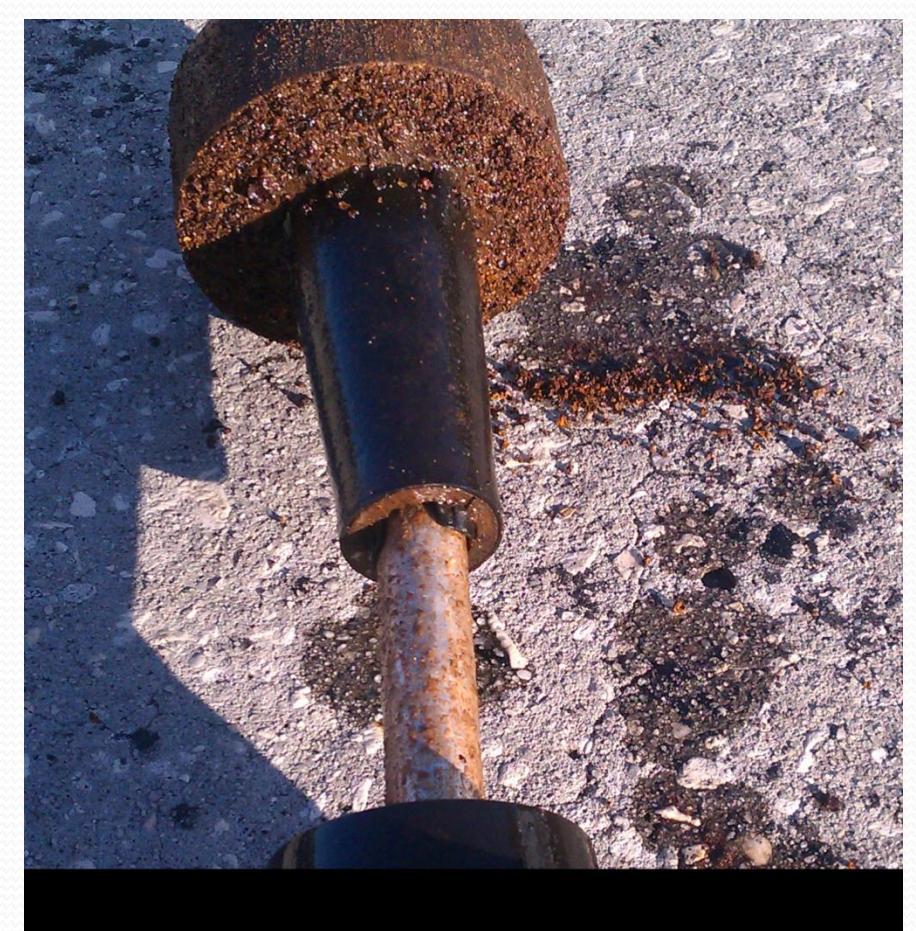
# Equipment from Southeast Region in fiberglass tank

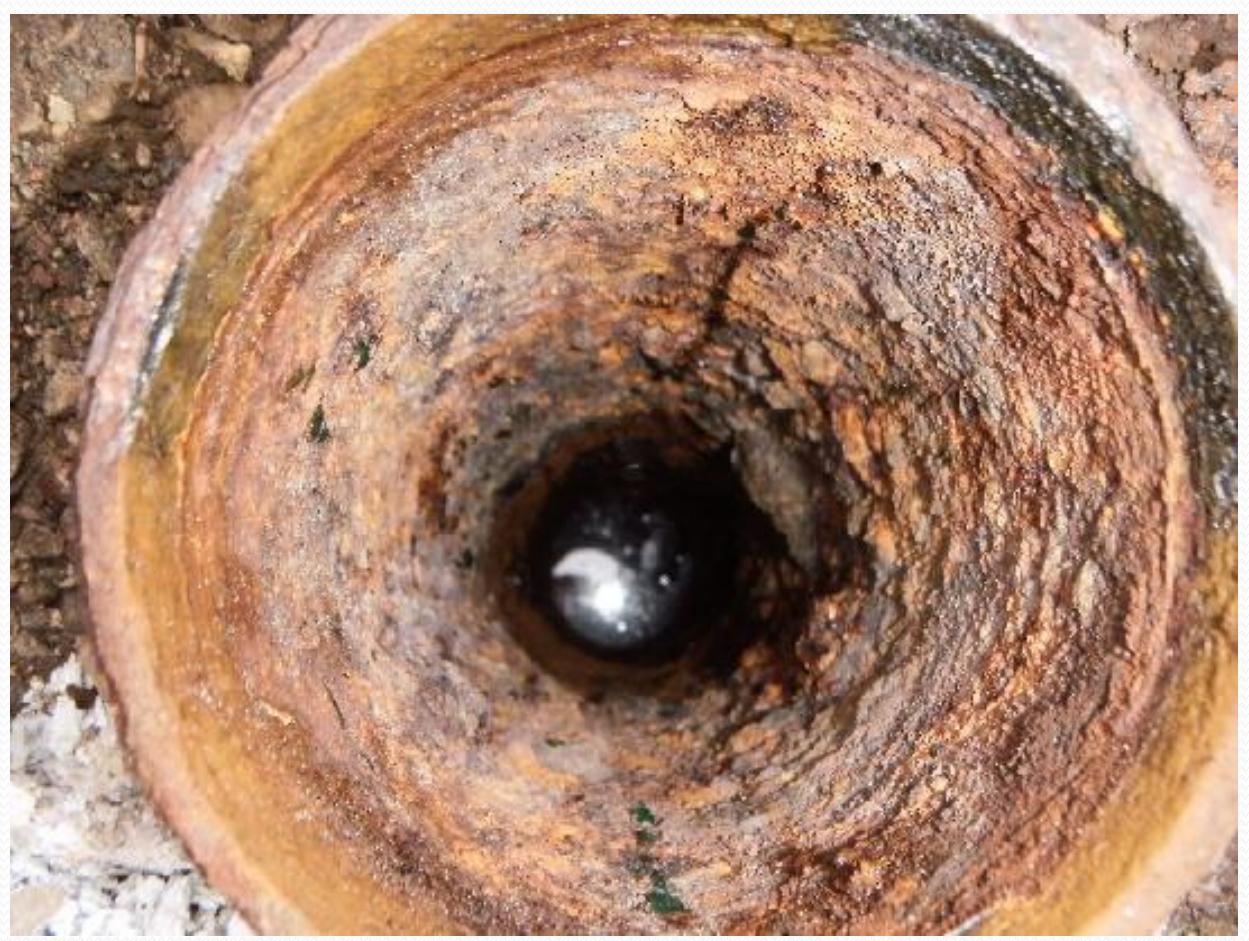
# FRP tank riser NW area Acetate 462 ppm

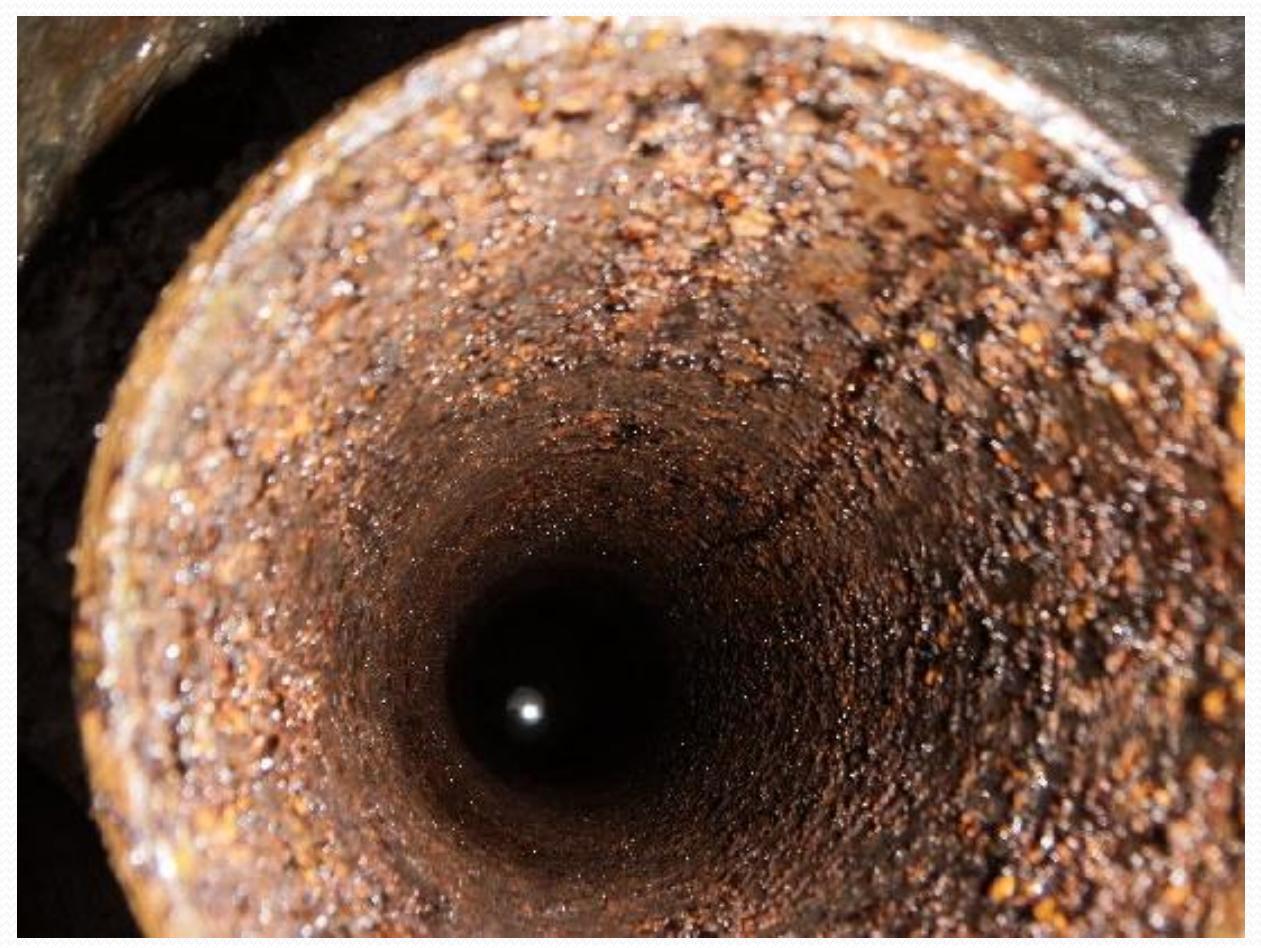
## Steel Tank riser, NW area Acetate 108 ppm

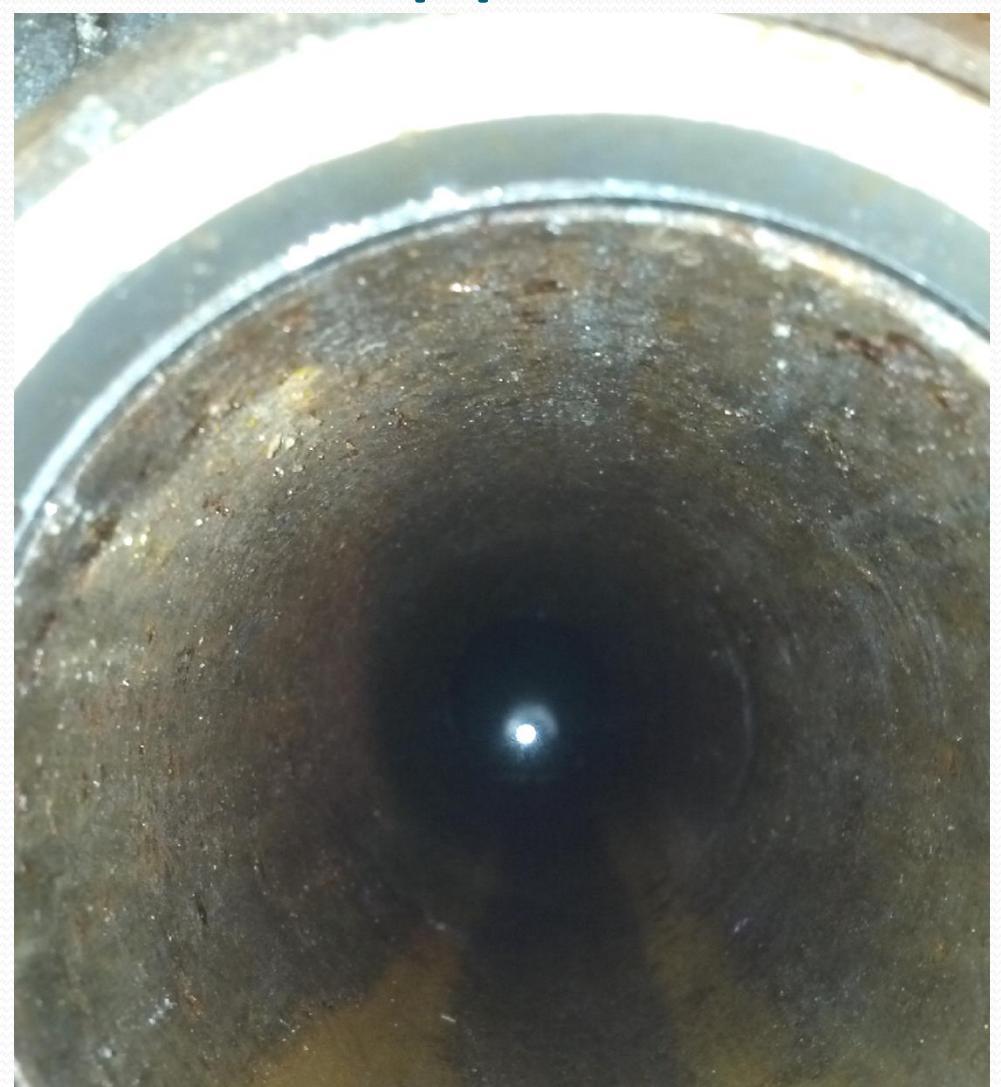
#### FRP riser, MA area Acetate 25,600 ppm

- Hypothesis that high acetate would indicate high corrosion
- Photos of risers don't indicate this
- Next step cameras inspected inside tanks at 3 locations

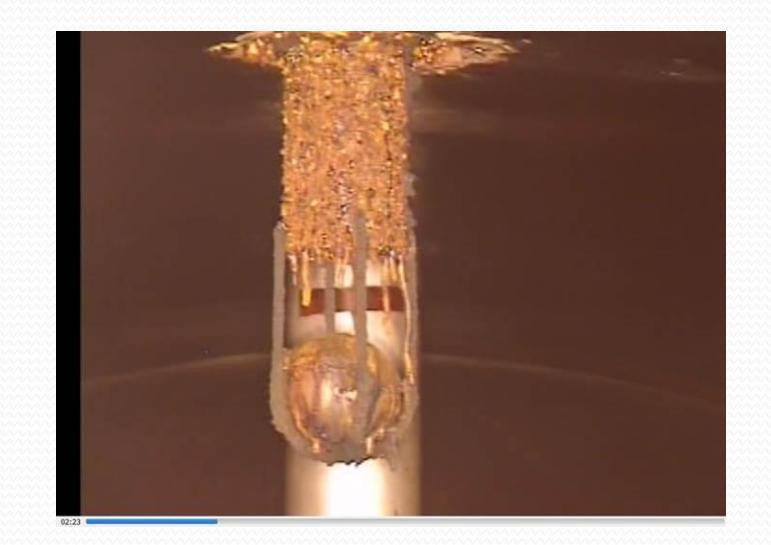
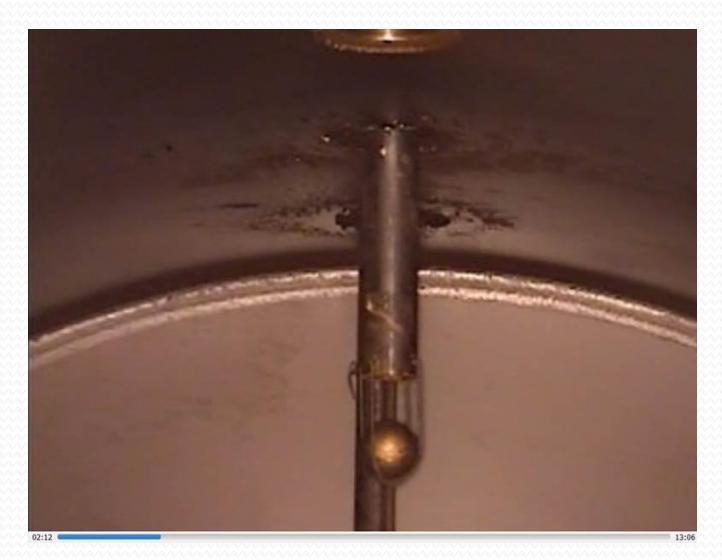
- Las Vegas service stations tanks under same owner
- FRP tank vapor control fitting top right photo
- Steel tank vapor control fitting – bottom right photo
