Addressing Defective Cathodic Protection Systems On Above Grade Storage Tanks

NISTM-2013

Ralph Eichlin
Corrosion Control
Incorporated

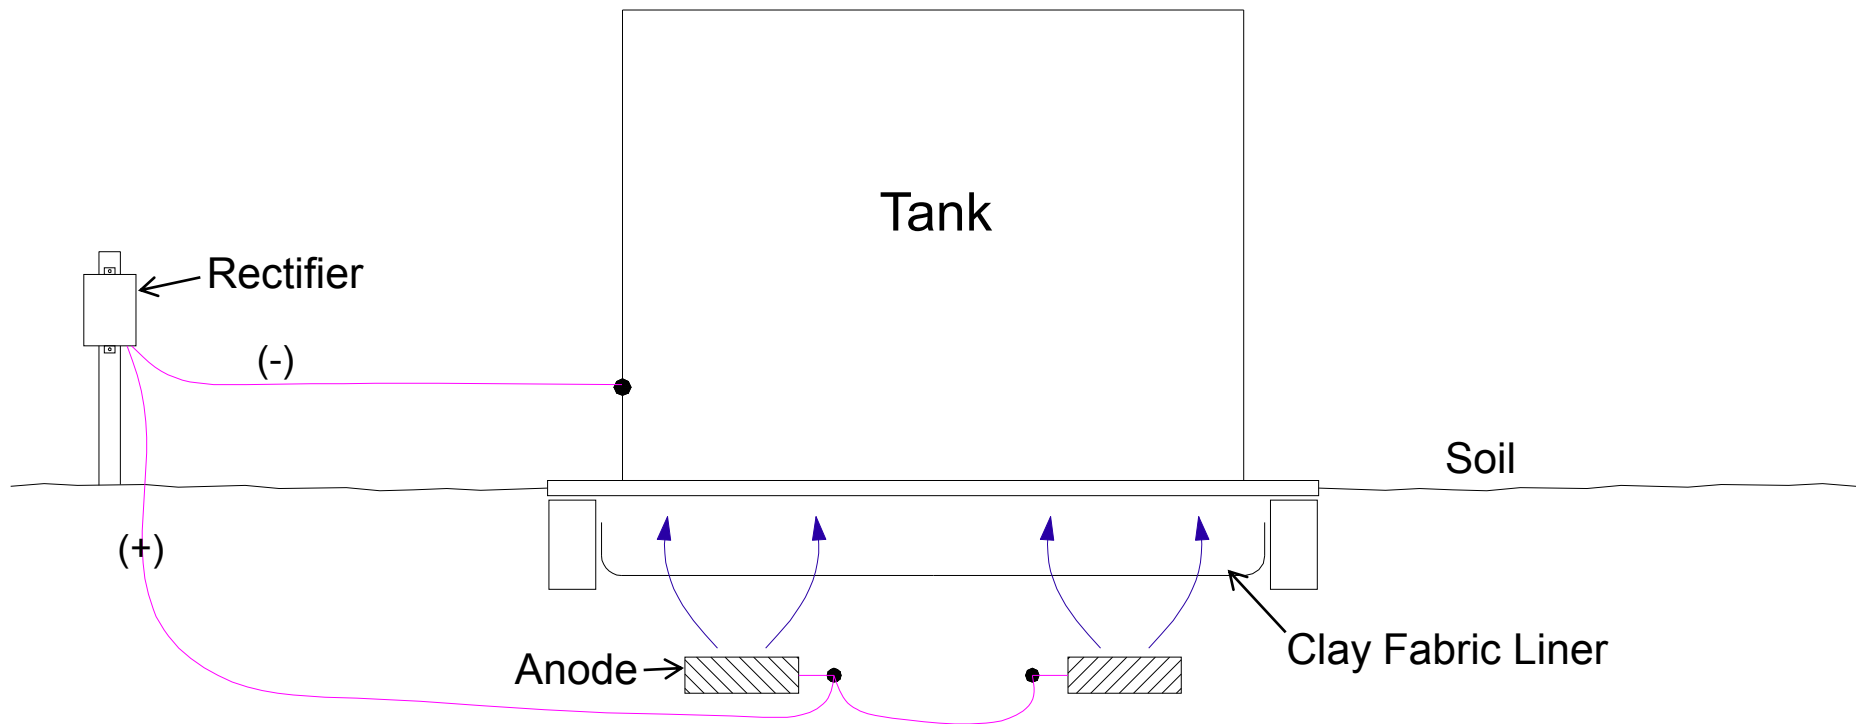
Clay Fabric Containment Liner

- Current passes through liner
- Anodes can be placed below liner or around tank
- Replacement anodes can be placed around tank

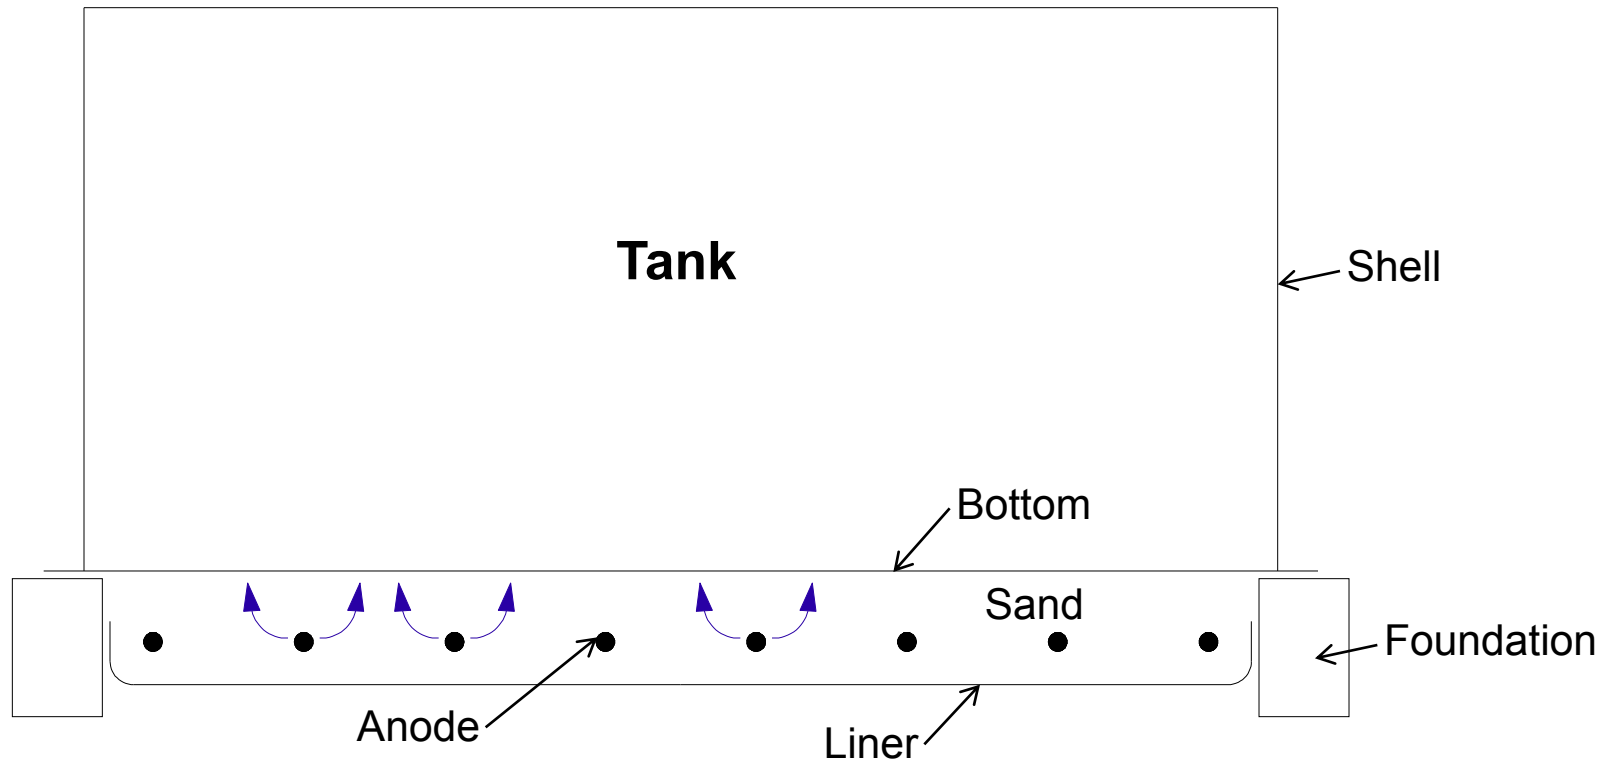
Cathodic Protection – Plastic Liner

- Anodes are placed in sand between liner and tank bottom
- Anodes can not come in contact with tank bottom
- Distance between anode and floor determines current distribution

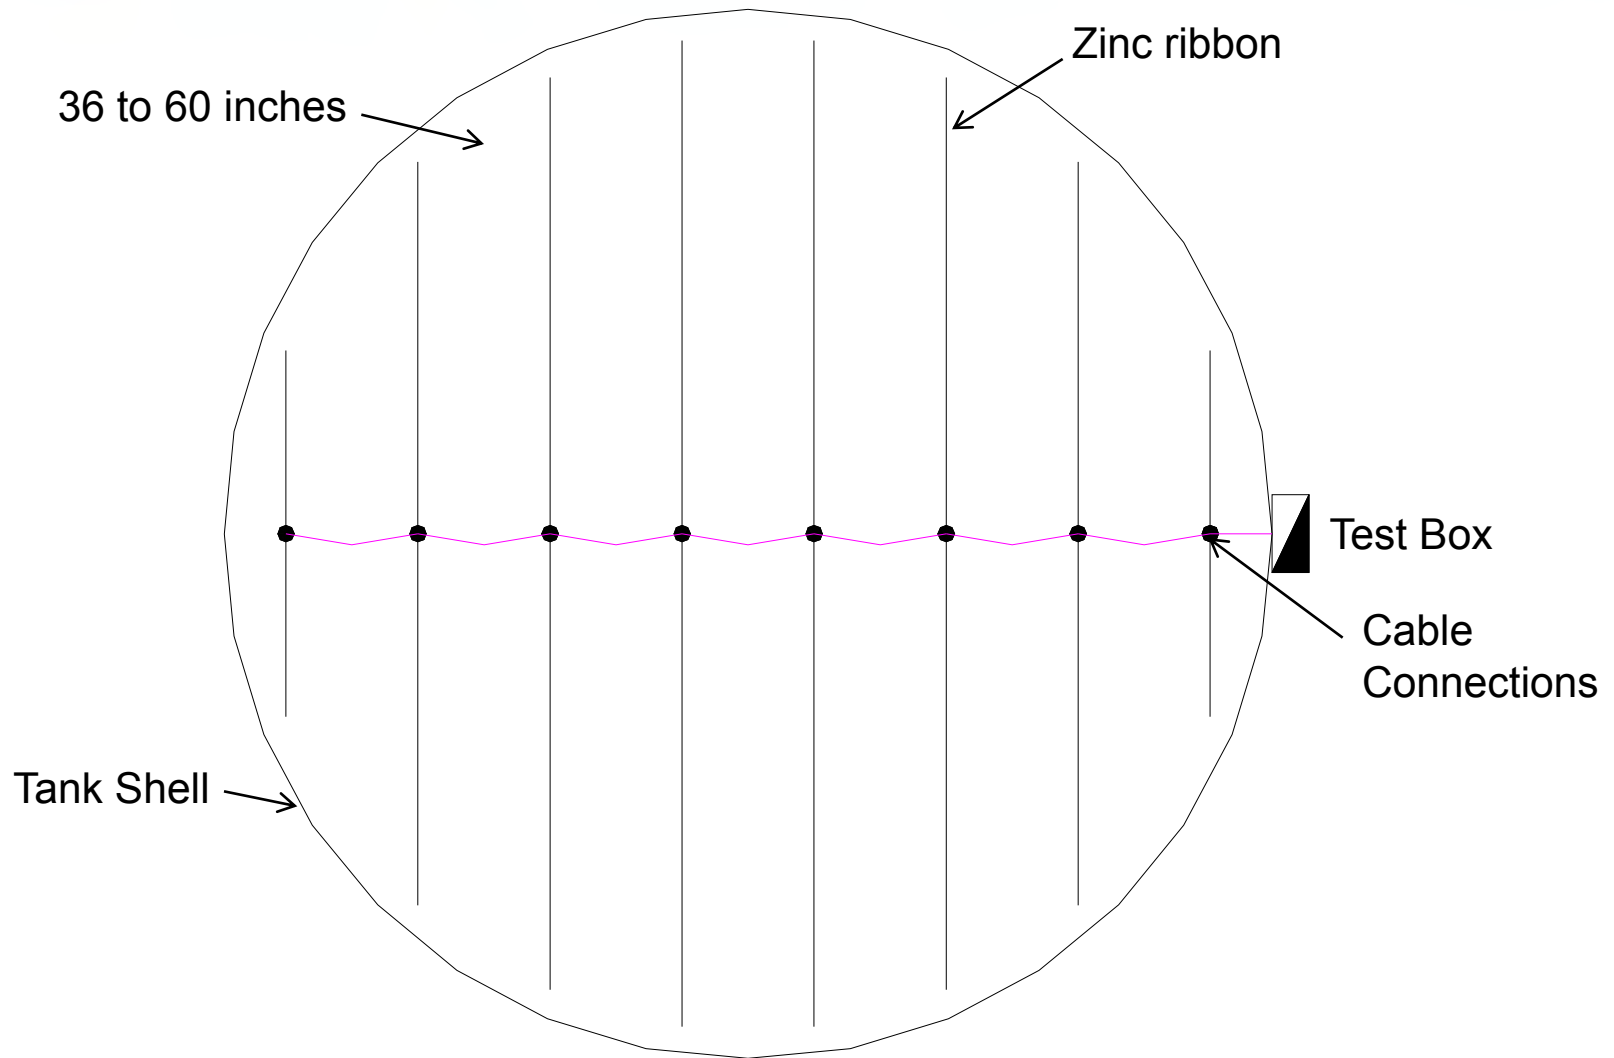
Zinc Anode Ribbons

- **Spacing between ribbons must adequate to provide current distribution**
- **Sand fill can not be corrosive, and must remain relatively dry**
- **When moisture enters the sand, most galvanic systems continue to protect the tank bottom but a shorter anode service life may result.**
- **Some early galvanic ribbon systems were actually used to detect leaks**

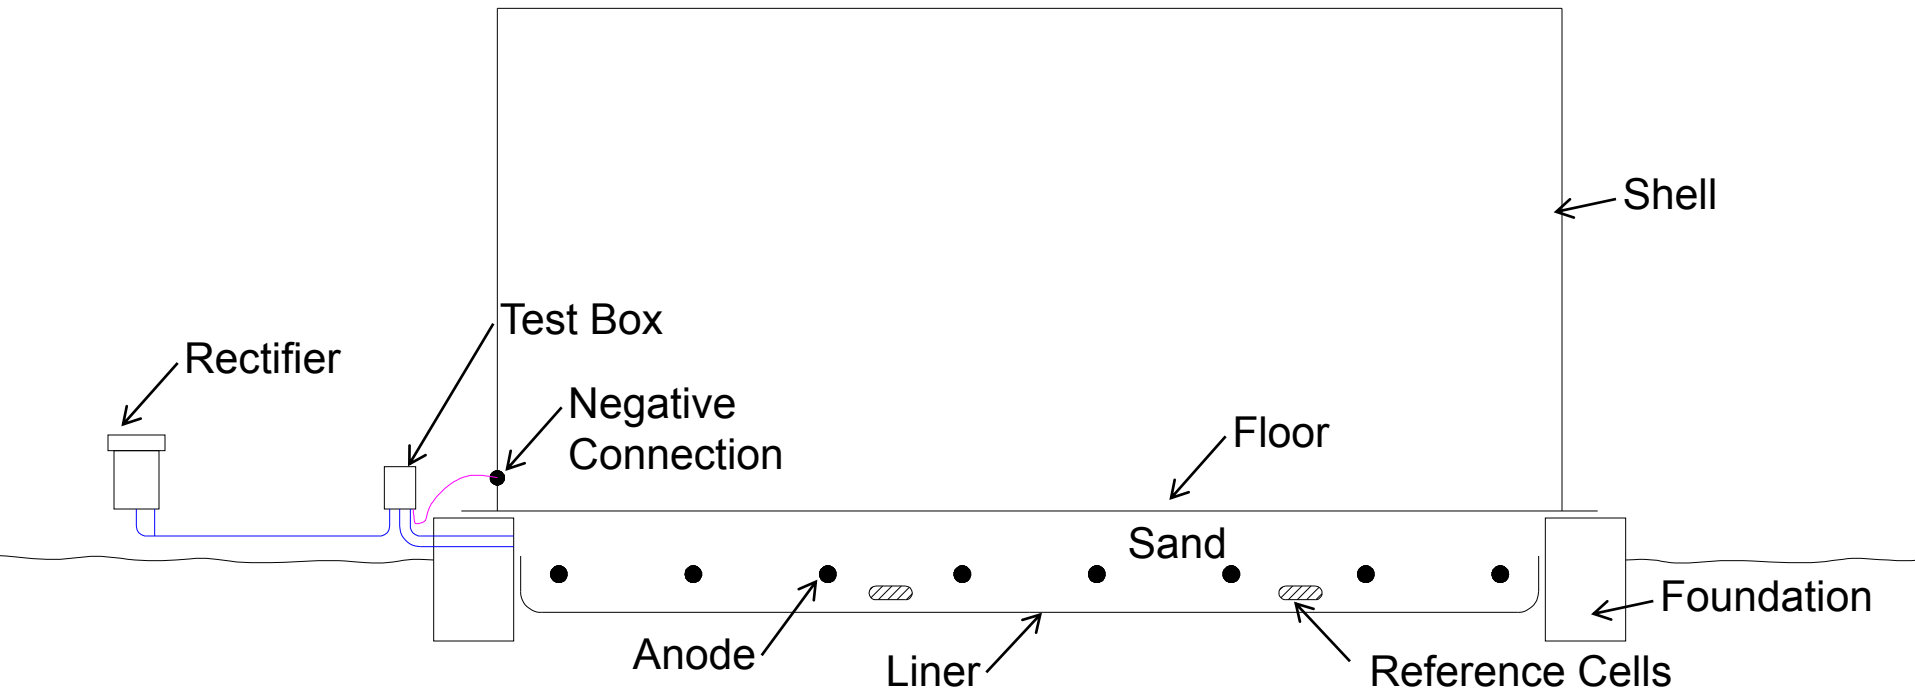
Impressed Current

- Rectifier supplies current to anodes in sand
- Anodes deliver current to floor which is returned to rectifier
- Reference cells are used to monitor protection levels

- **Rectifier inoperable or not properly adjusted**
- **Cables between rectifier and anode box are severed**
- **Anodes are spaced too far apart**
- **Anode ratings are too low**
- **Anodes are grounded to tank bottom**
- **Reference cells are inaccurate or inoperable**
- **Positive and negative cables are connected with the wrong polarity**
- **Sand is too dry**
