Lifting a Steel Pan Roof

Tank

- 100 ft diameter by 48 ft high cone roof tank
- Service: Crude Oil
- Tank removed from service for cleaning and inspection

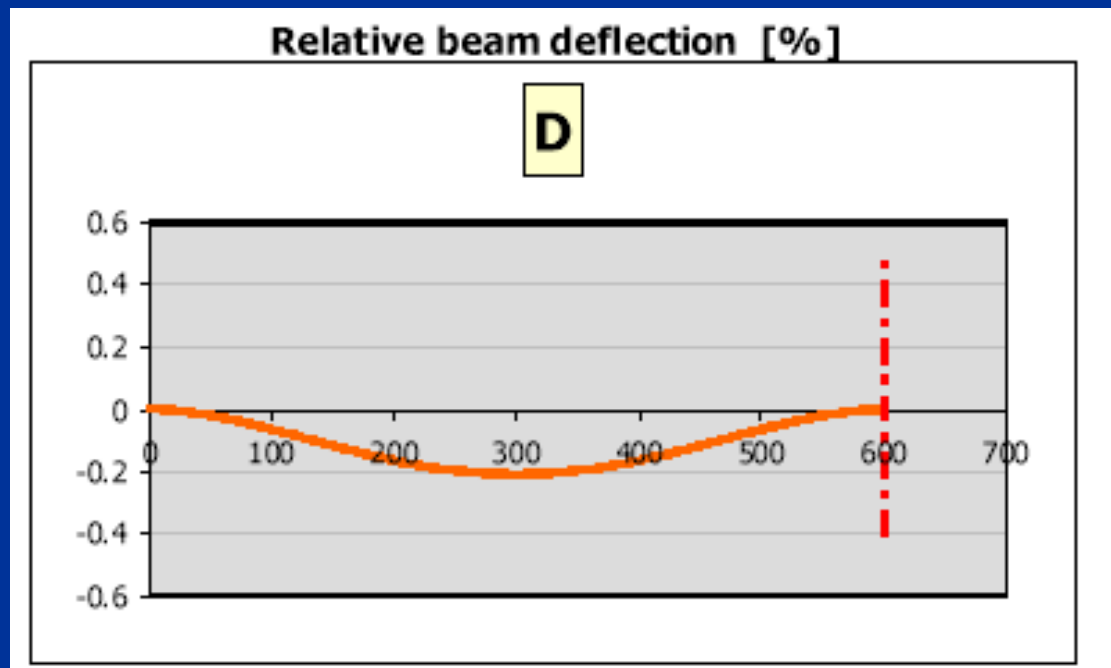
- Found maximum deflection of a rafter was 0.207%

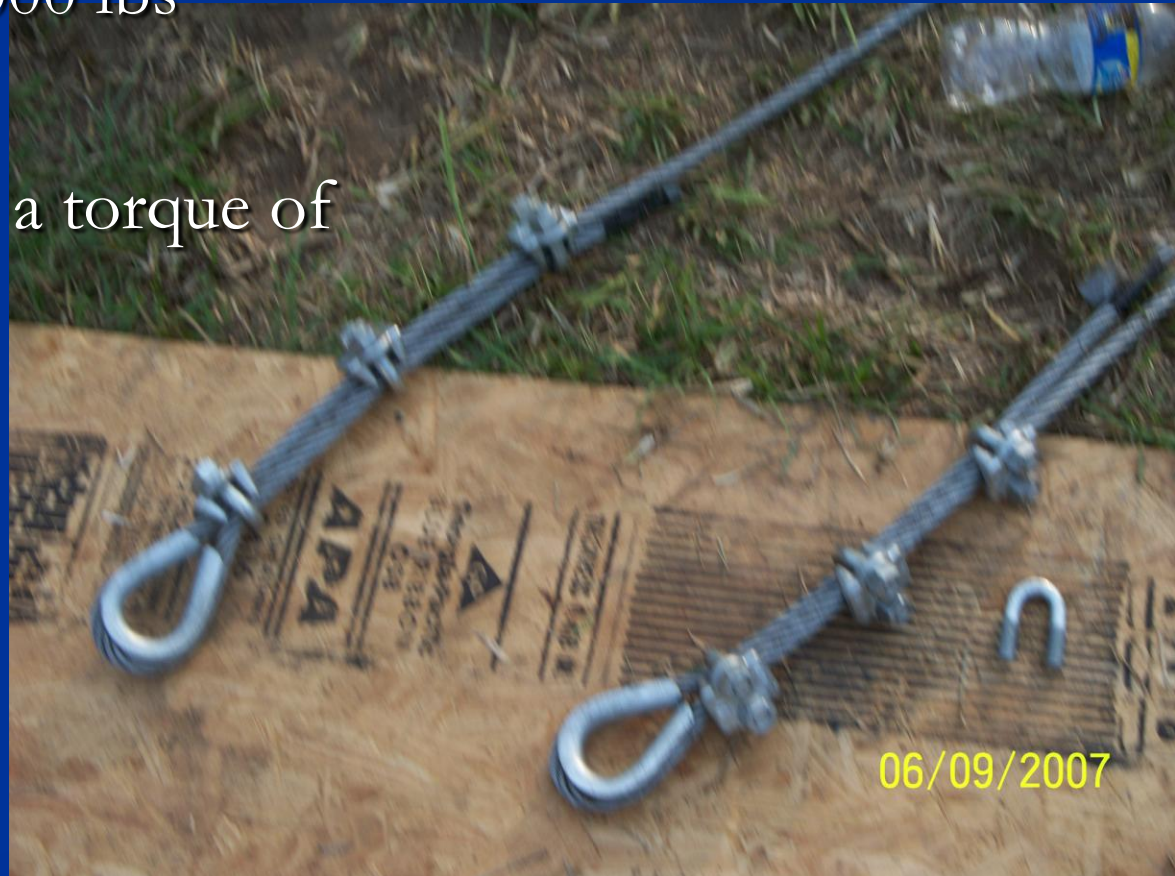
- 1/2" galvanized steel
- Working load of 6,000 lbs
- 1/2" Thimble
- 3 cable clamps with a torque of 68 ft-lbs

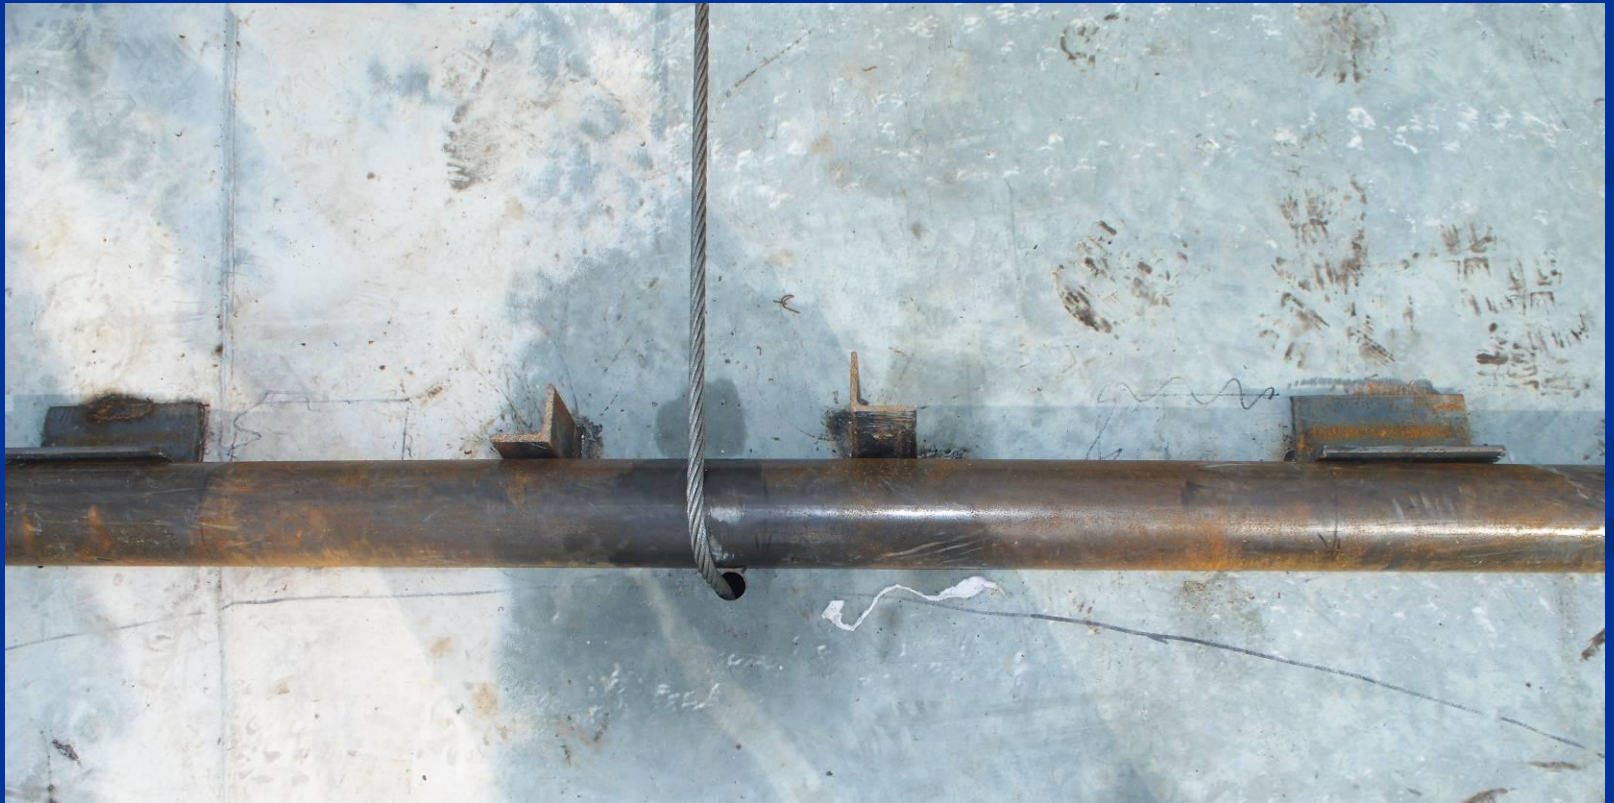
- Cable locations were identified on the roof.
- Pipes located such that the cable loads were distributed over two to three rafters for additional safety.

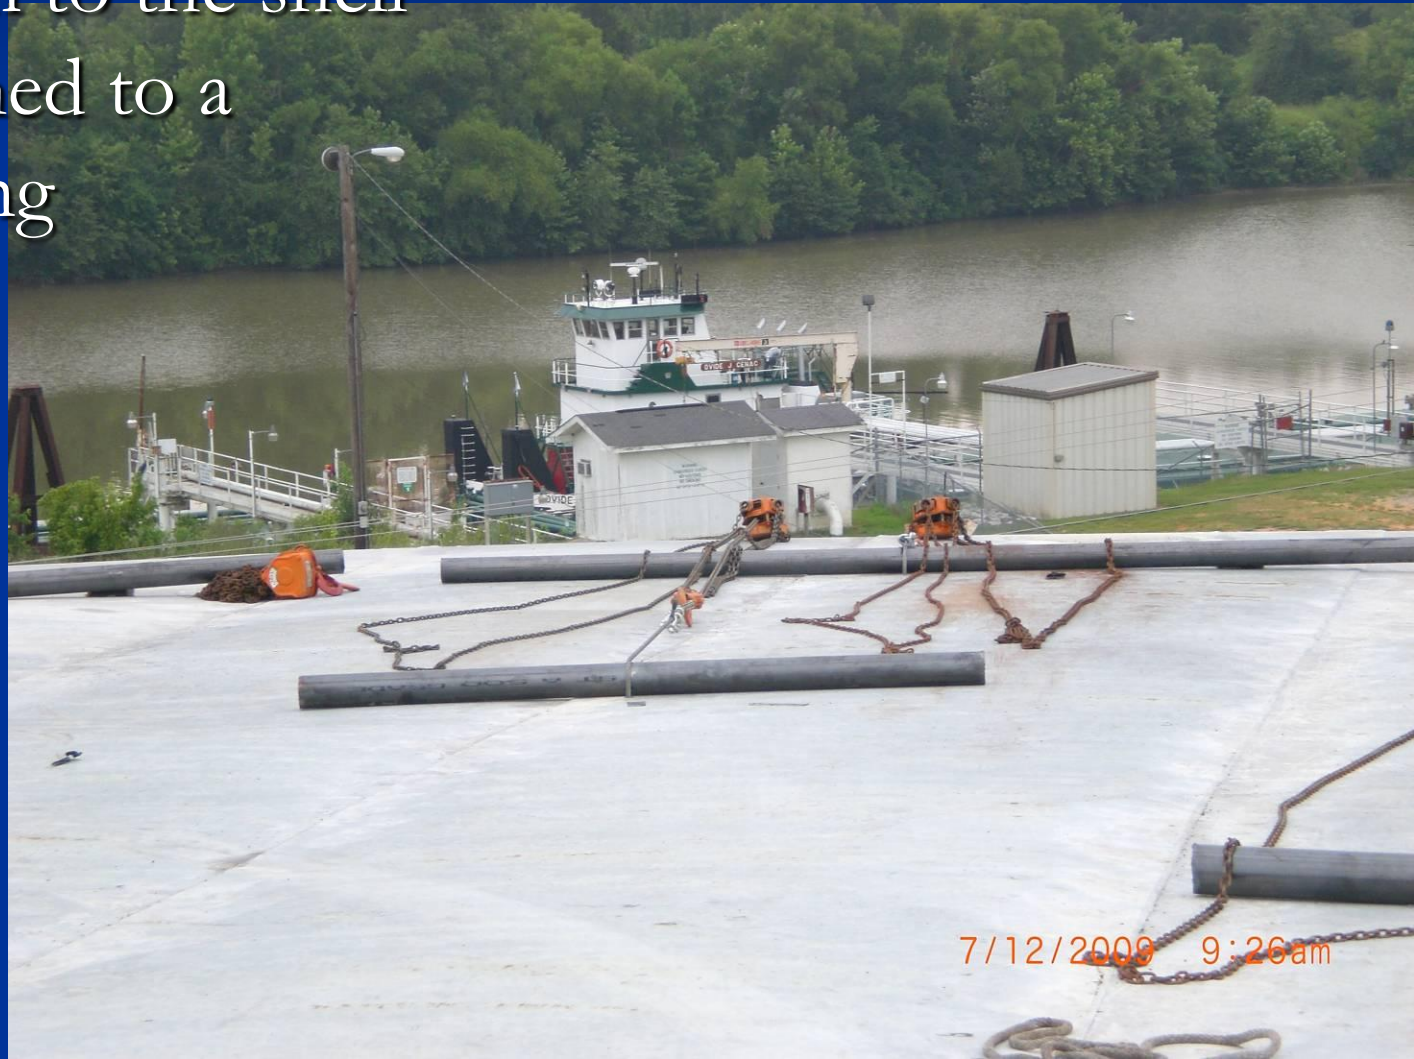
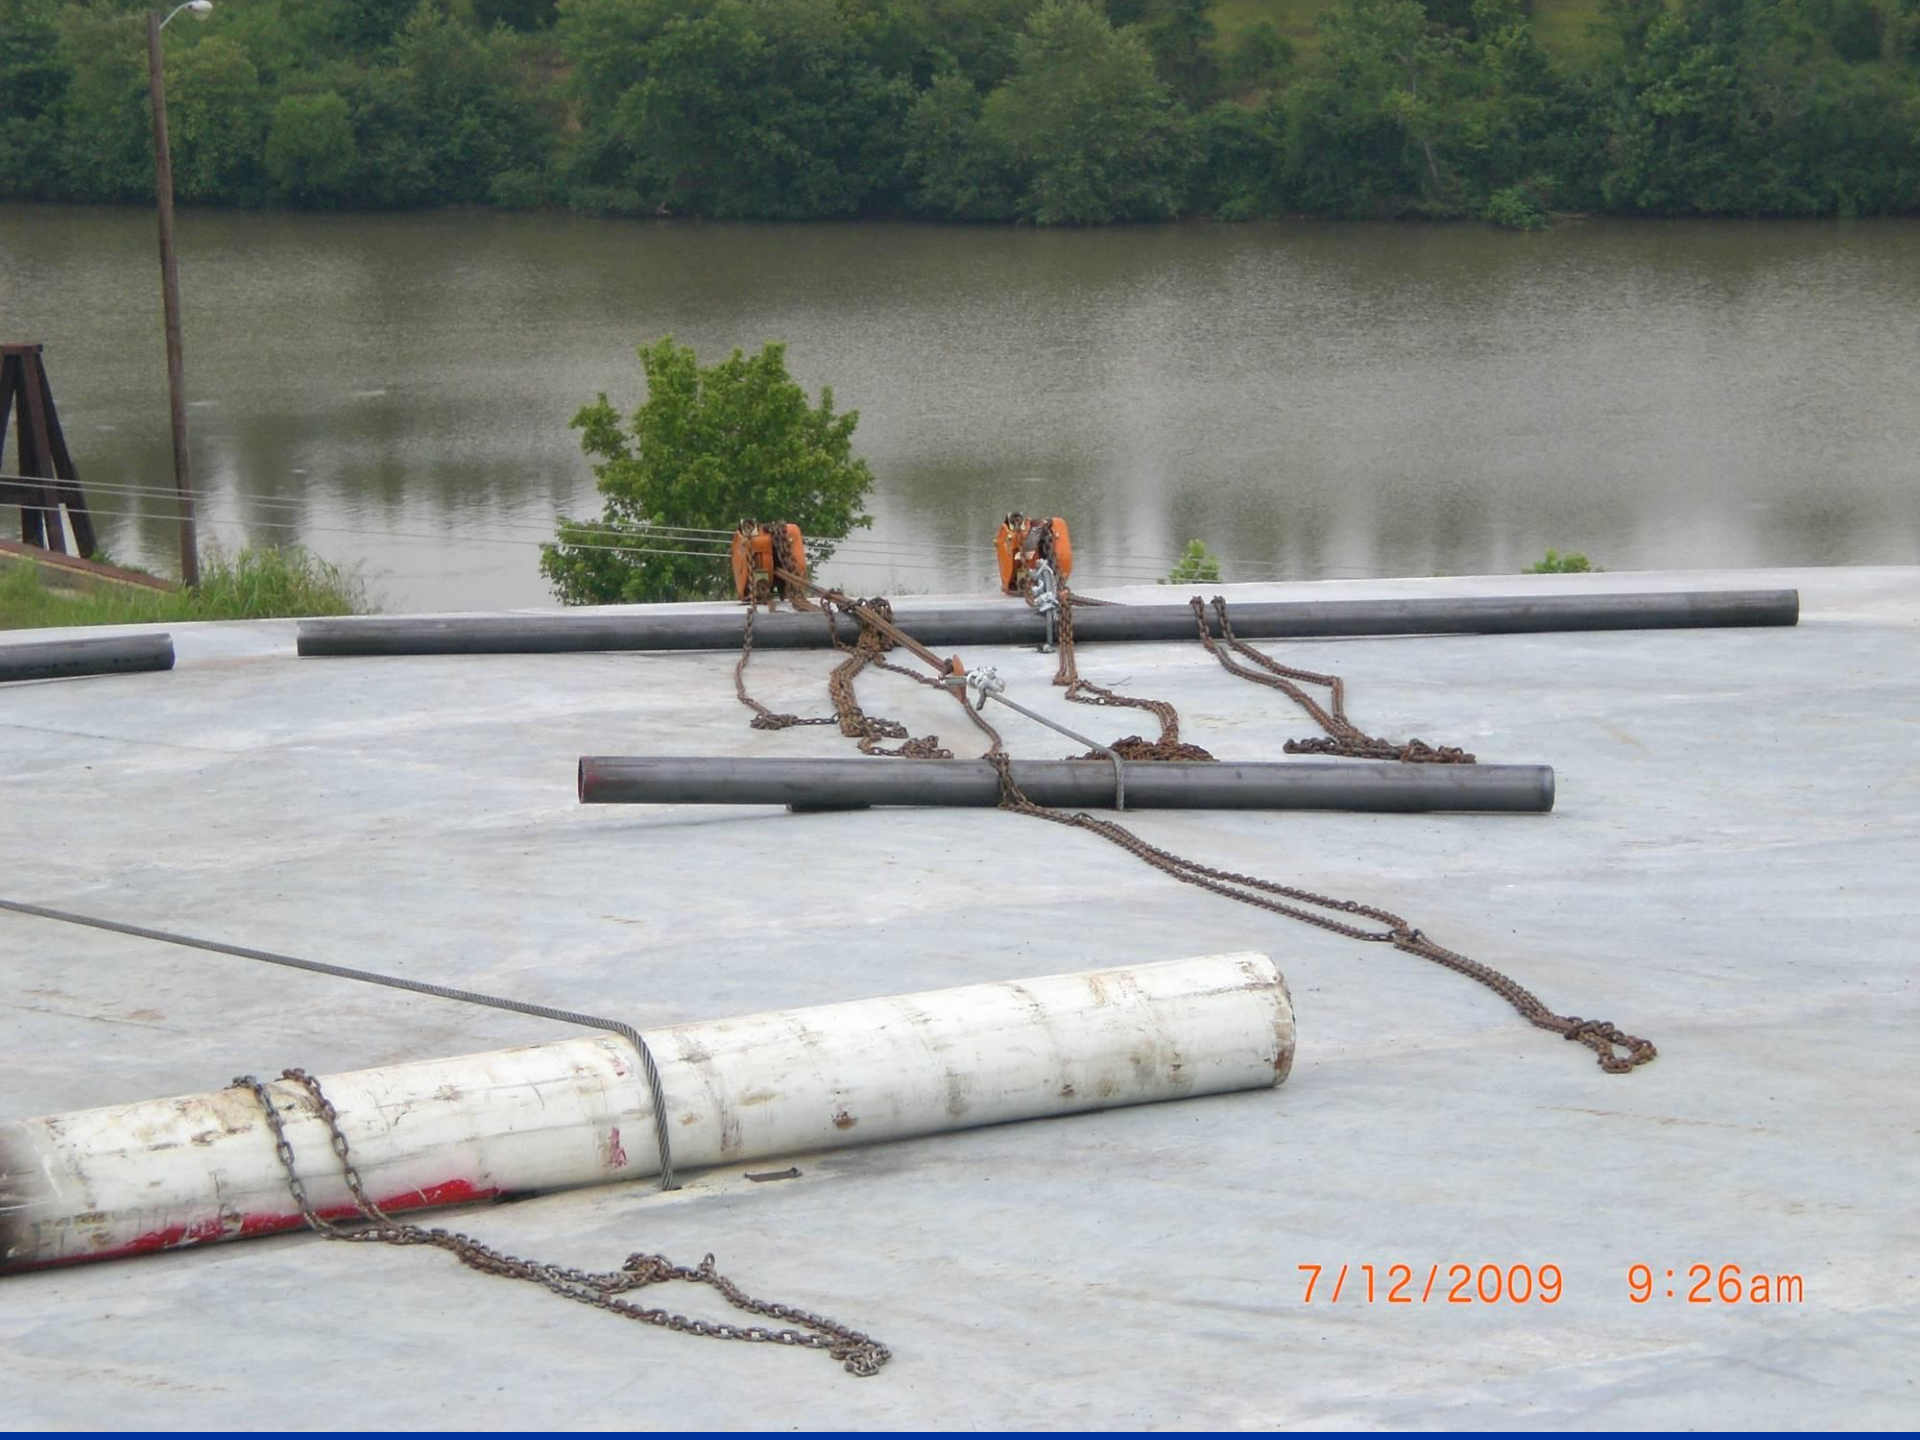
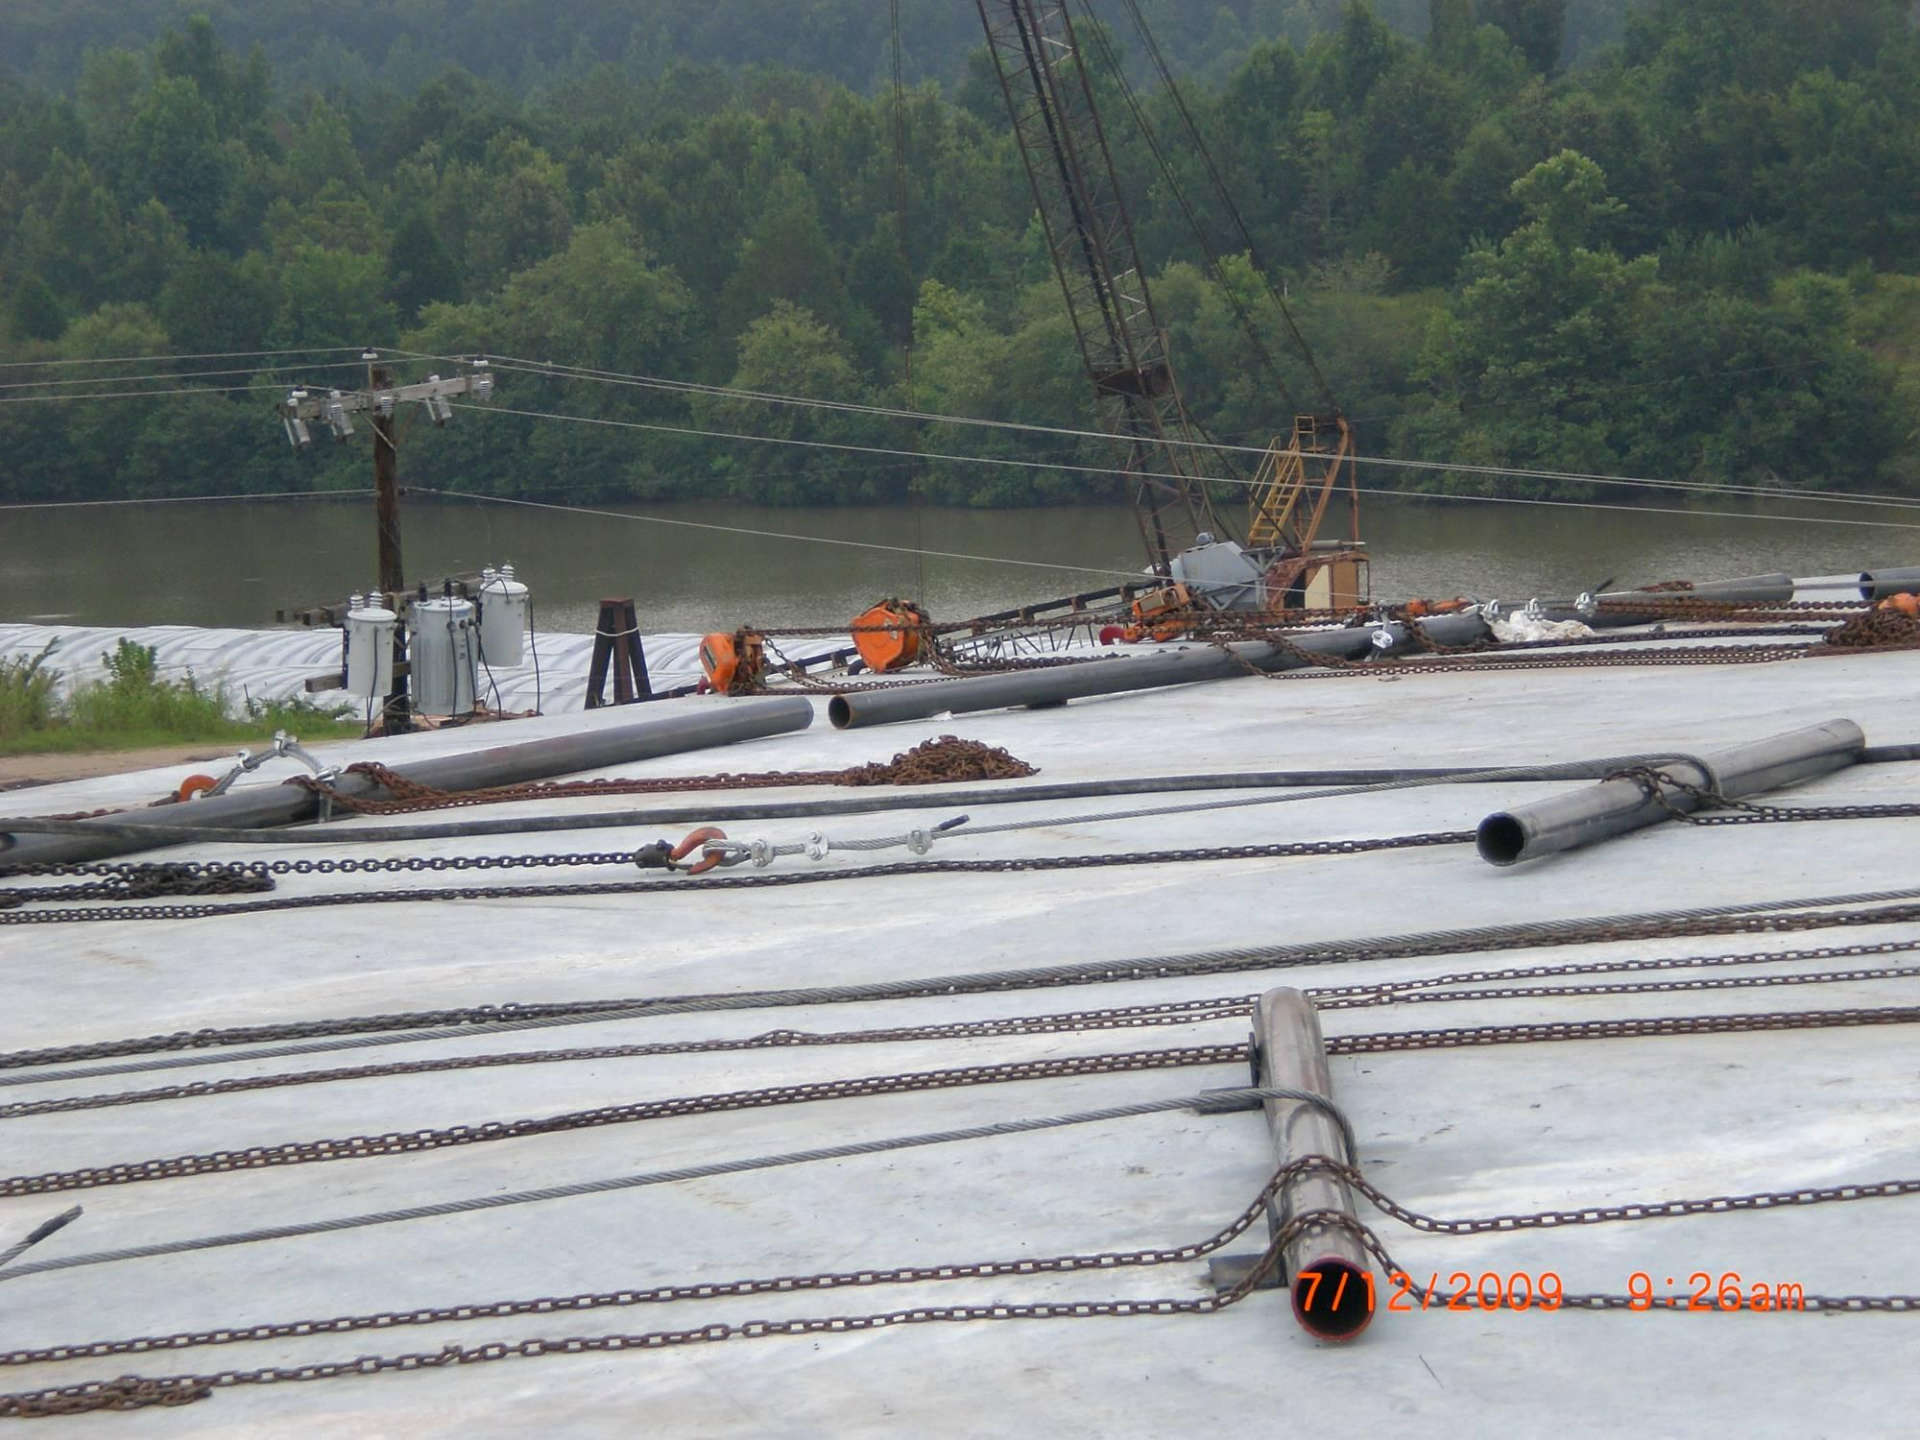
- Cables run to the shell and attached to a come-along

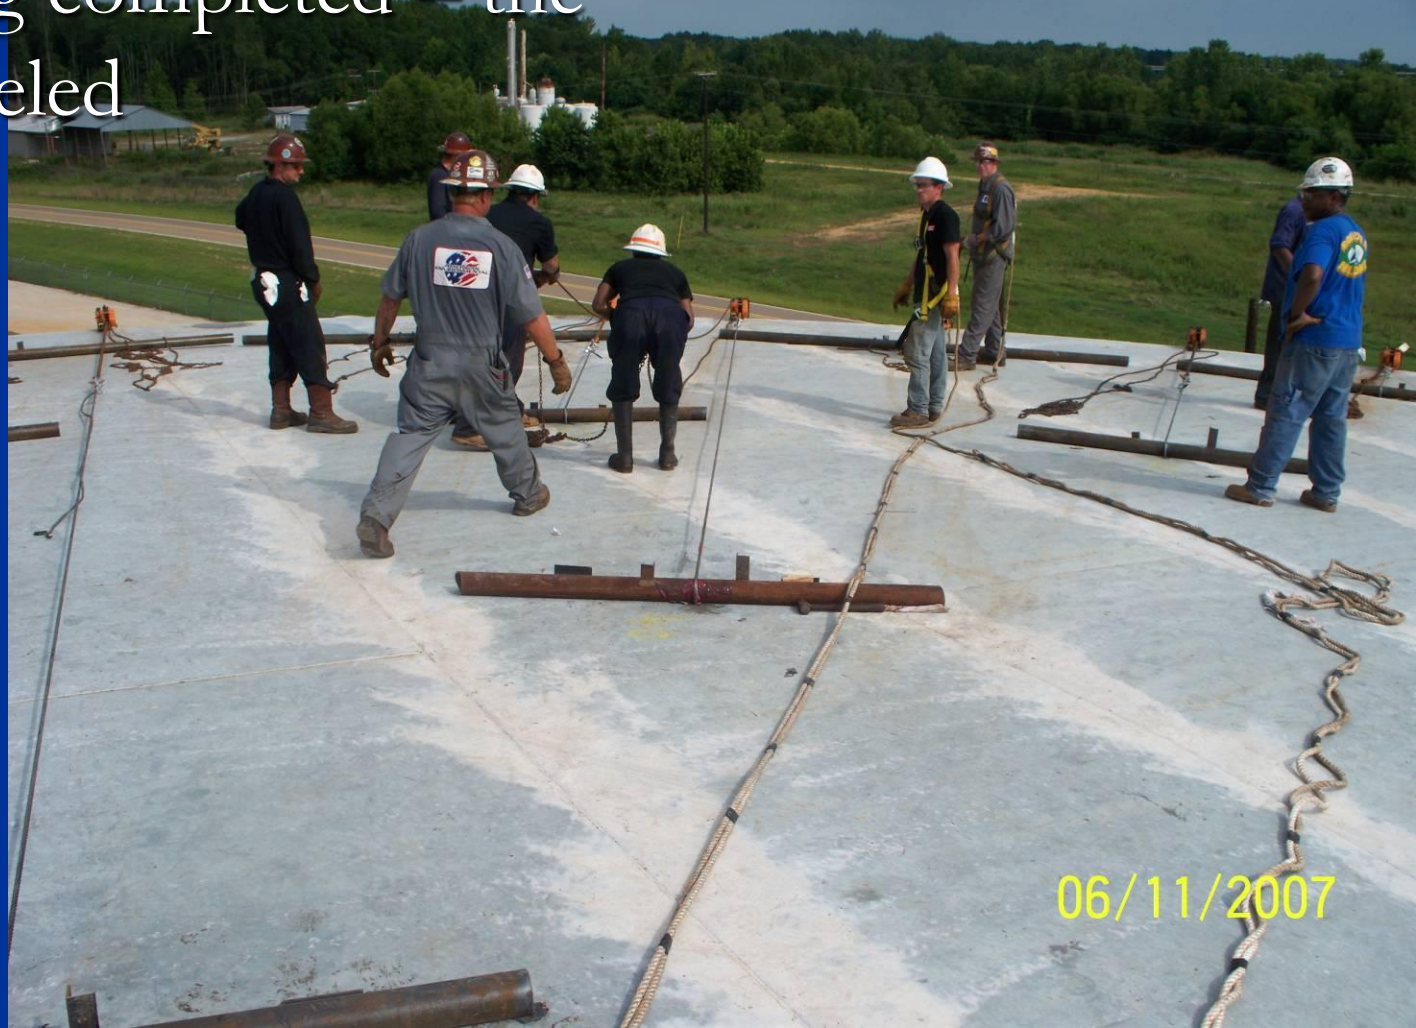
- Once cabling completed – the roof was leveled

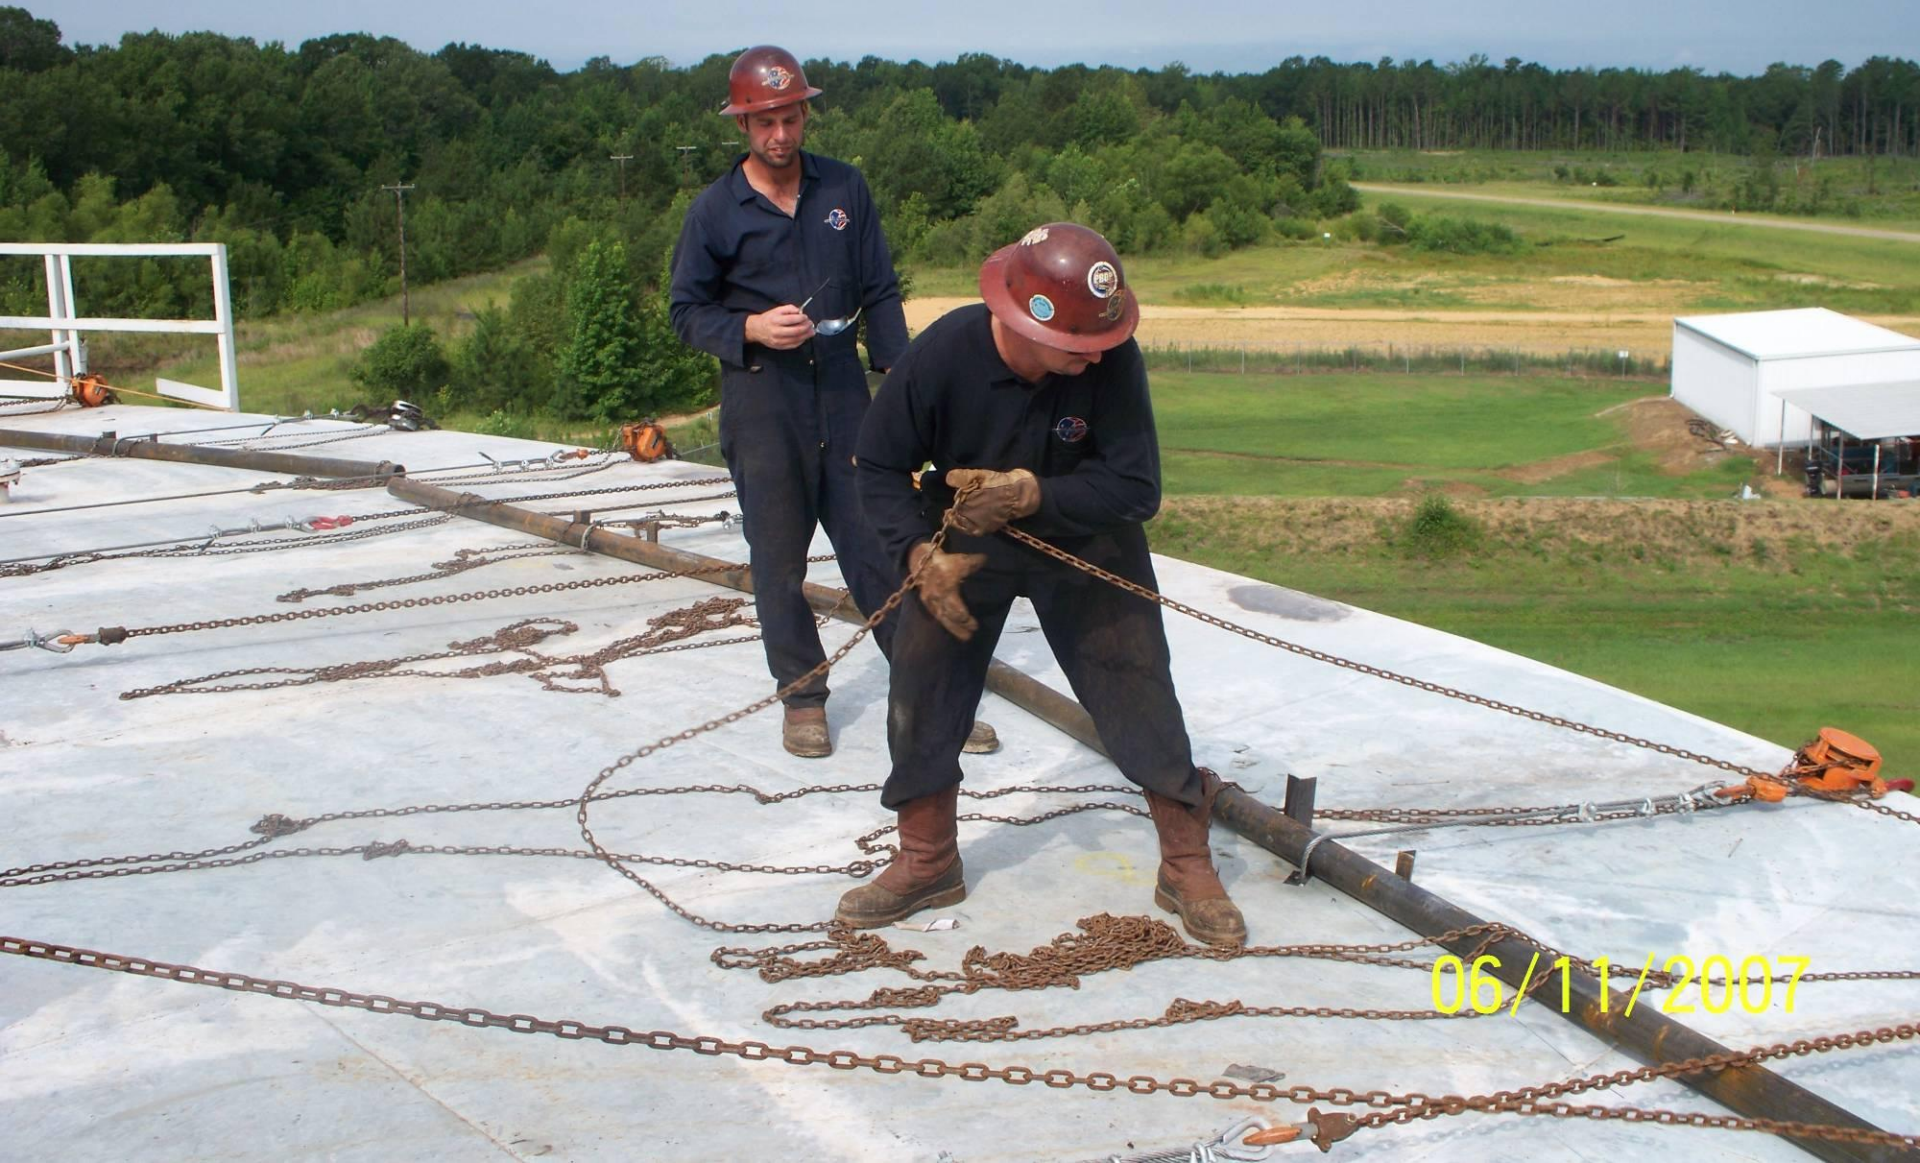
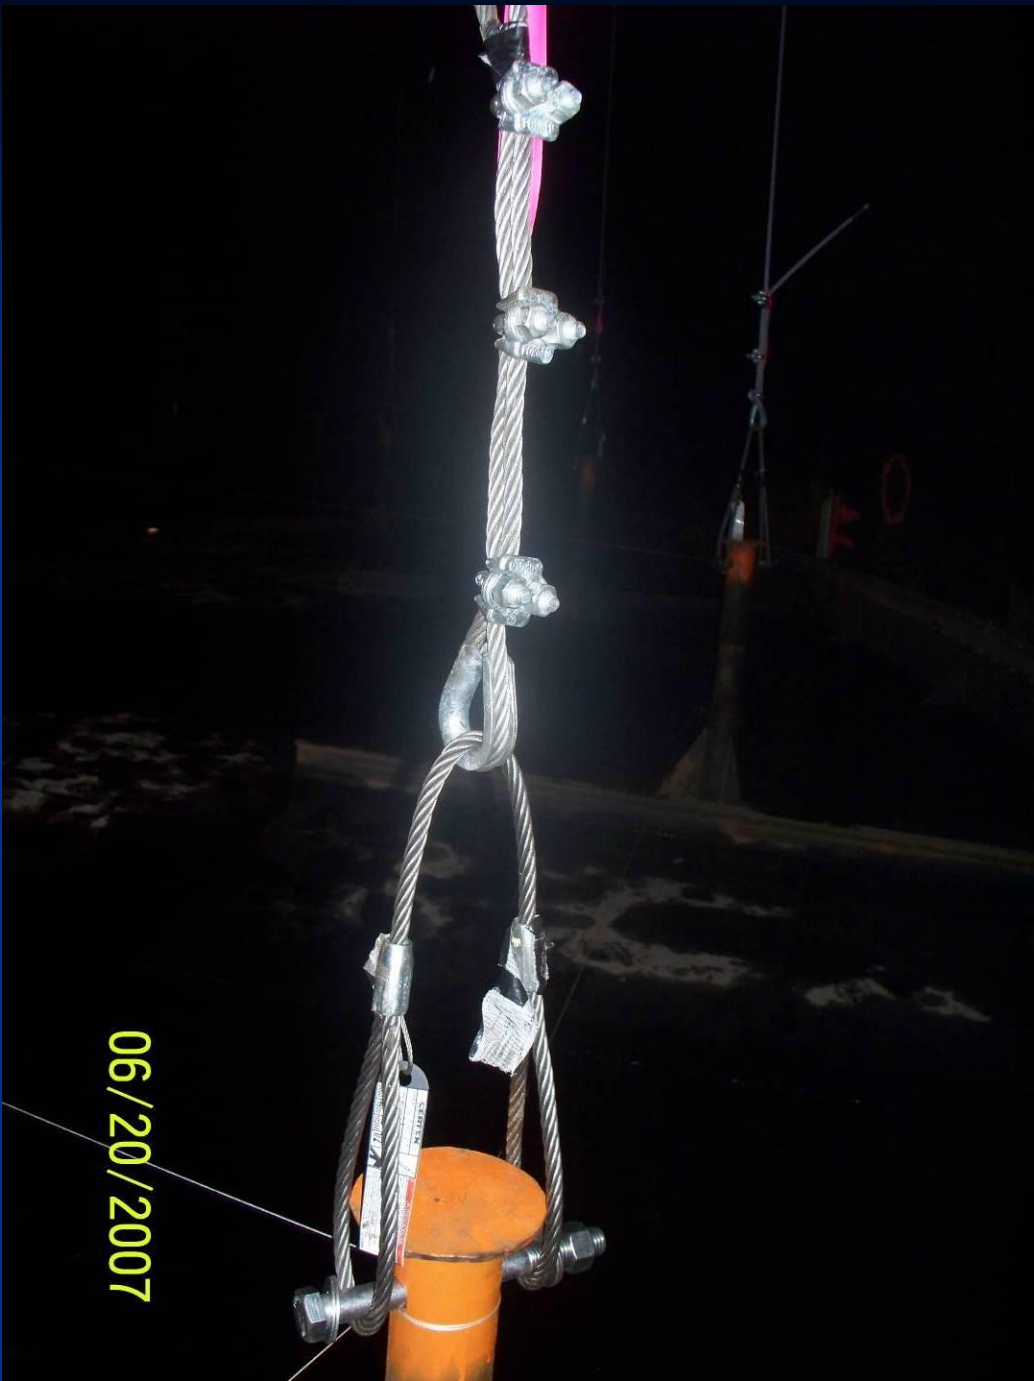
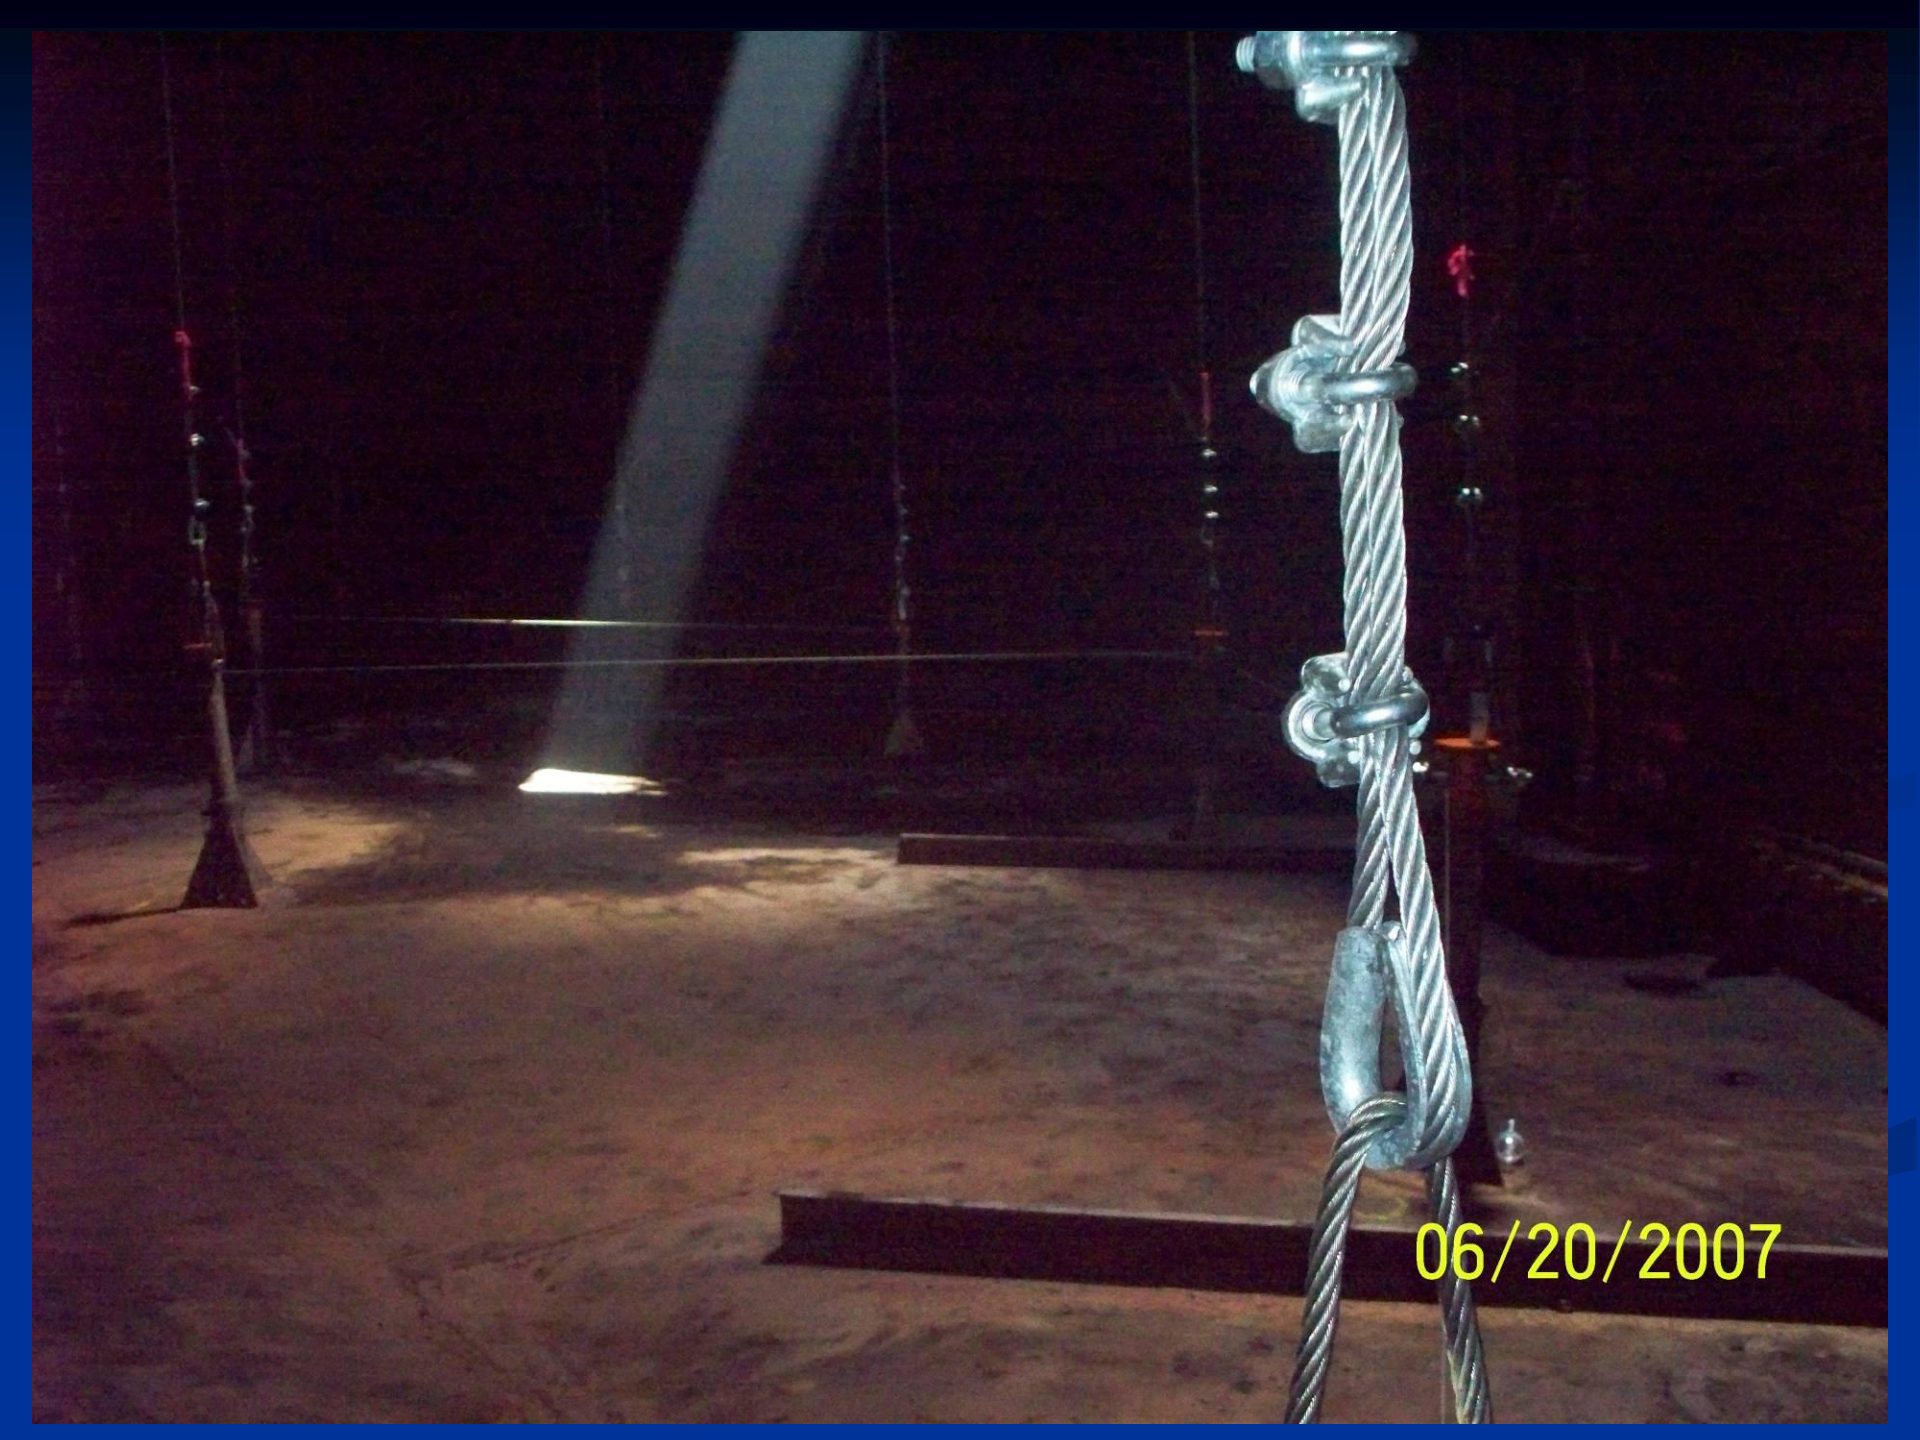
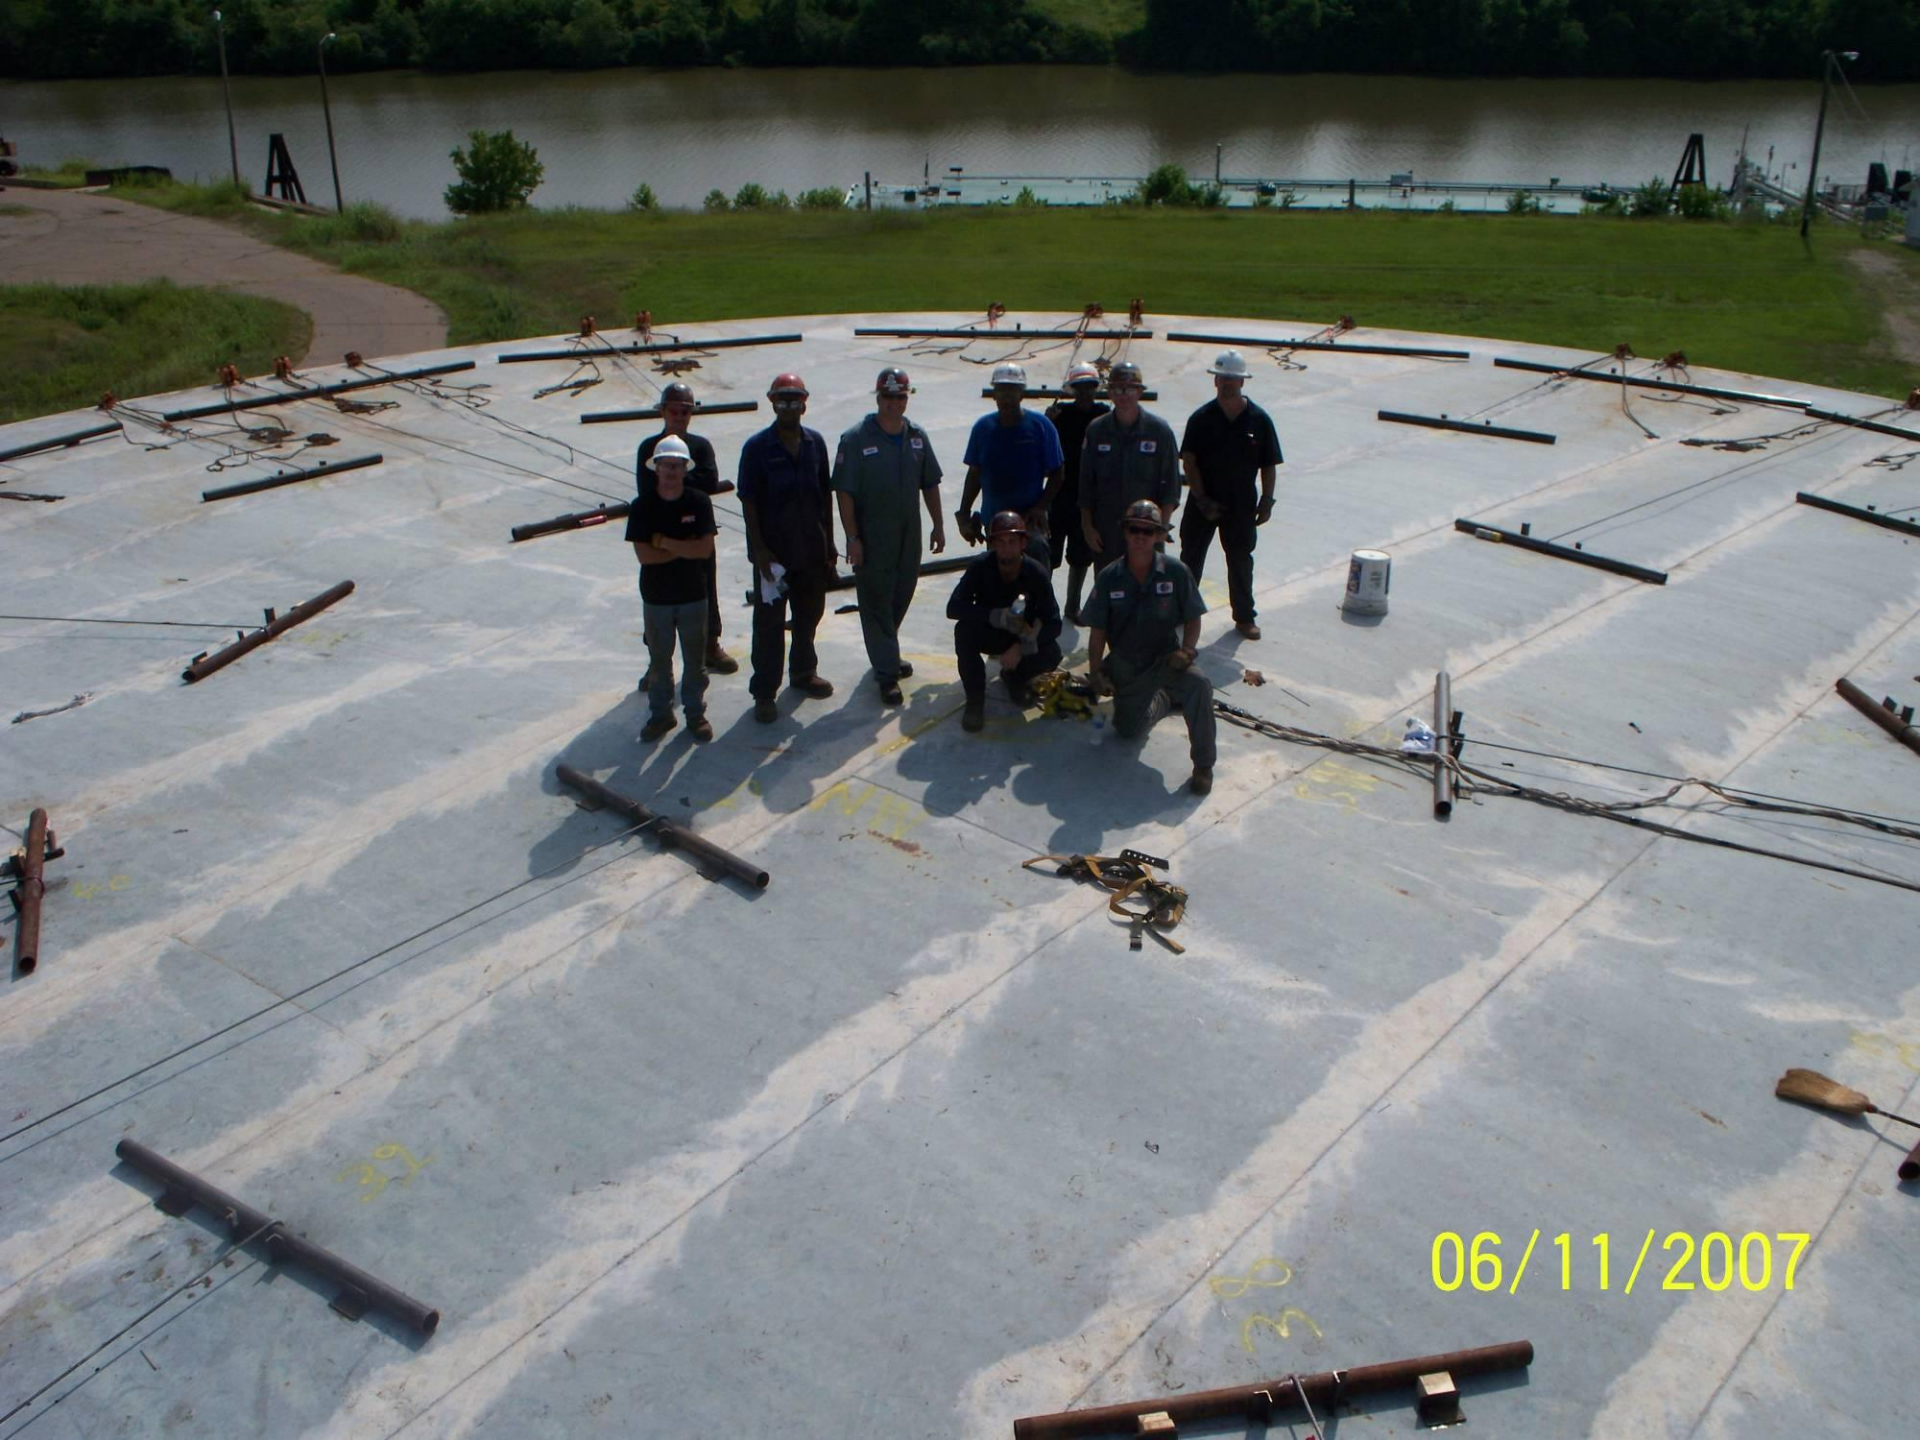
And The Roof Lifted

- Roof was lifted in 2 hours after cabling completed.
- The cable lift system was successful for this type of floating roof.
- Cable support of a steel floating roof is not practical as most of the roof strength is required to support the floating roof and little left for other loads.
