# Hazards Management for ASTs

# Hazard Events that can Affect Your Facility

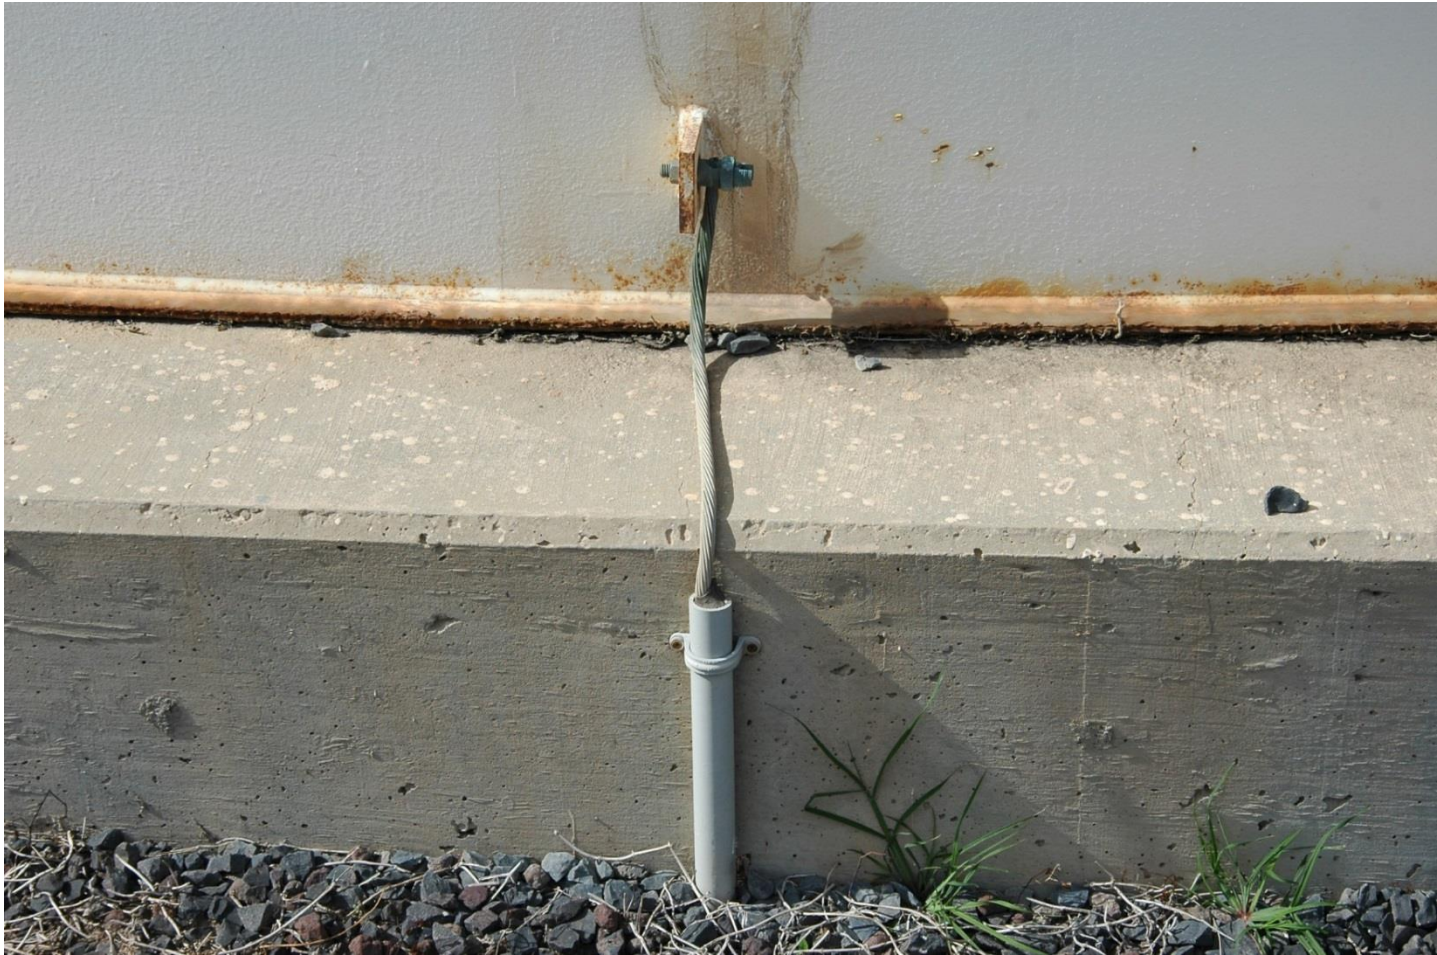
# Lightning Protection - Grounding

- API 650 – Tank Grounding
  - A minimum of 4 grounding lugs, equally spaced at a maximum 30 meters spacing is recommended

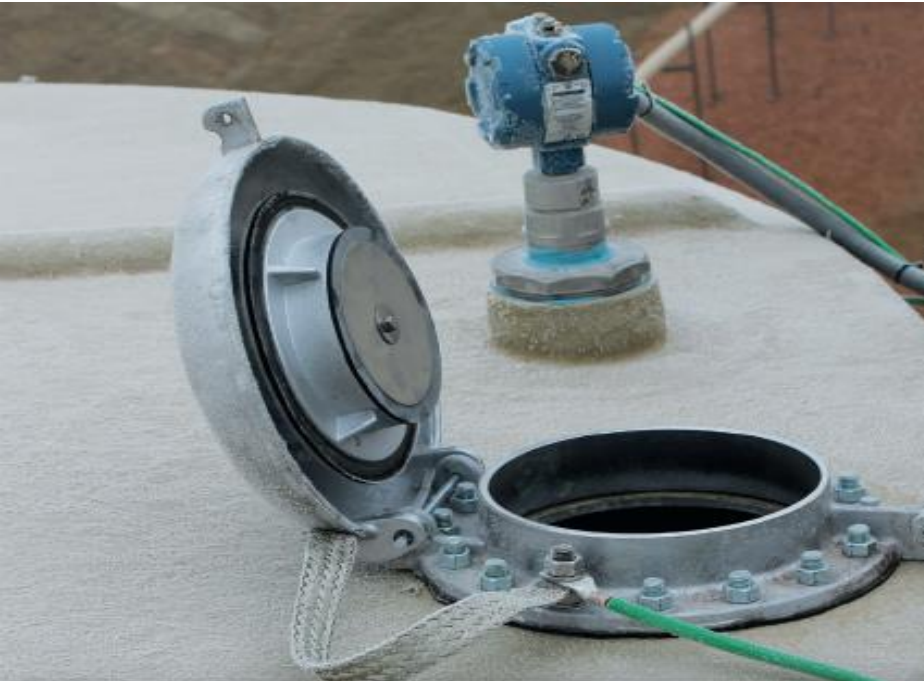
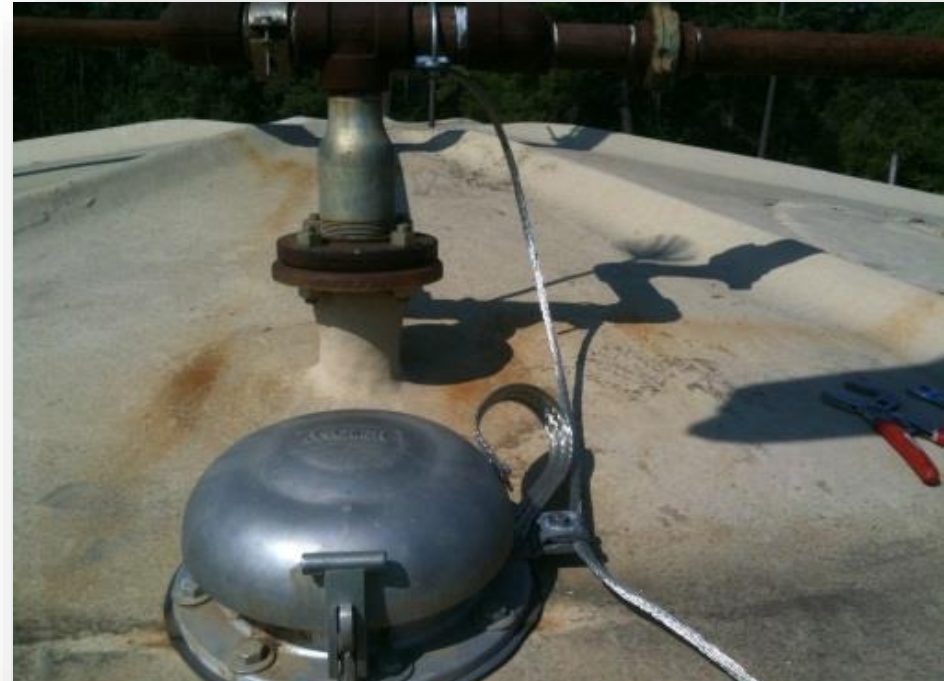
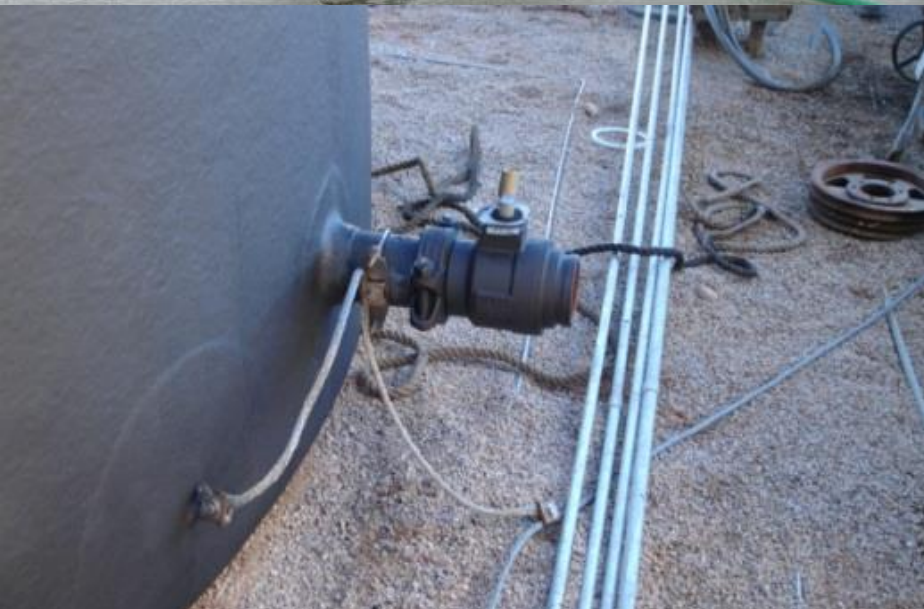
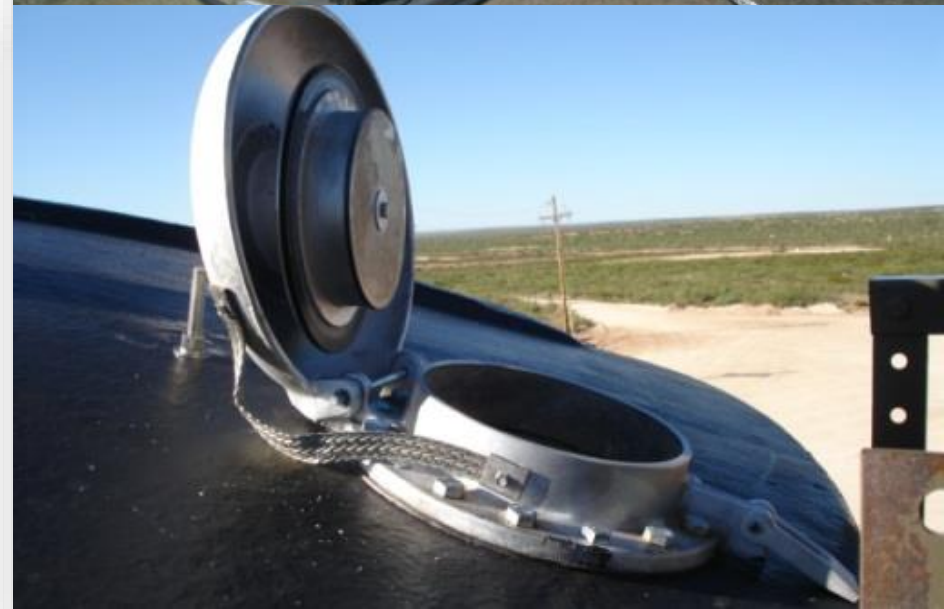
# Lightning Protection – Shunts and Bonding

1. All conductive parts shall be grounded
2. All movable cover accessories (hatches, manholes, pressure relief devices, etc.) on the external floating roof shall be electrically bonded to the external floating roof to prevent static electricity sparking when they are opened
3. Ladders shall be grounded to both the roof and the gauger's platform
4. Shunts should be provided on the uppermost seal and bond the shell and roof of the tank in 3m intervals

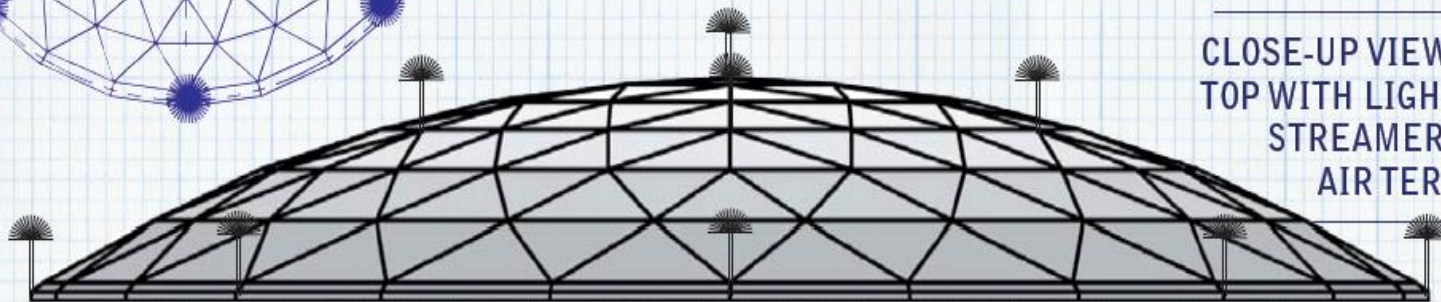
CLOSE-UP VIEW OF HMT DOME  
TOP WITH LIGHTNING MASTER  
STREAMER-DELAYING  
AIR TERMINALS

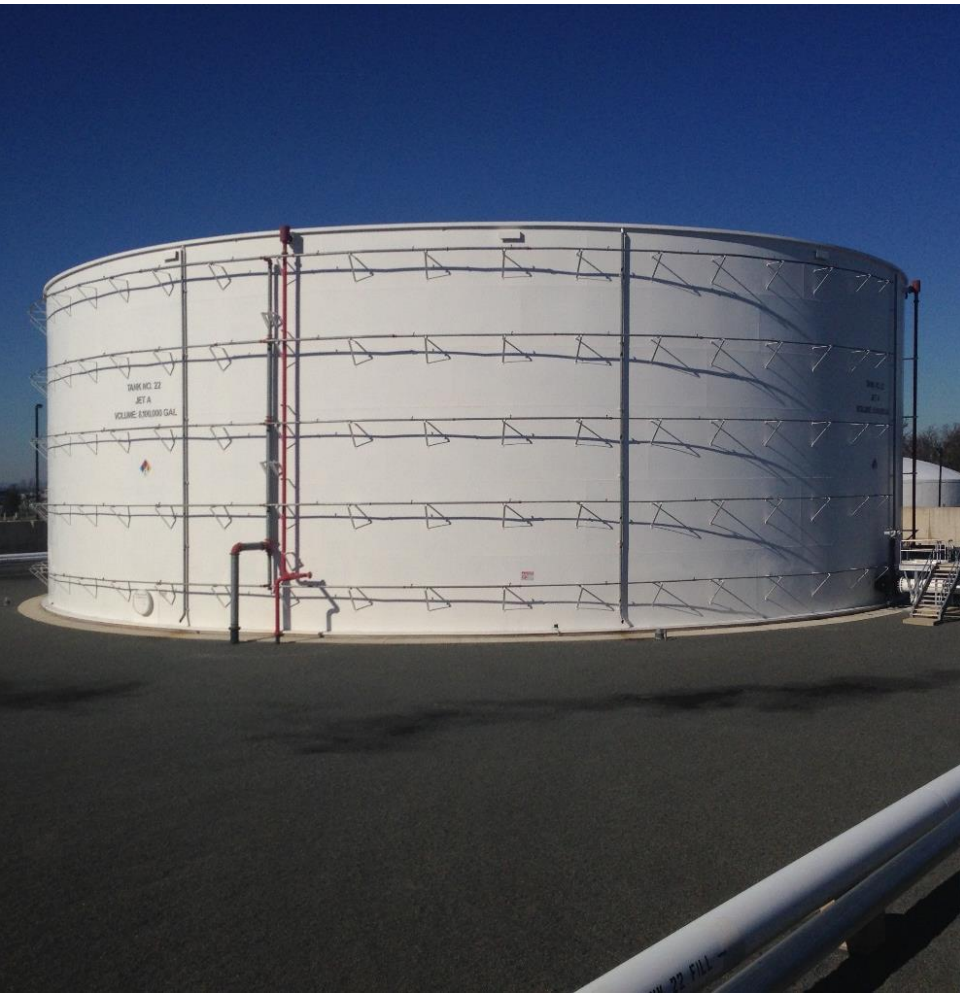
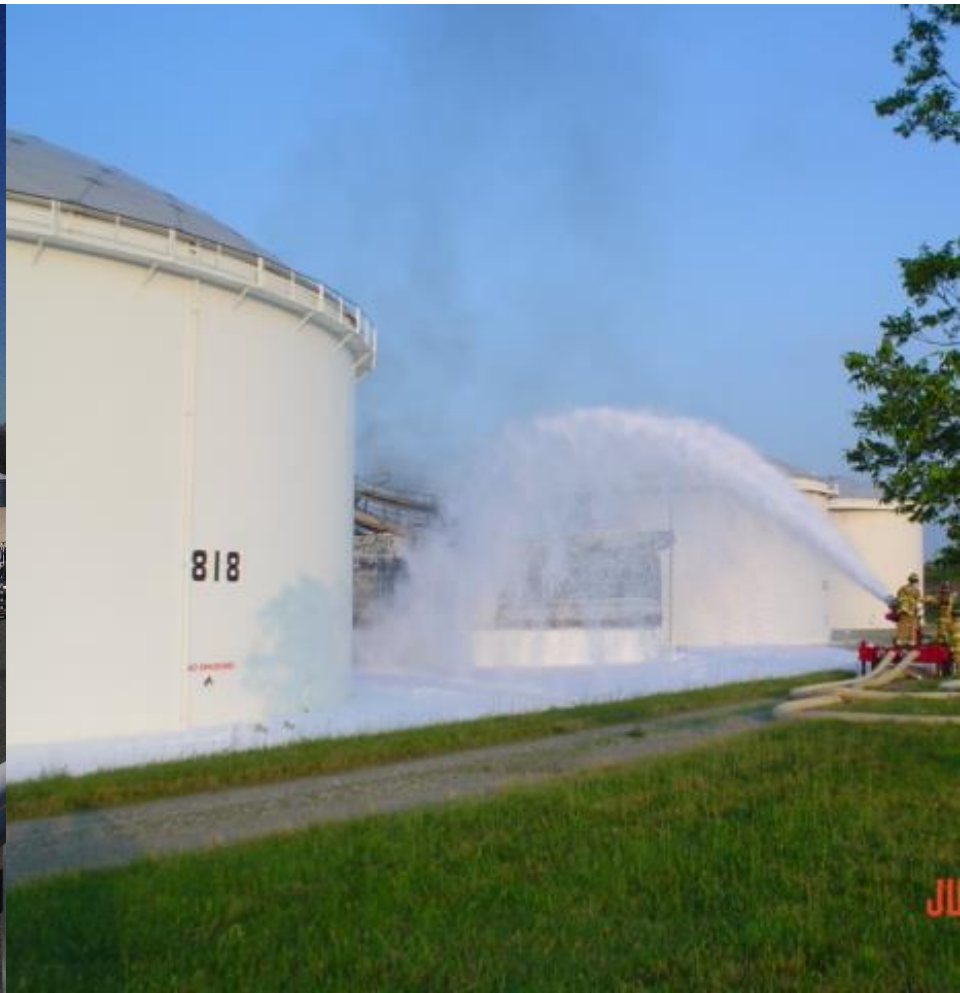
# Fire Response

- Most response plans include effort to prevent the fire from spreading, not just extinguishing a tank fire.

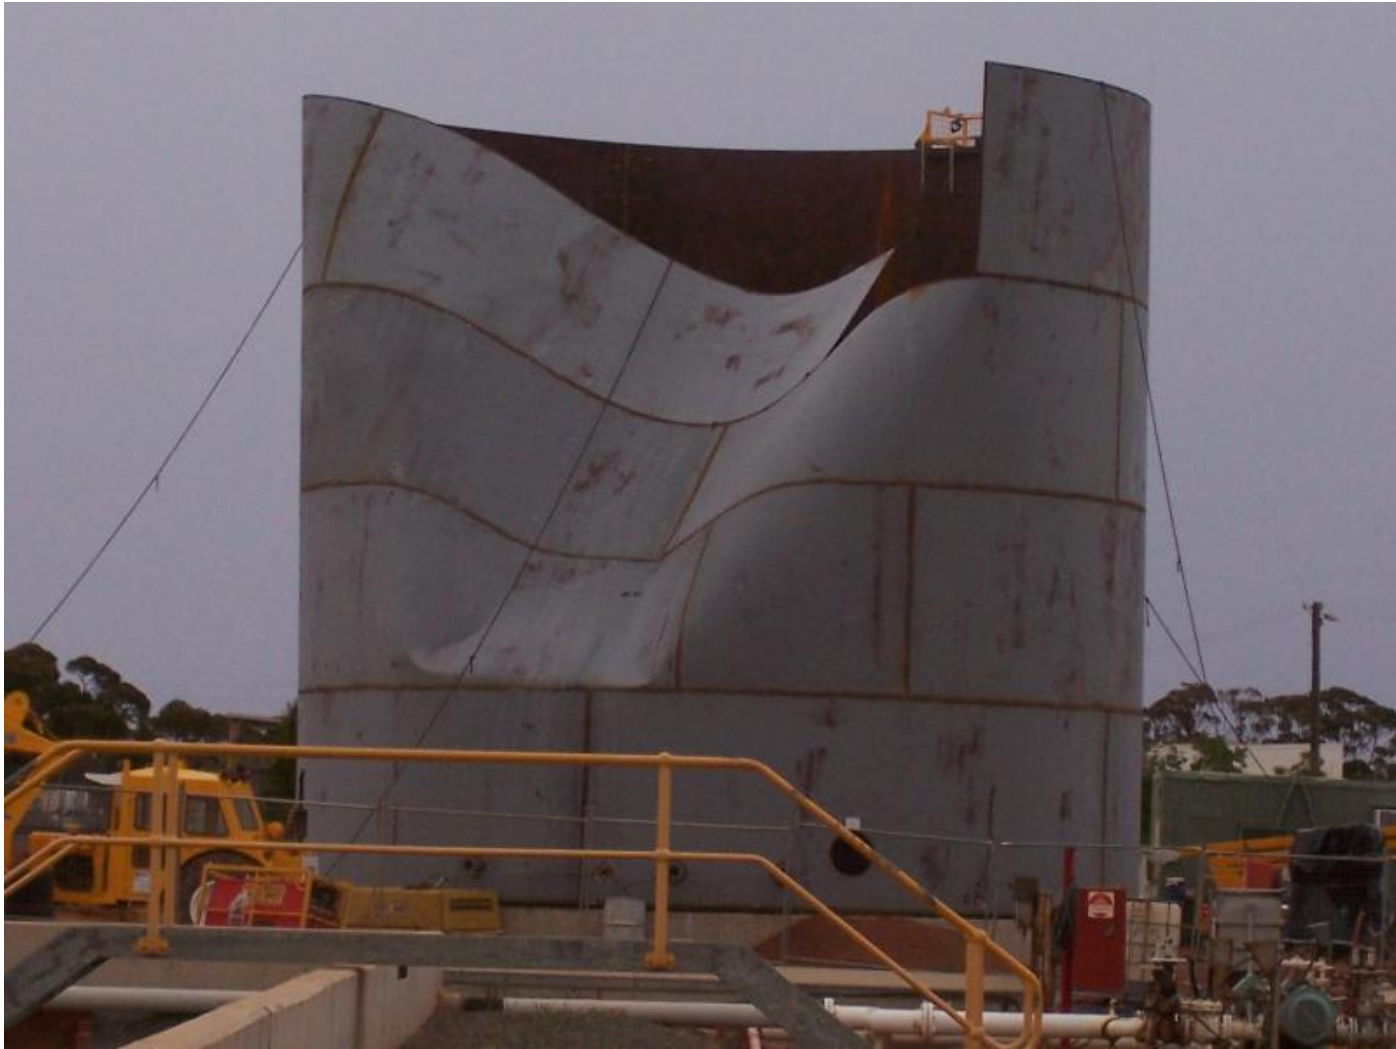
# What are the Risks from Wind Damage?

Wind Issues...Shell Buckling, Tank  
Overturning, and Roof Damage

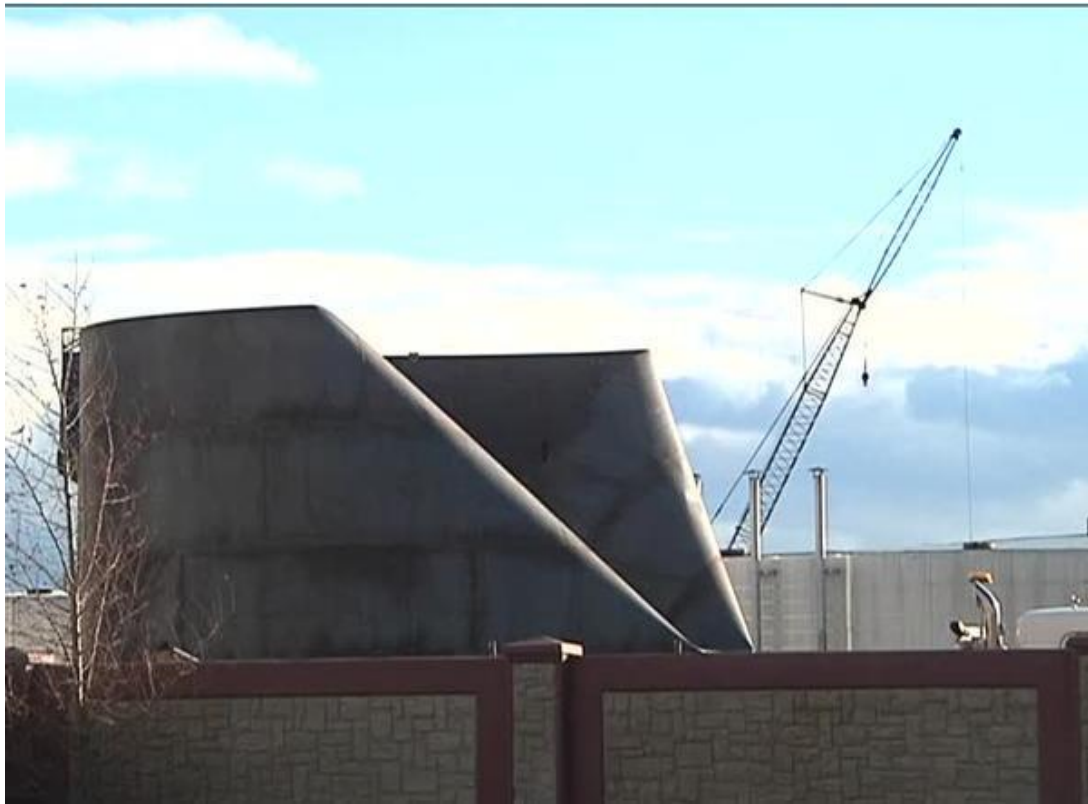
# API-650 Shell Stability

- Tank is most vulnerable when empty
- API procedures originated in early 1960s
- Methods based on uniform vacuum analogy using the maximum wind pressures on shell

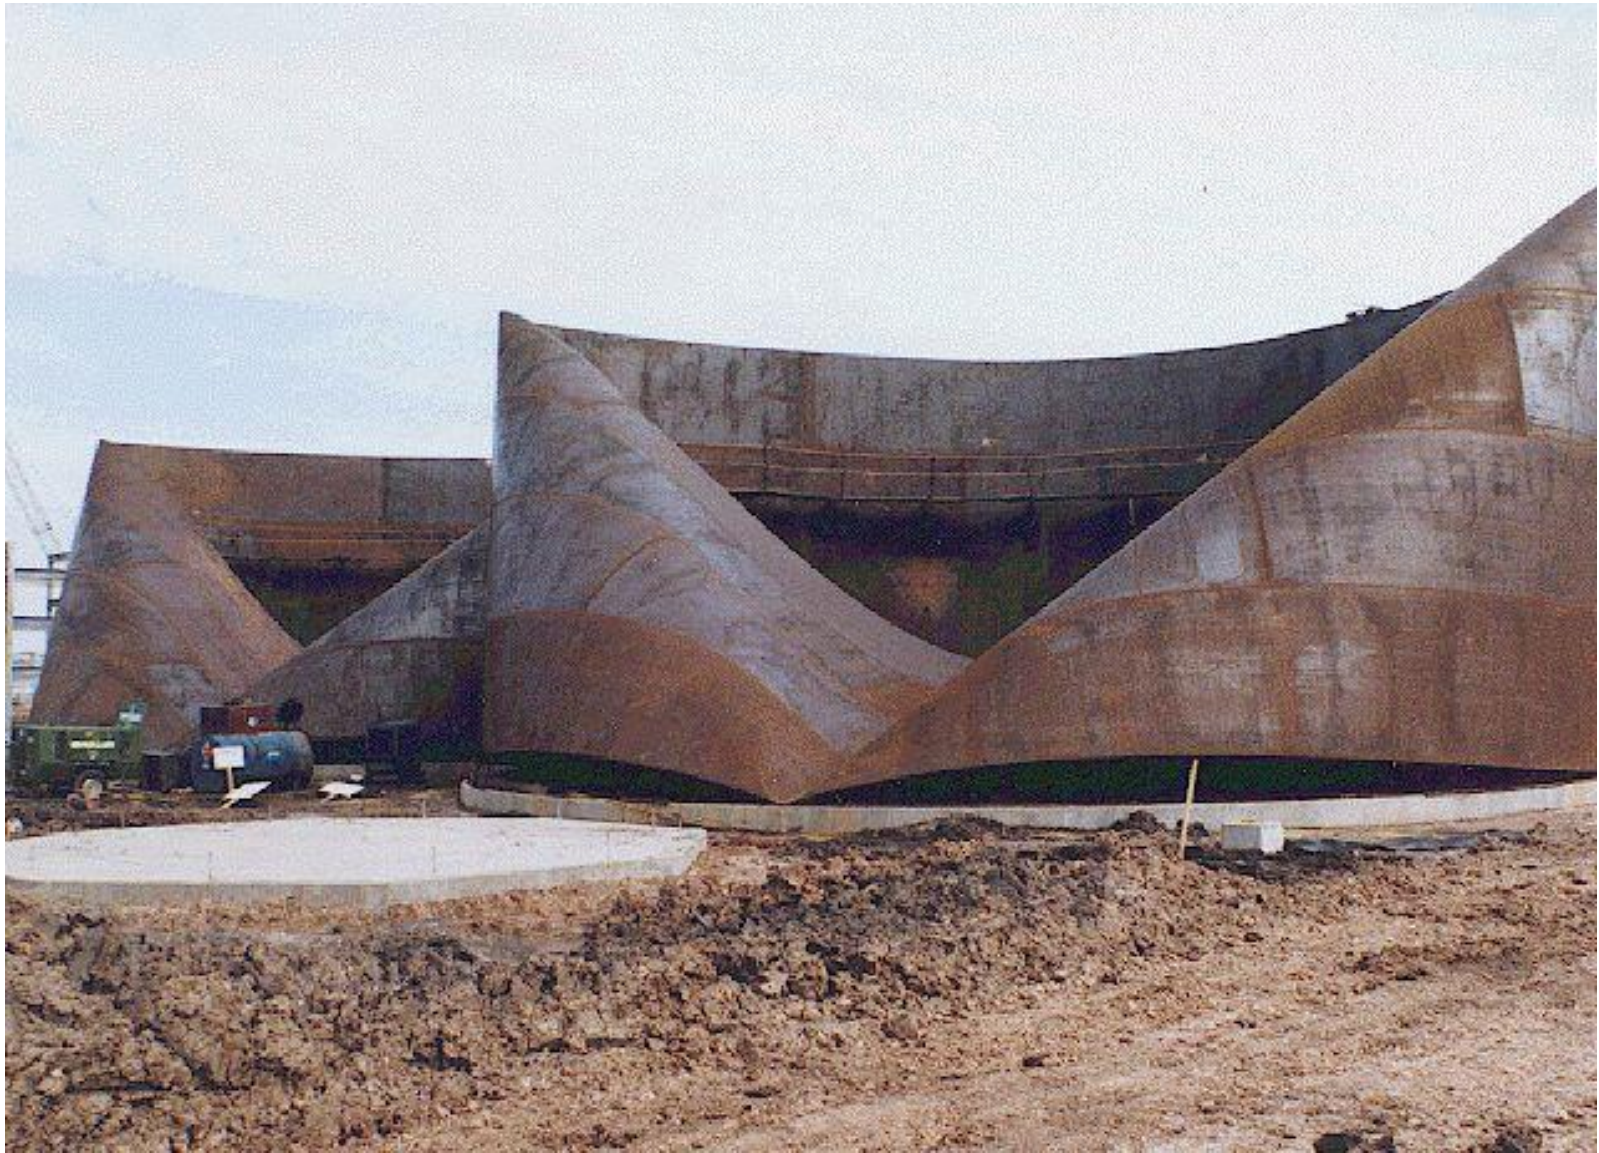
# Shell Buckling During Construction - Vulnerable Without Wind Girder

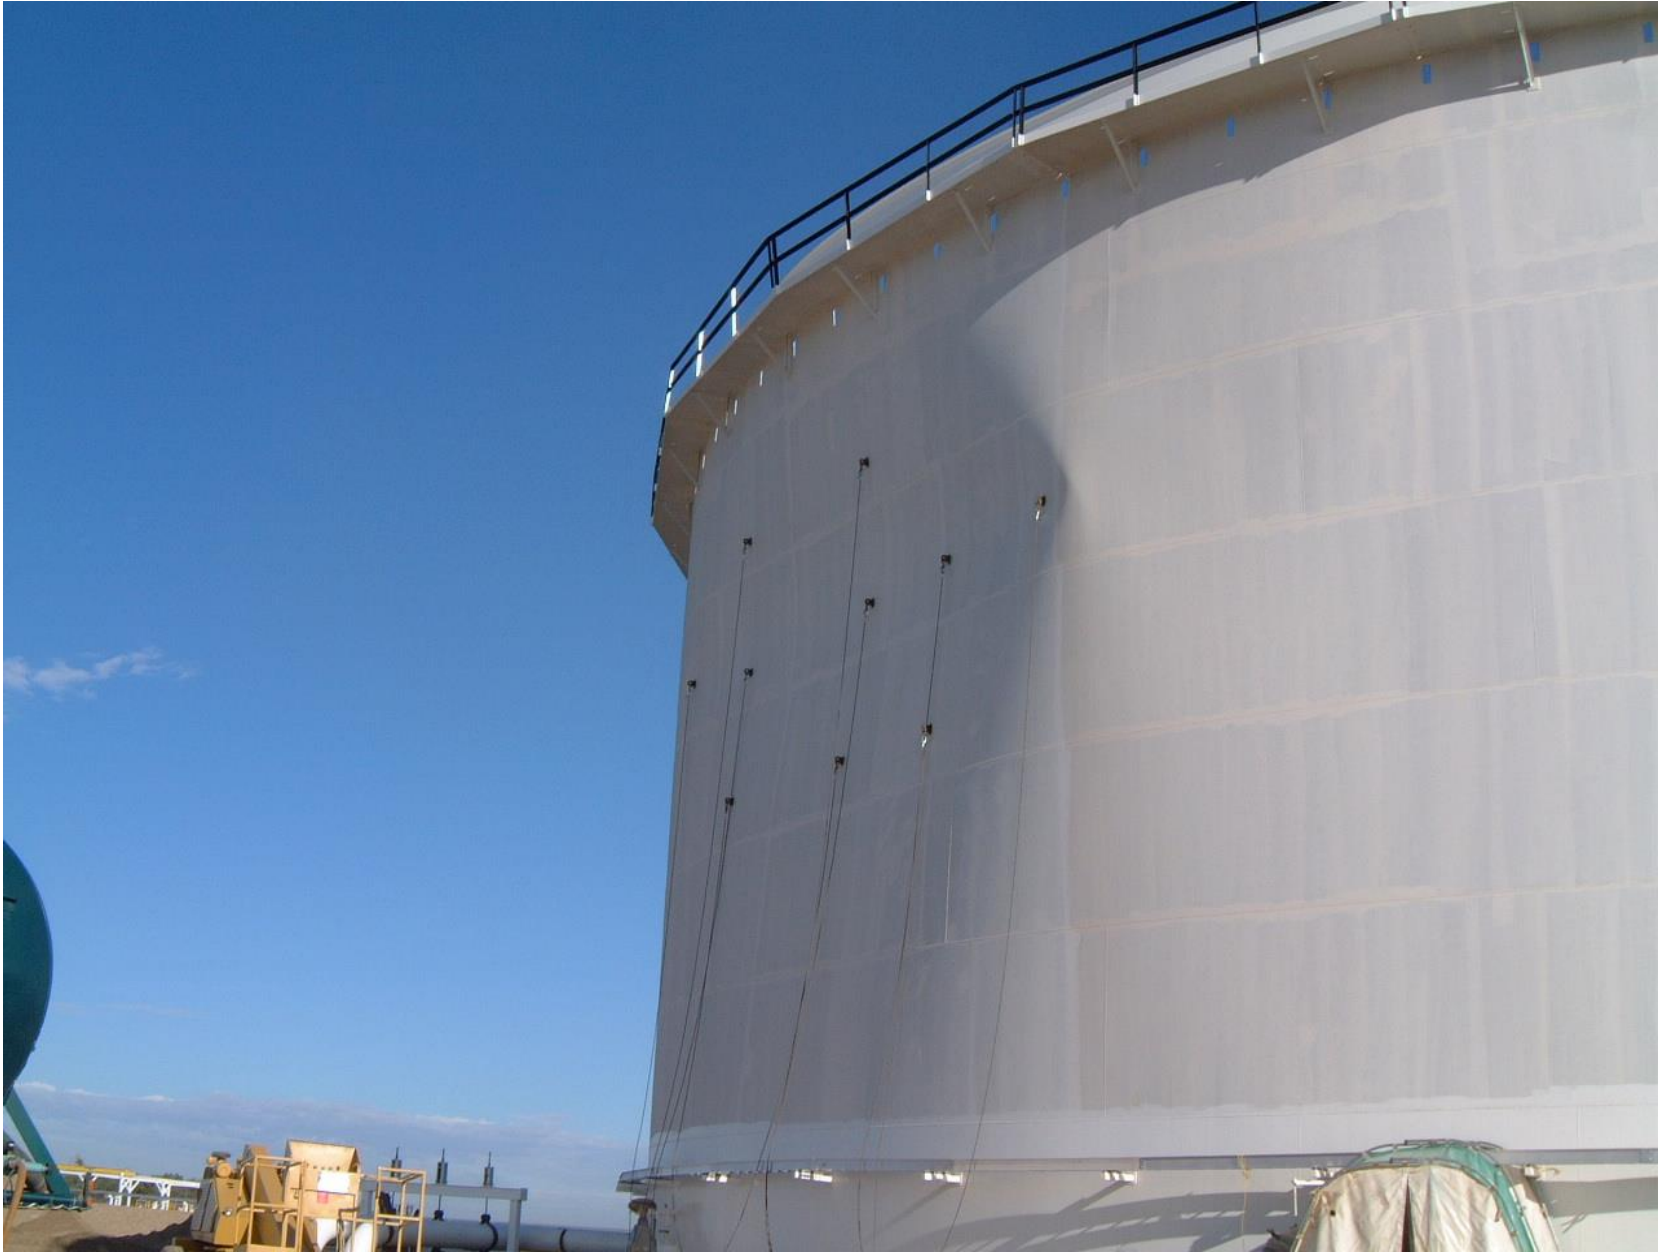
# Shell Buckling When Empty

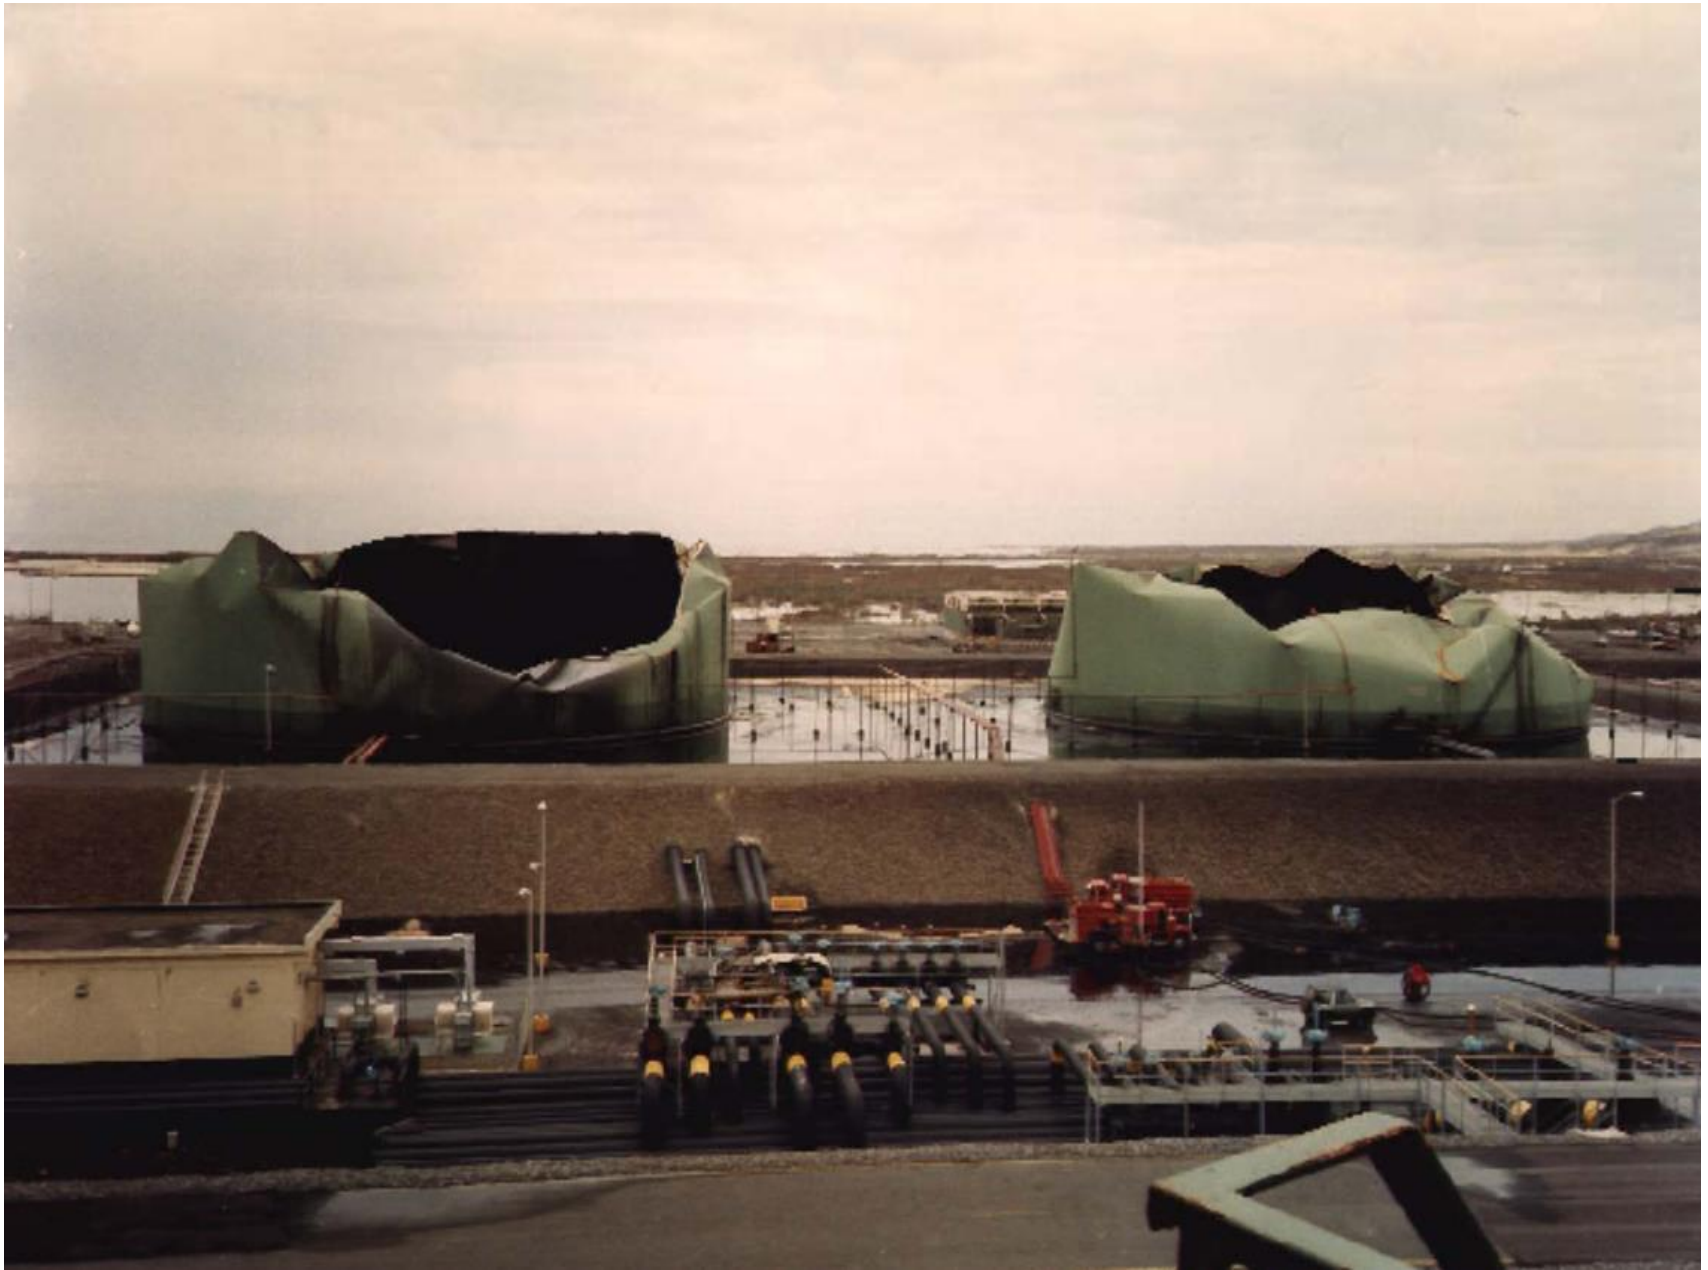
# Shell Buckling After Loss of Roof

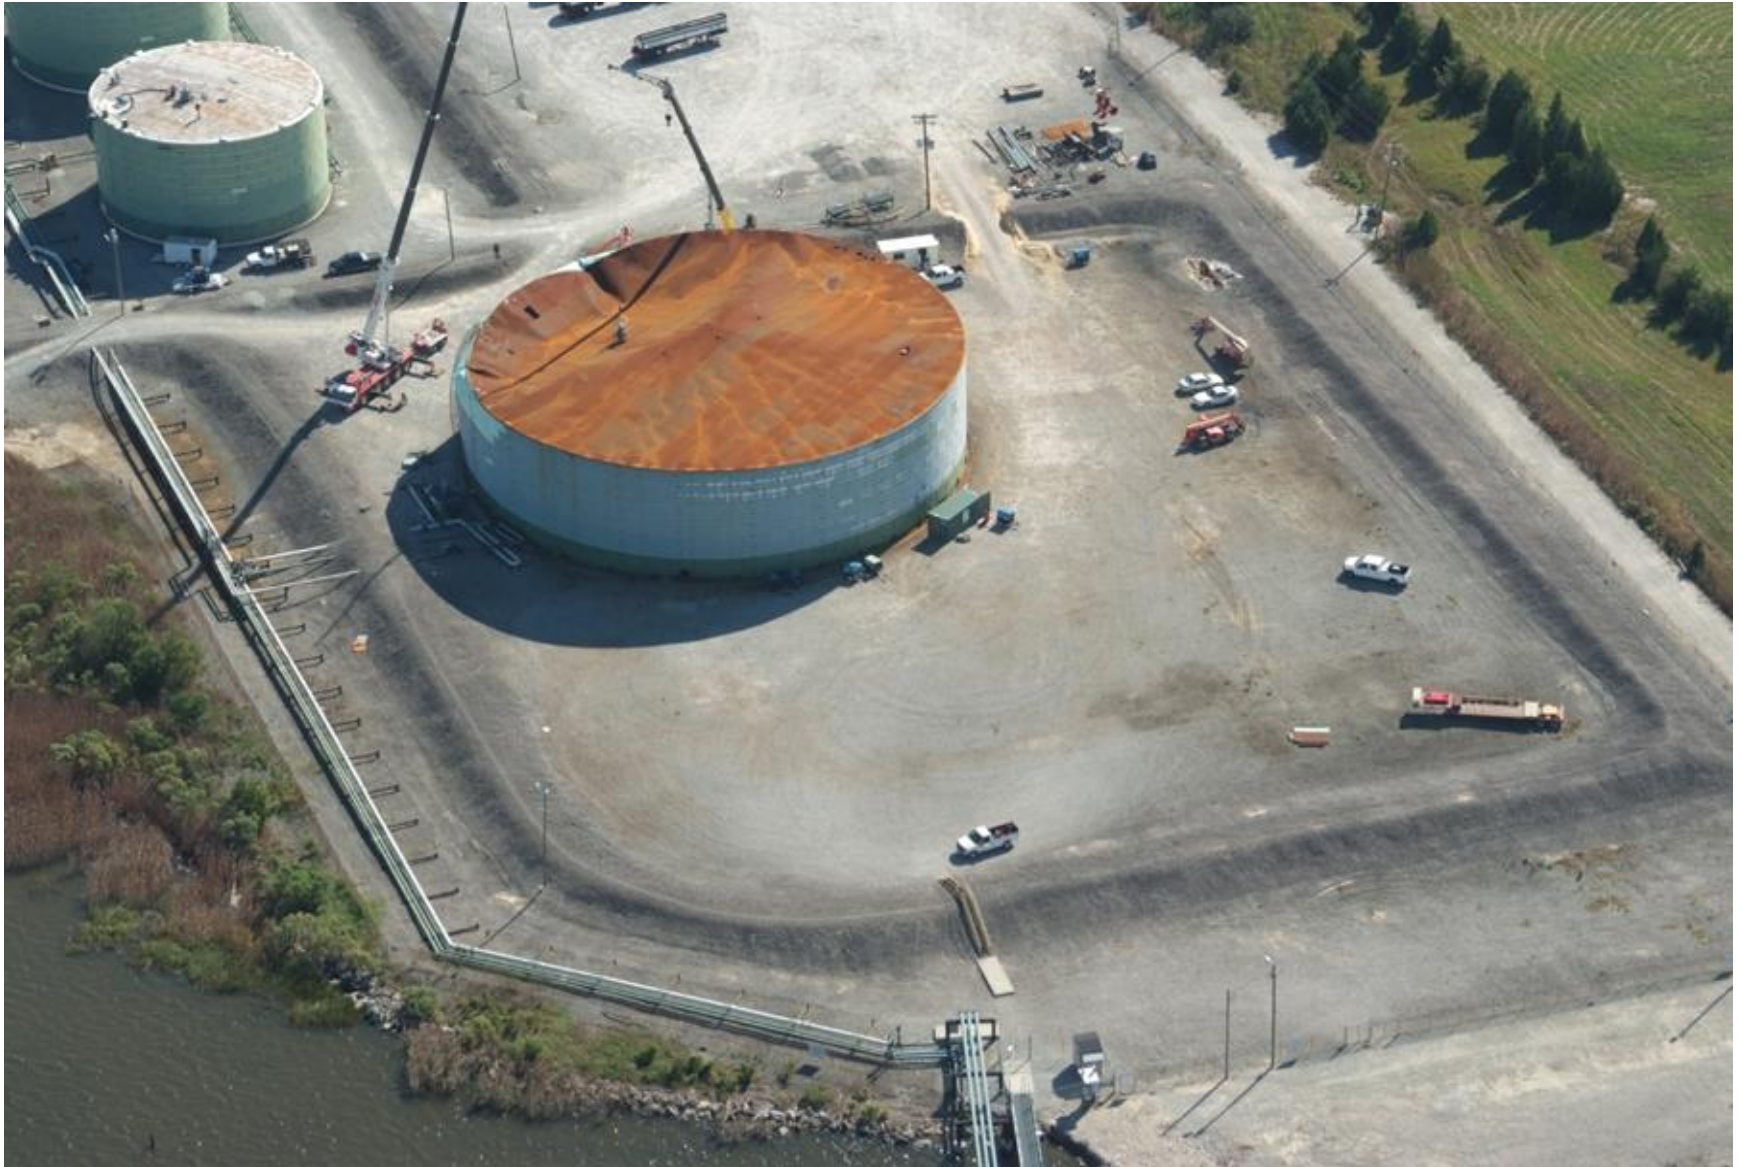
# Shell Buckling BEFORE the Storm...Then Water Ponded on the Roof

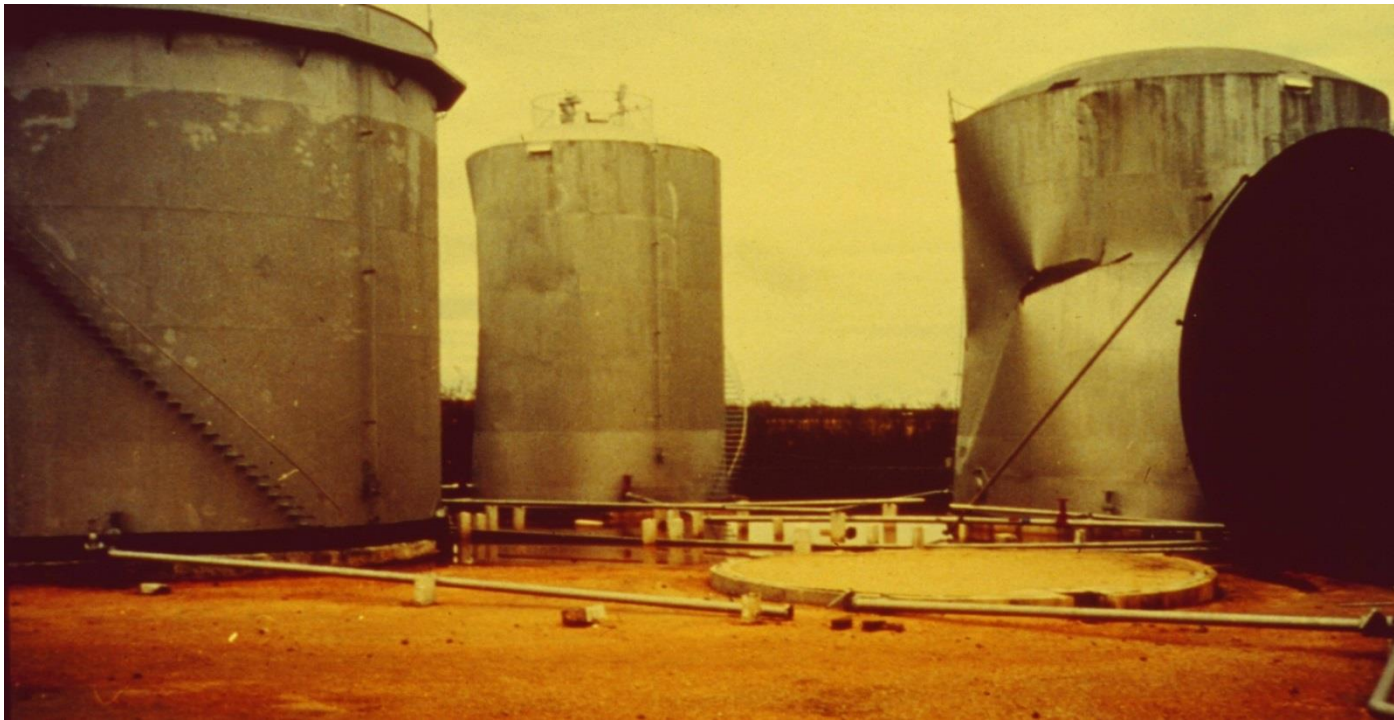
# Wind Overturning

- Primarily a problem for small diameter tanks that are empty
- Doesn't happen often, but should be considered
- API-650 has simplified procedures to verify

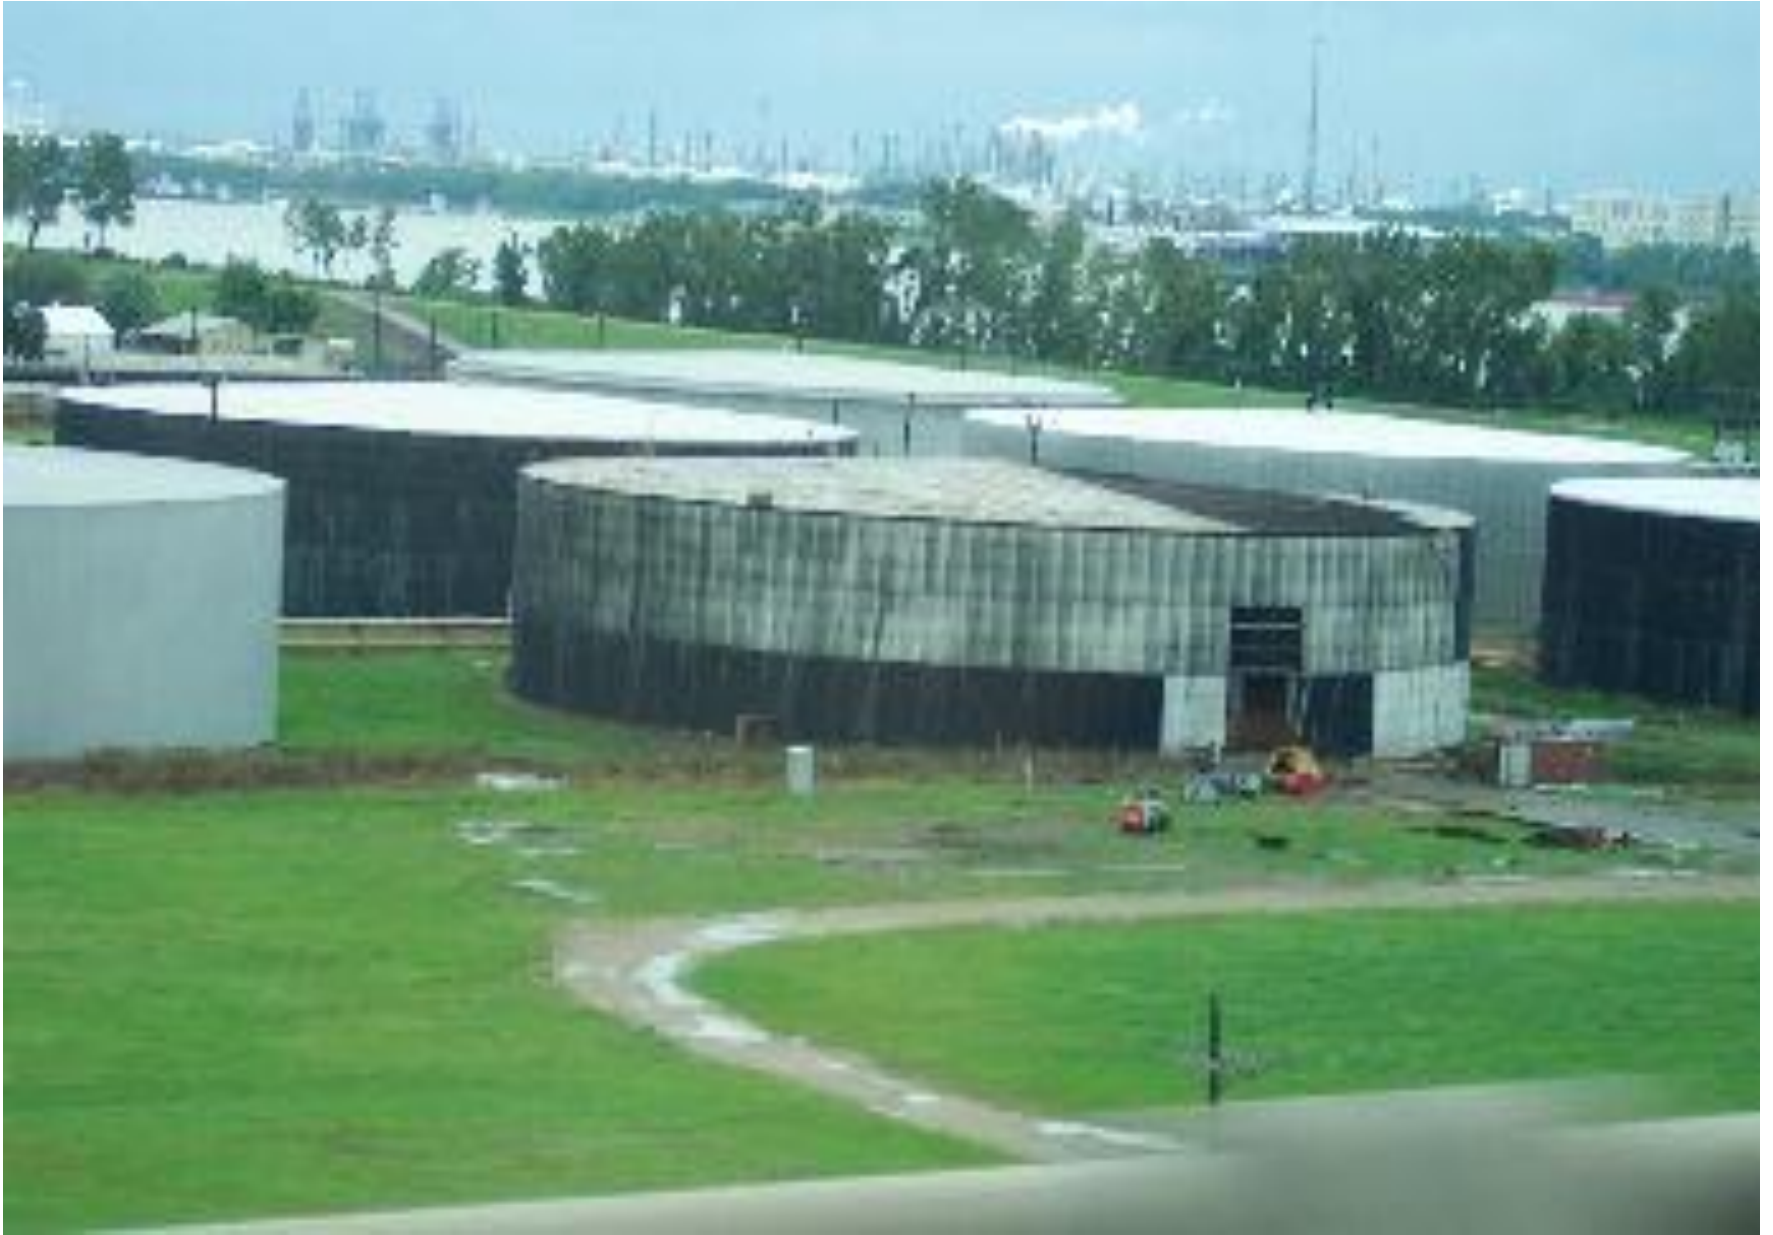
# Peeling Off of Roof Insulation

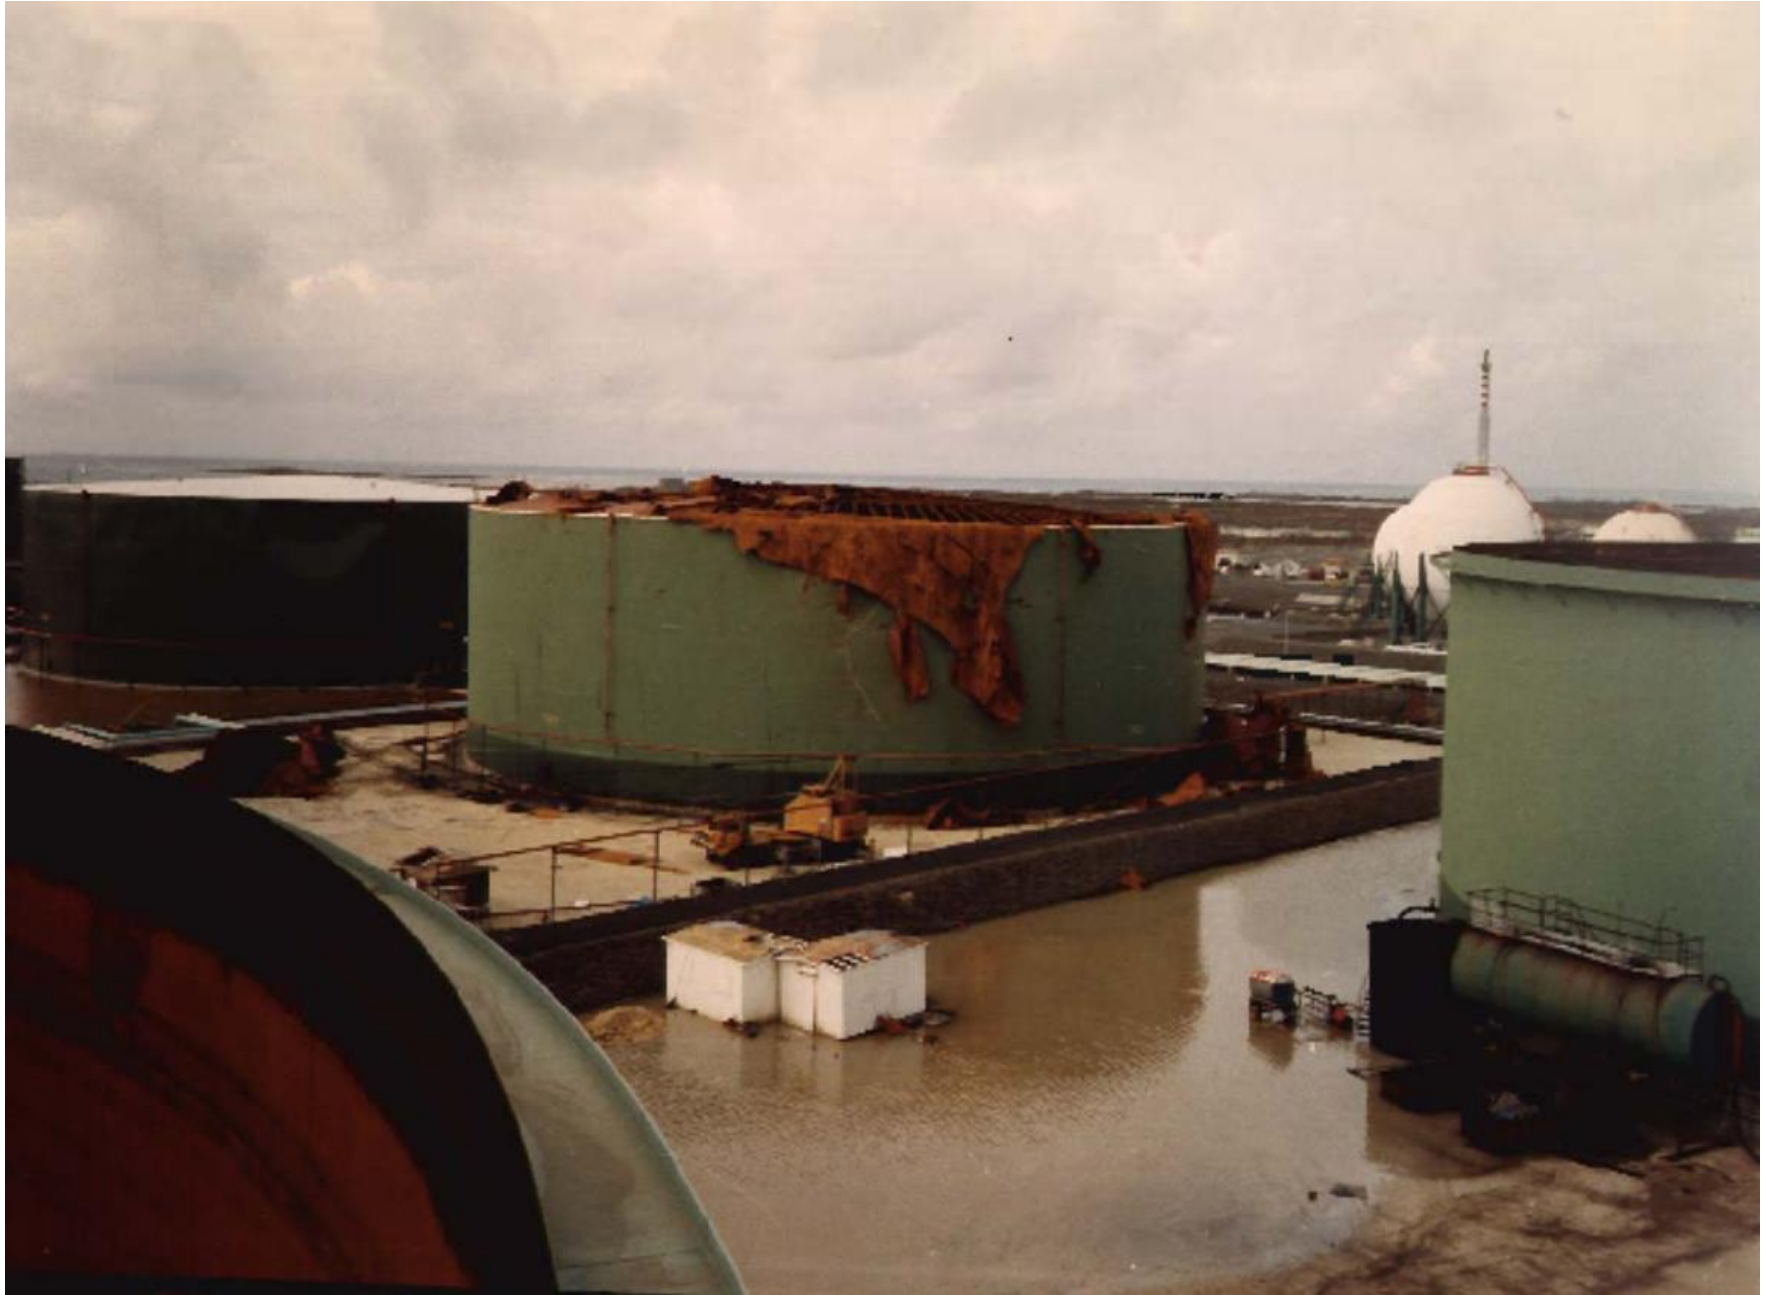
# Peeling Off of Roof Plate
