# Hazards Management for ASTs

# Hazard Events that can Affect Your Facility

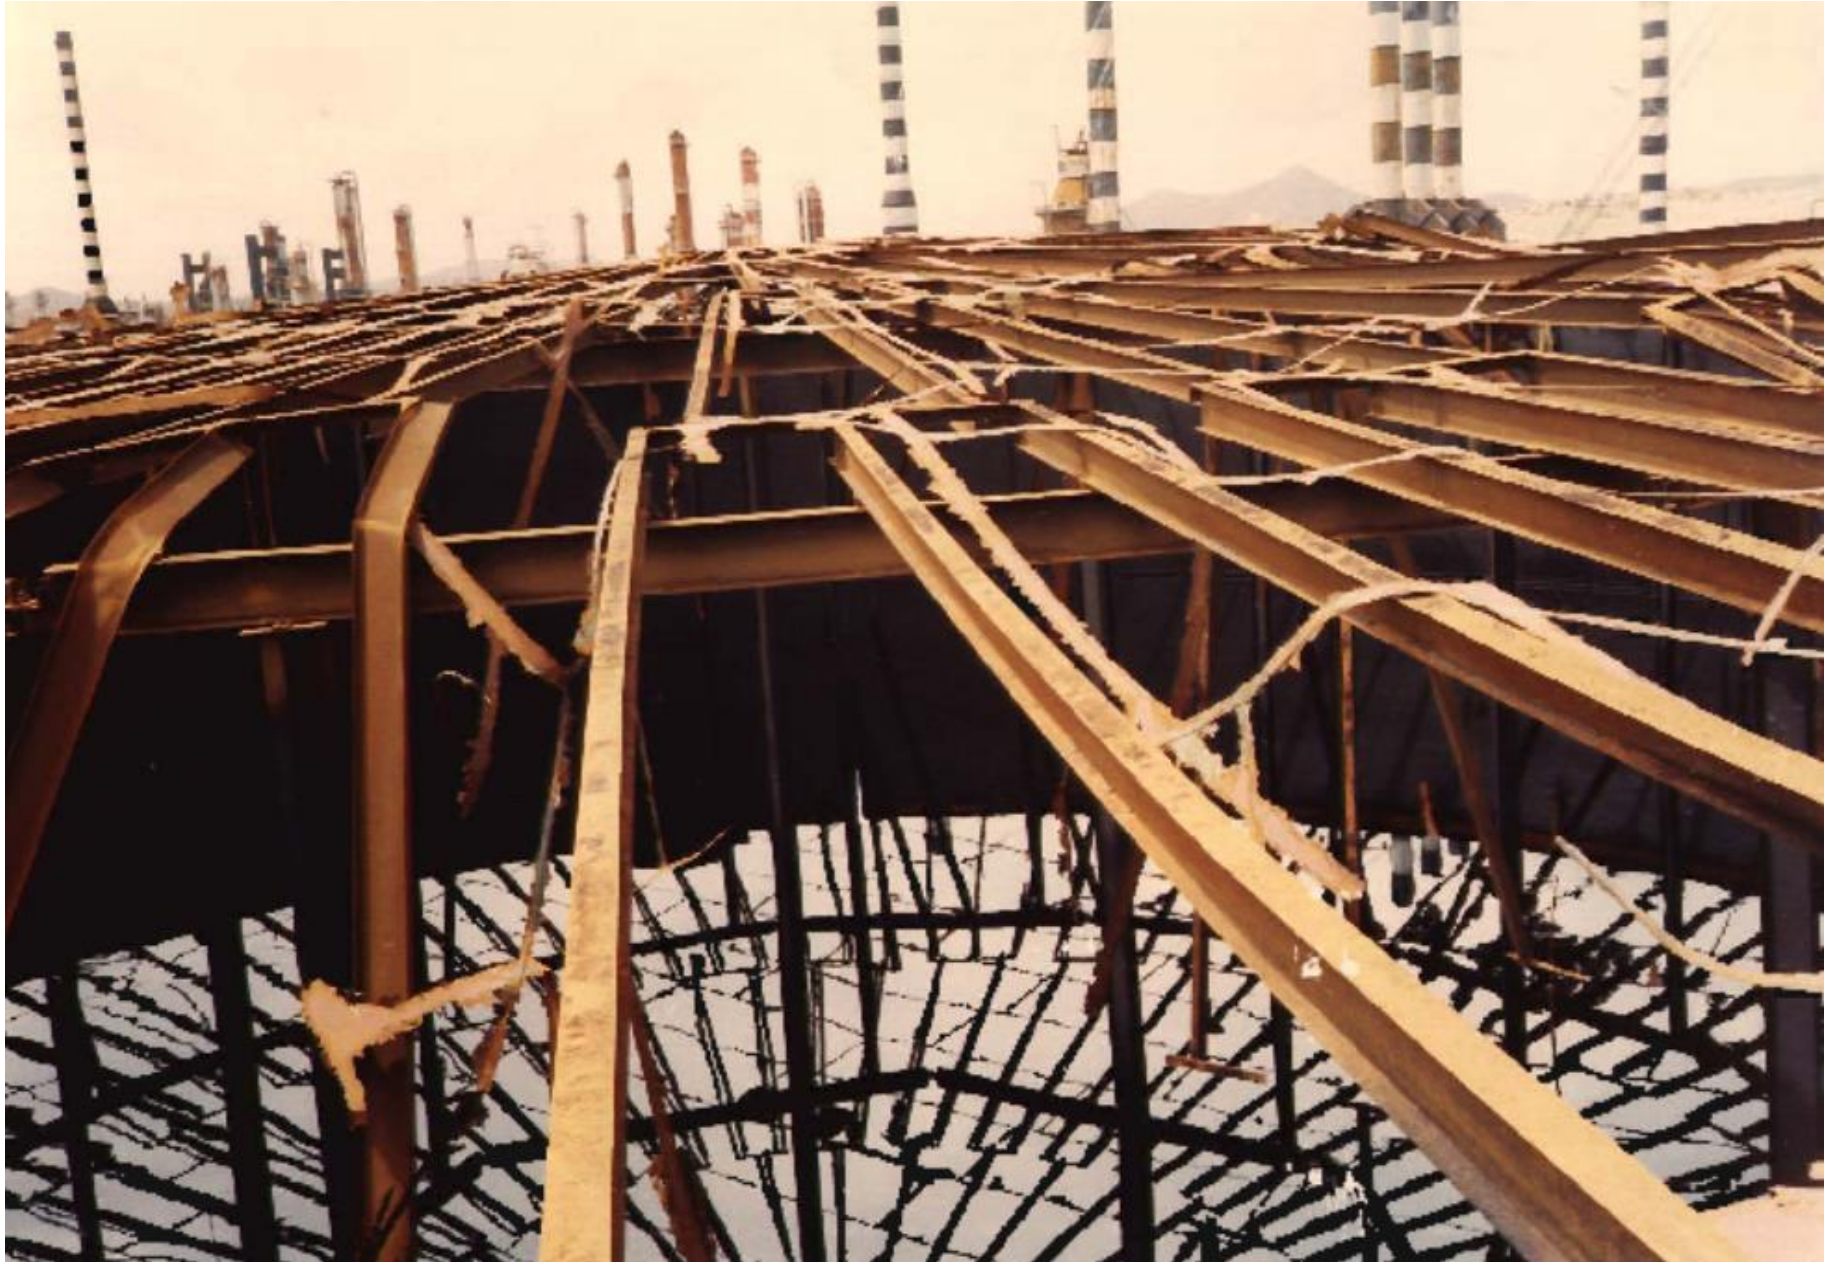
# Plate Pulled Off Tank Roof

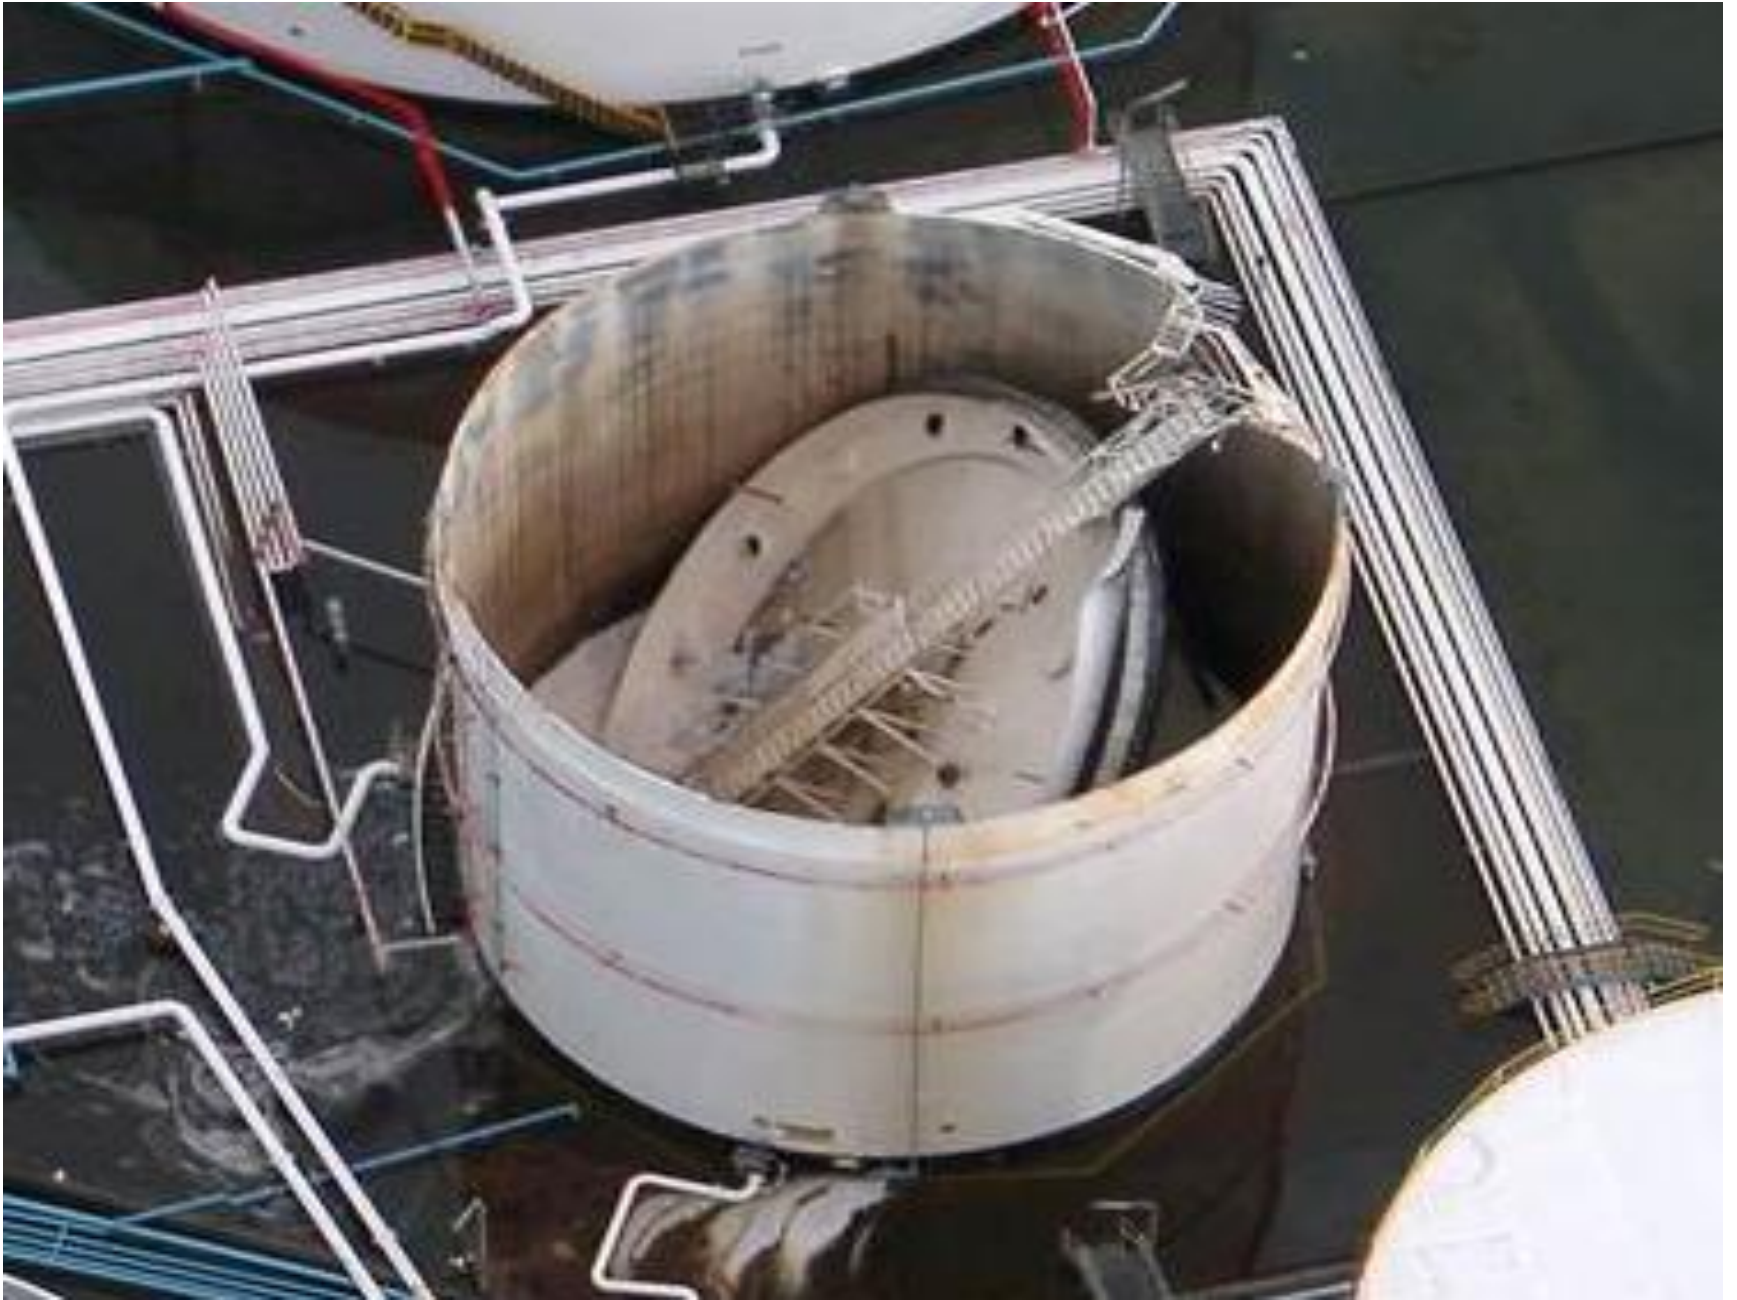
# Floating Roof Damage

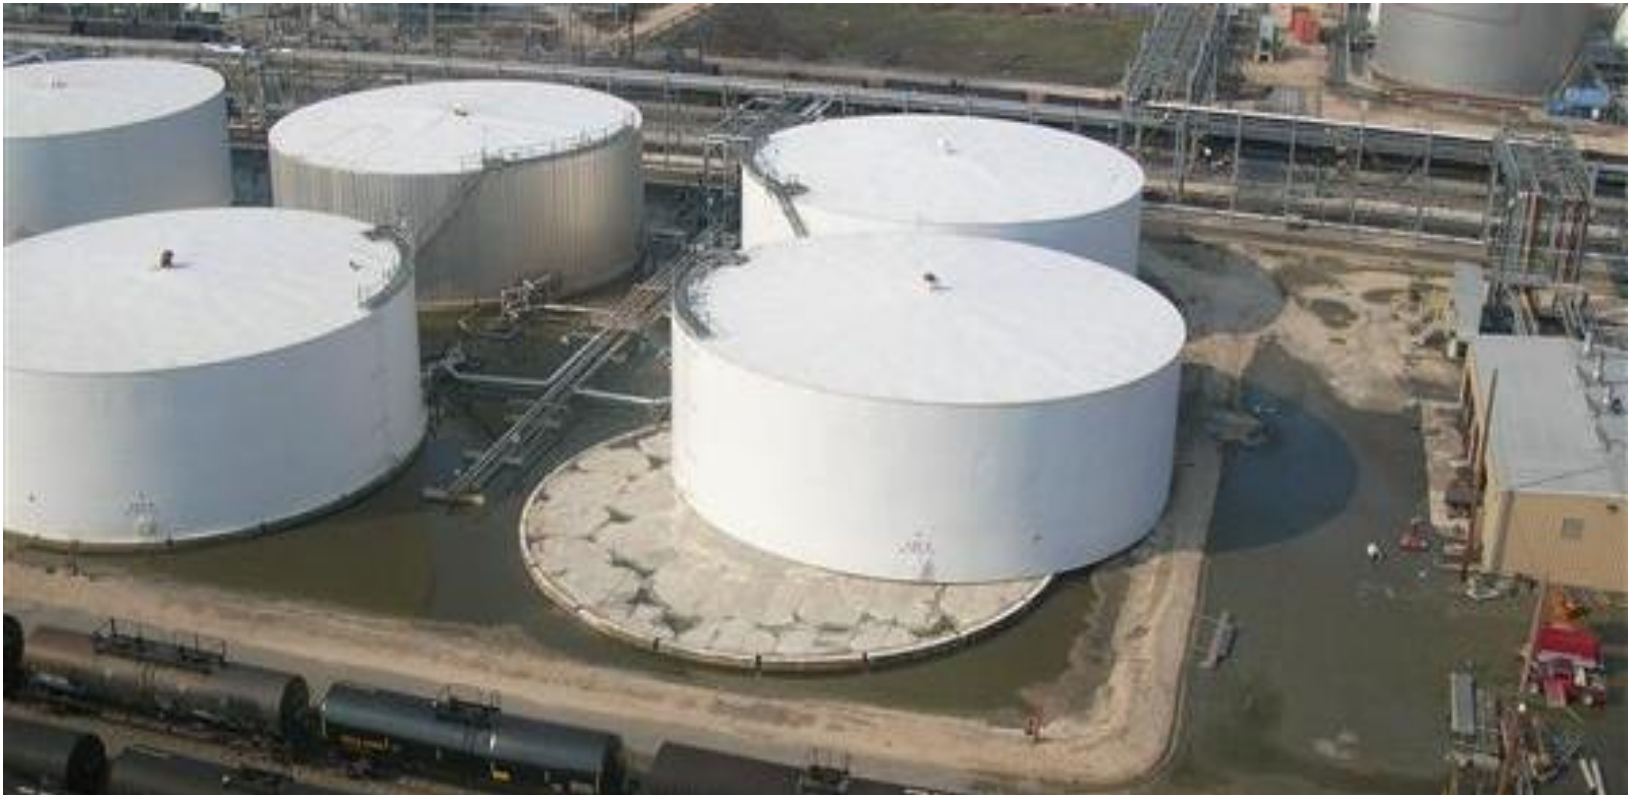
# Tank Flotation

- Empty tanks are most vulnerable to flotation
- Minimal flood depth required to float a tank off of its foundation
- Wind may displace a floating tank laterally

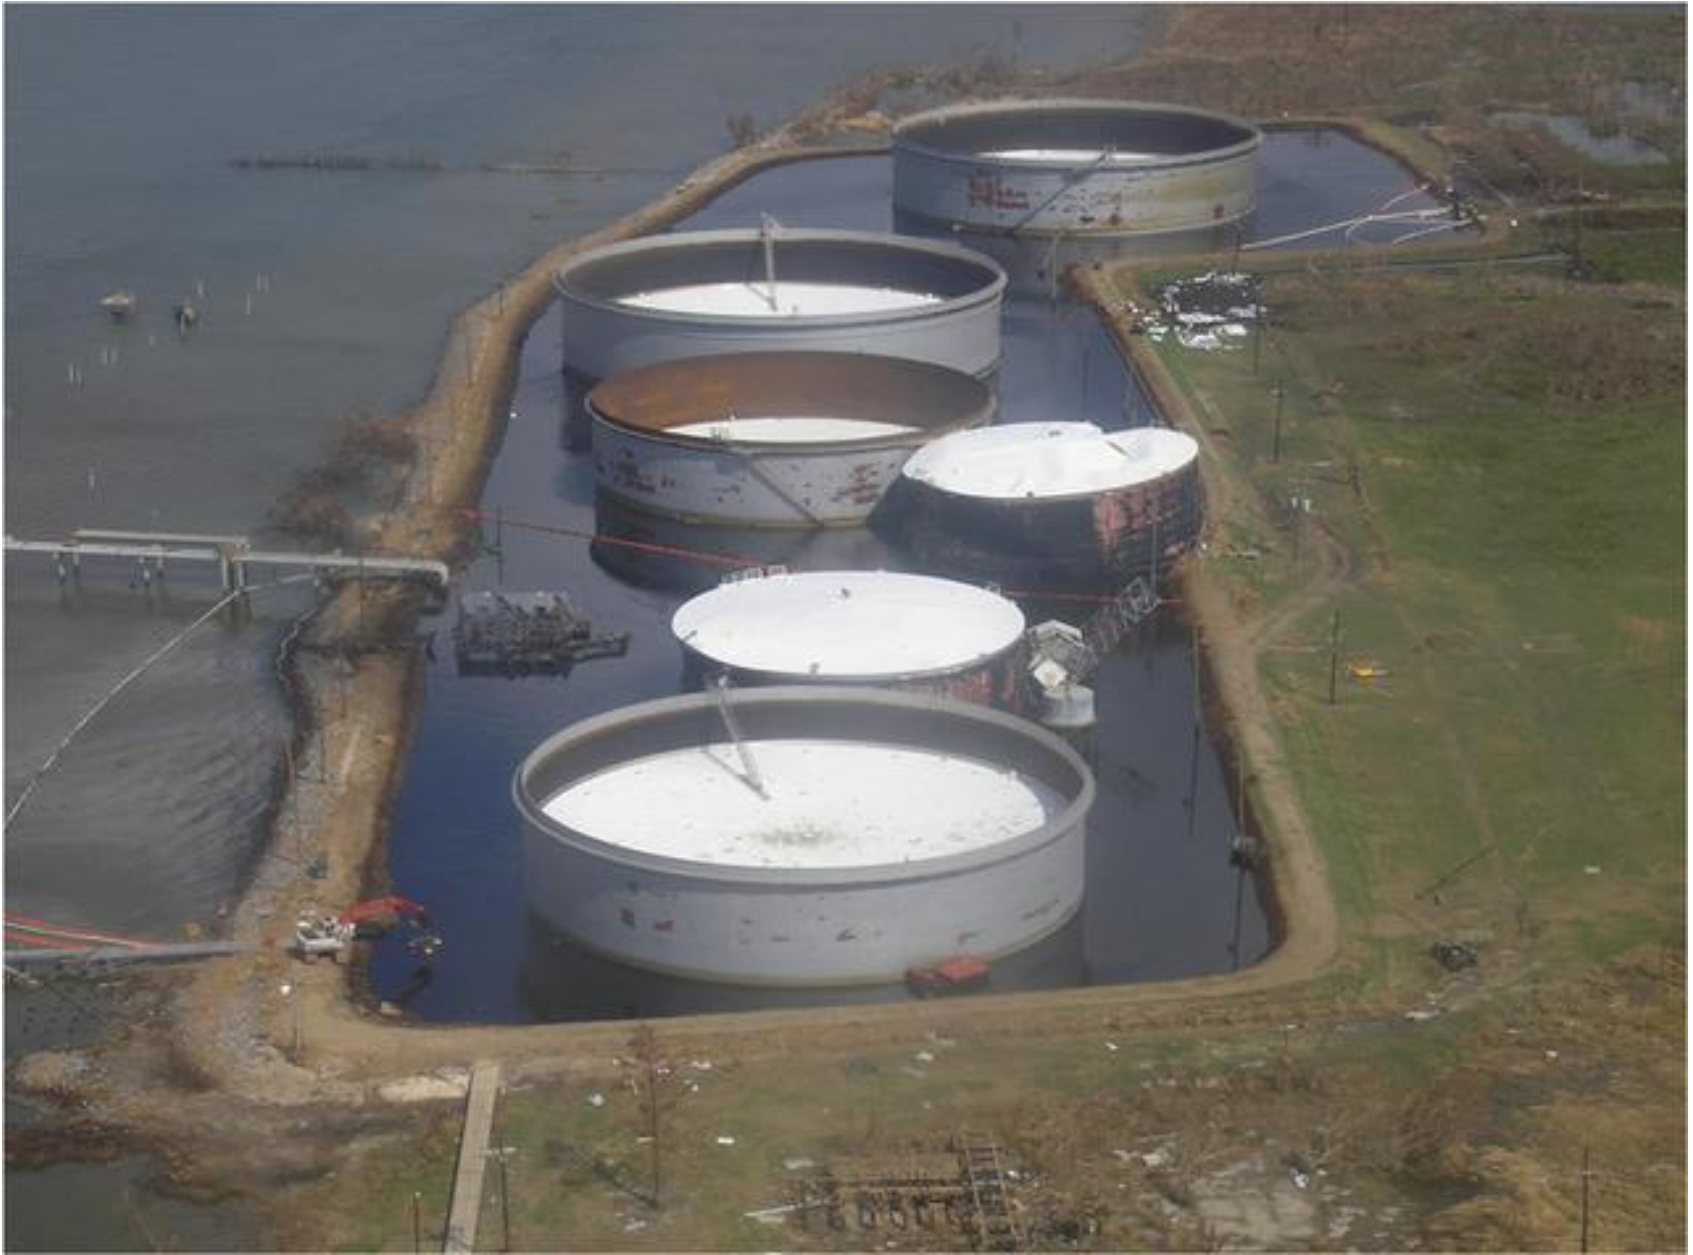
# ASTs Displaced by Flooding

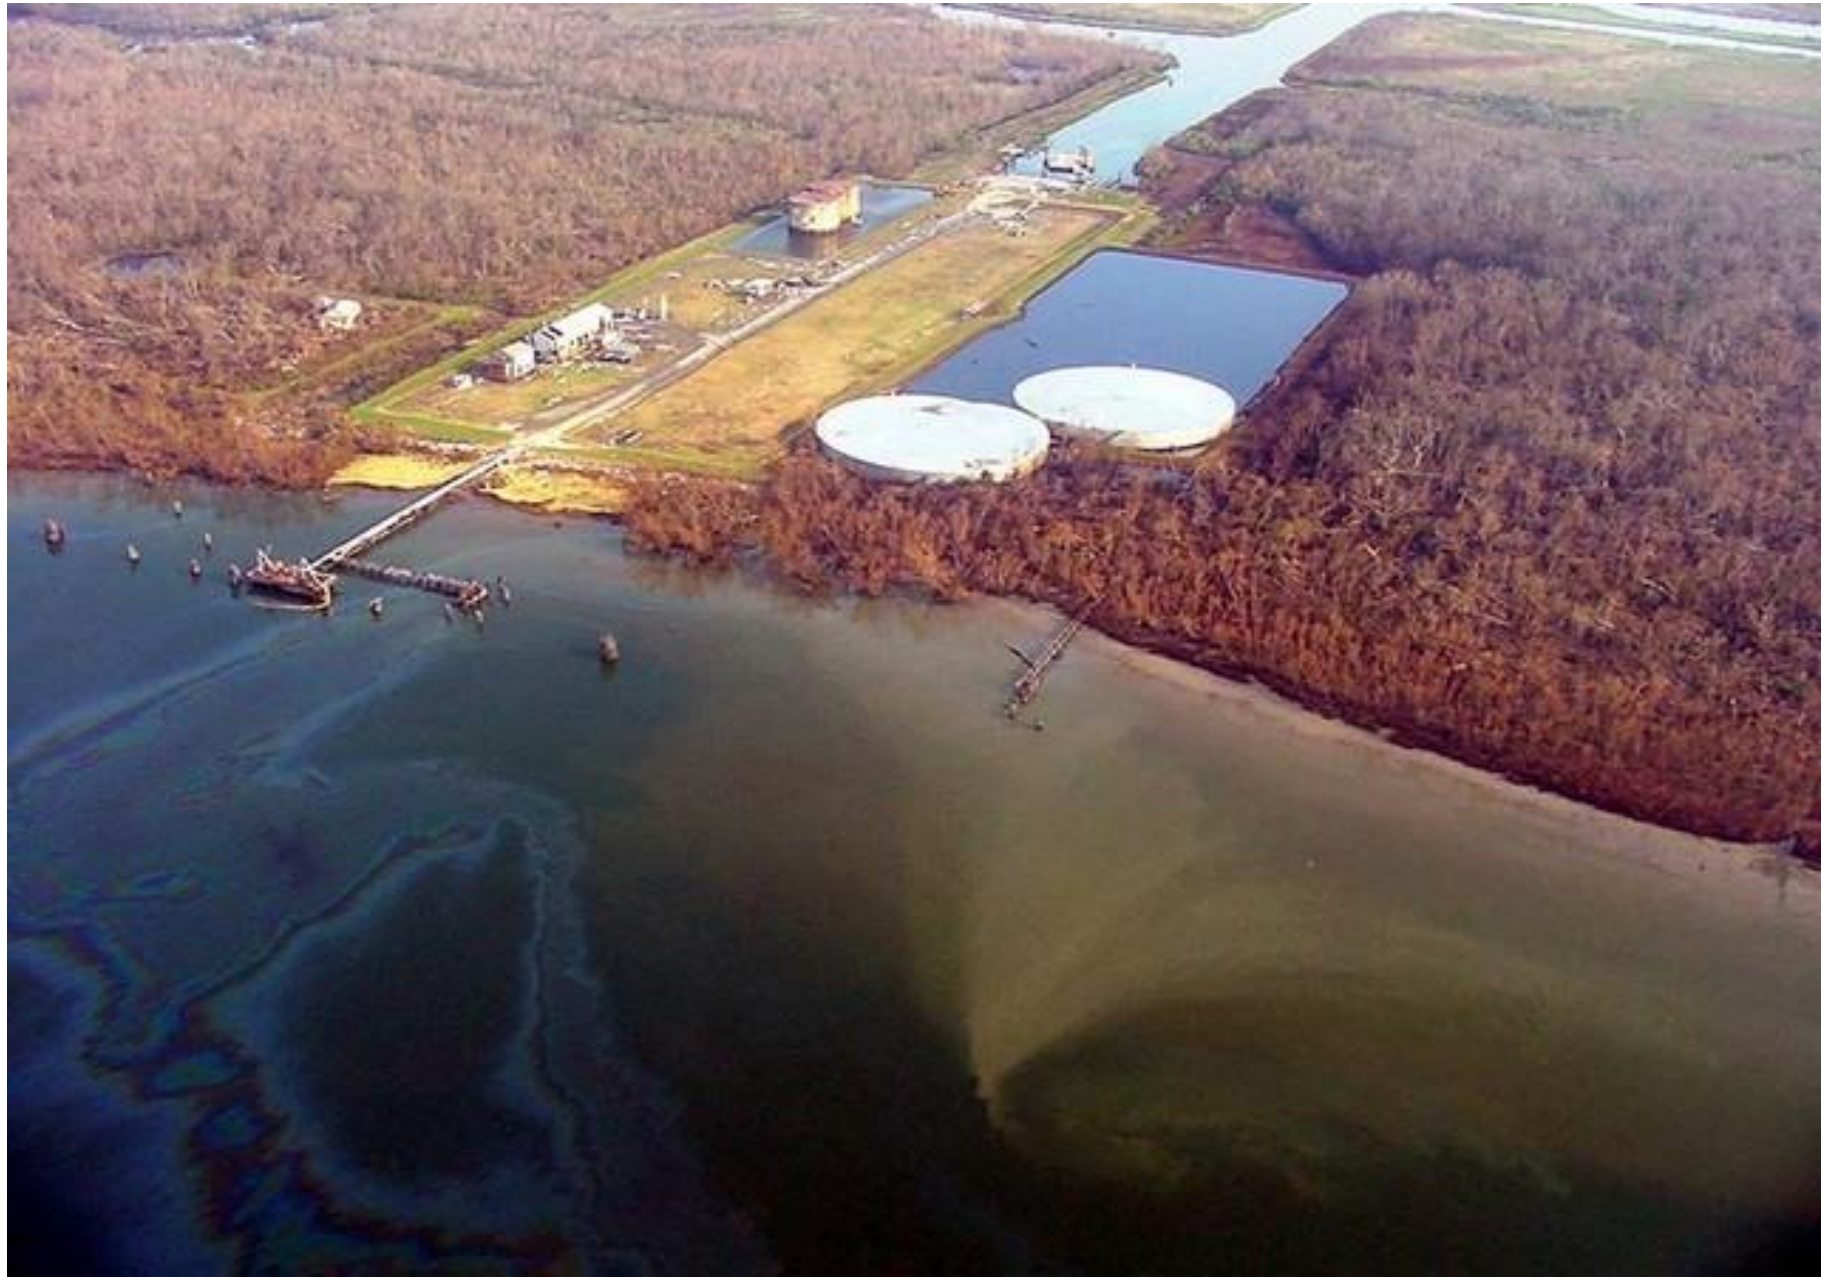
# ASTs Displaced by Flooding

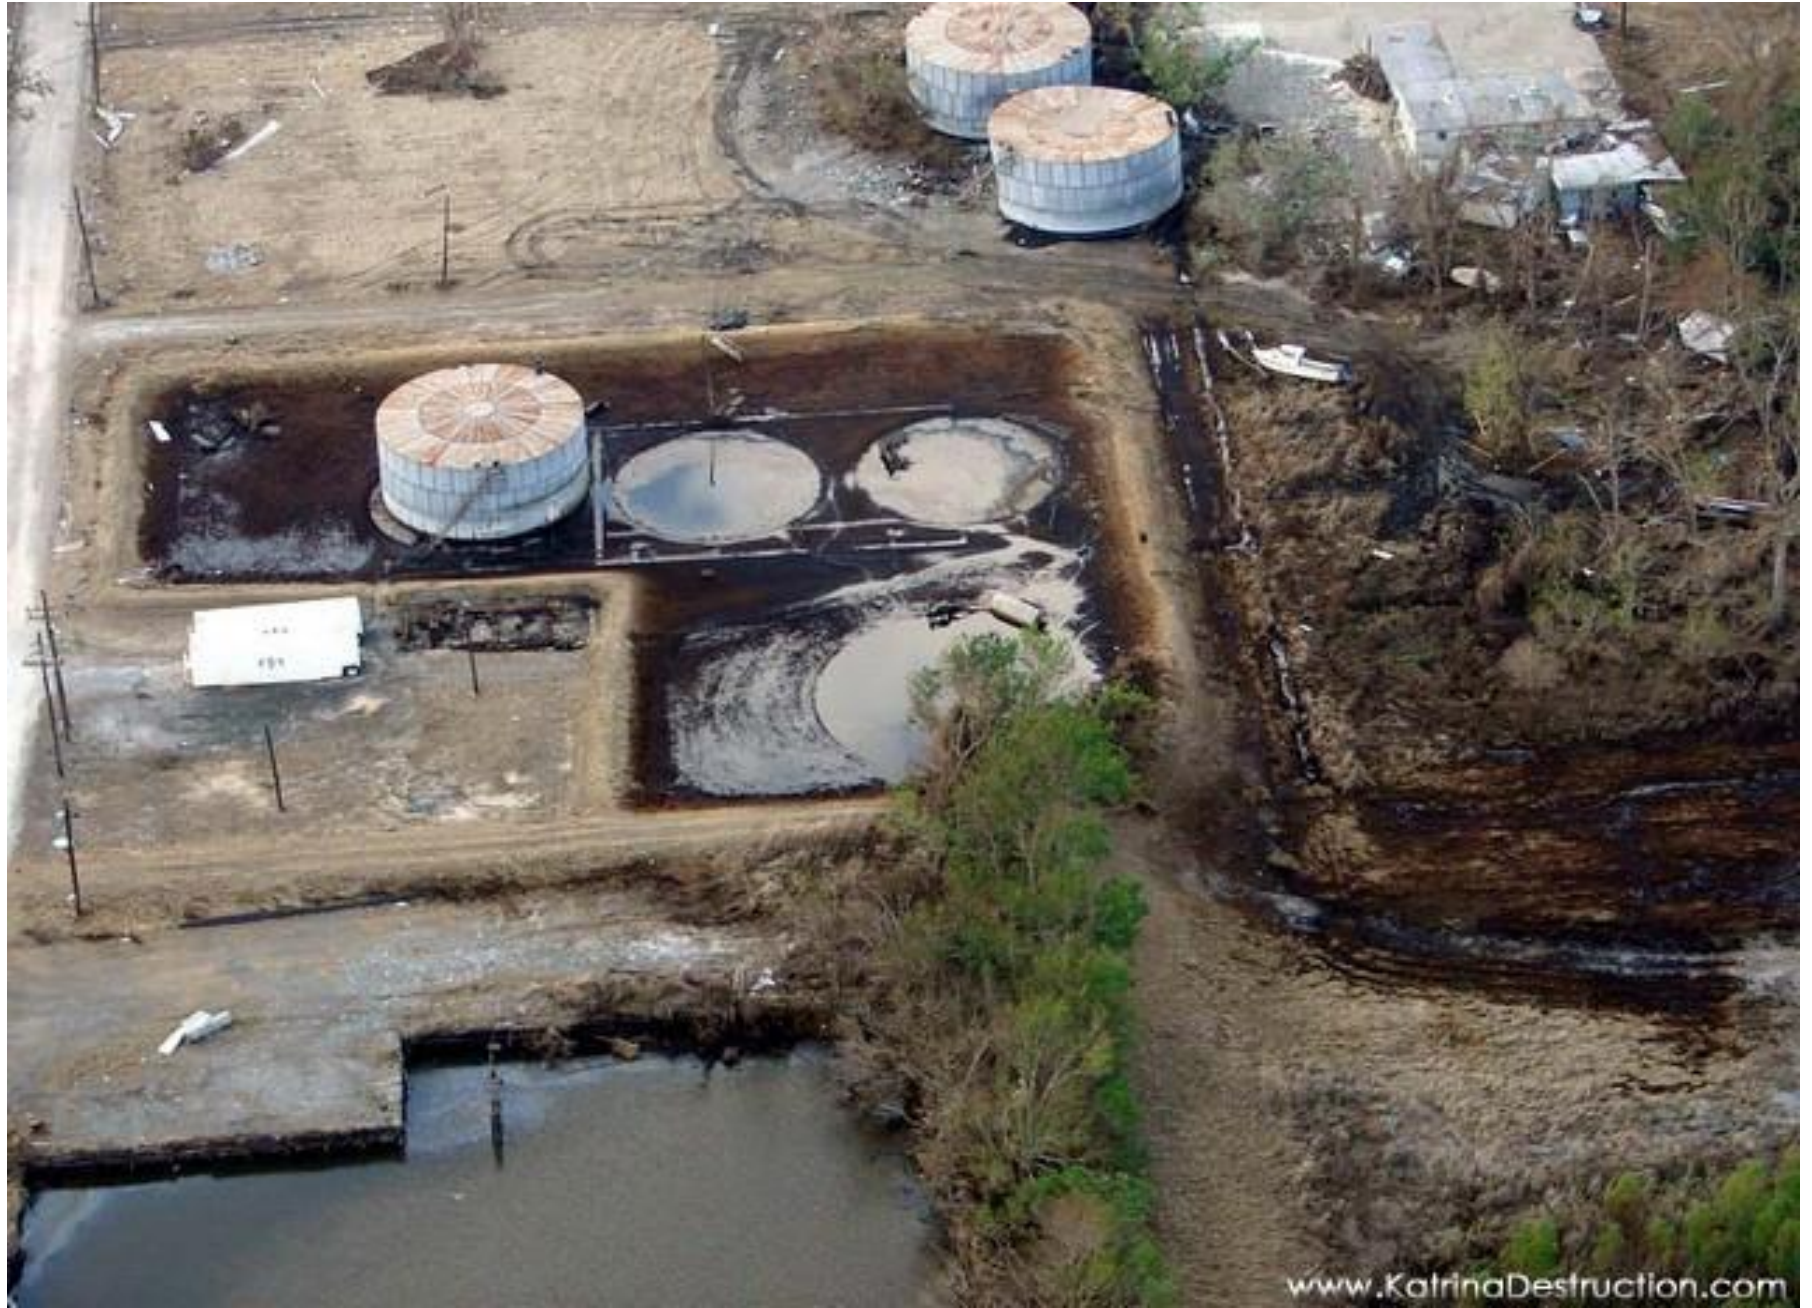
# ASTs Displaced by Flooding

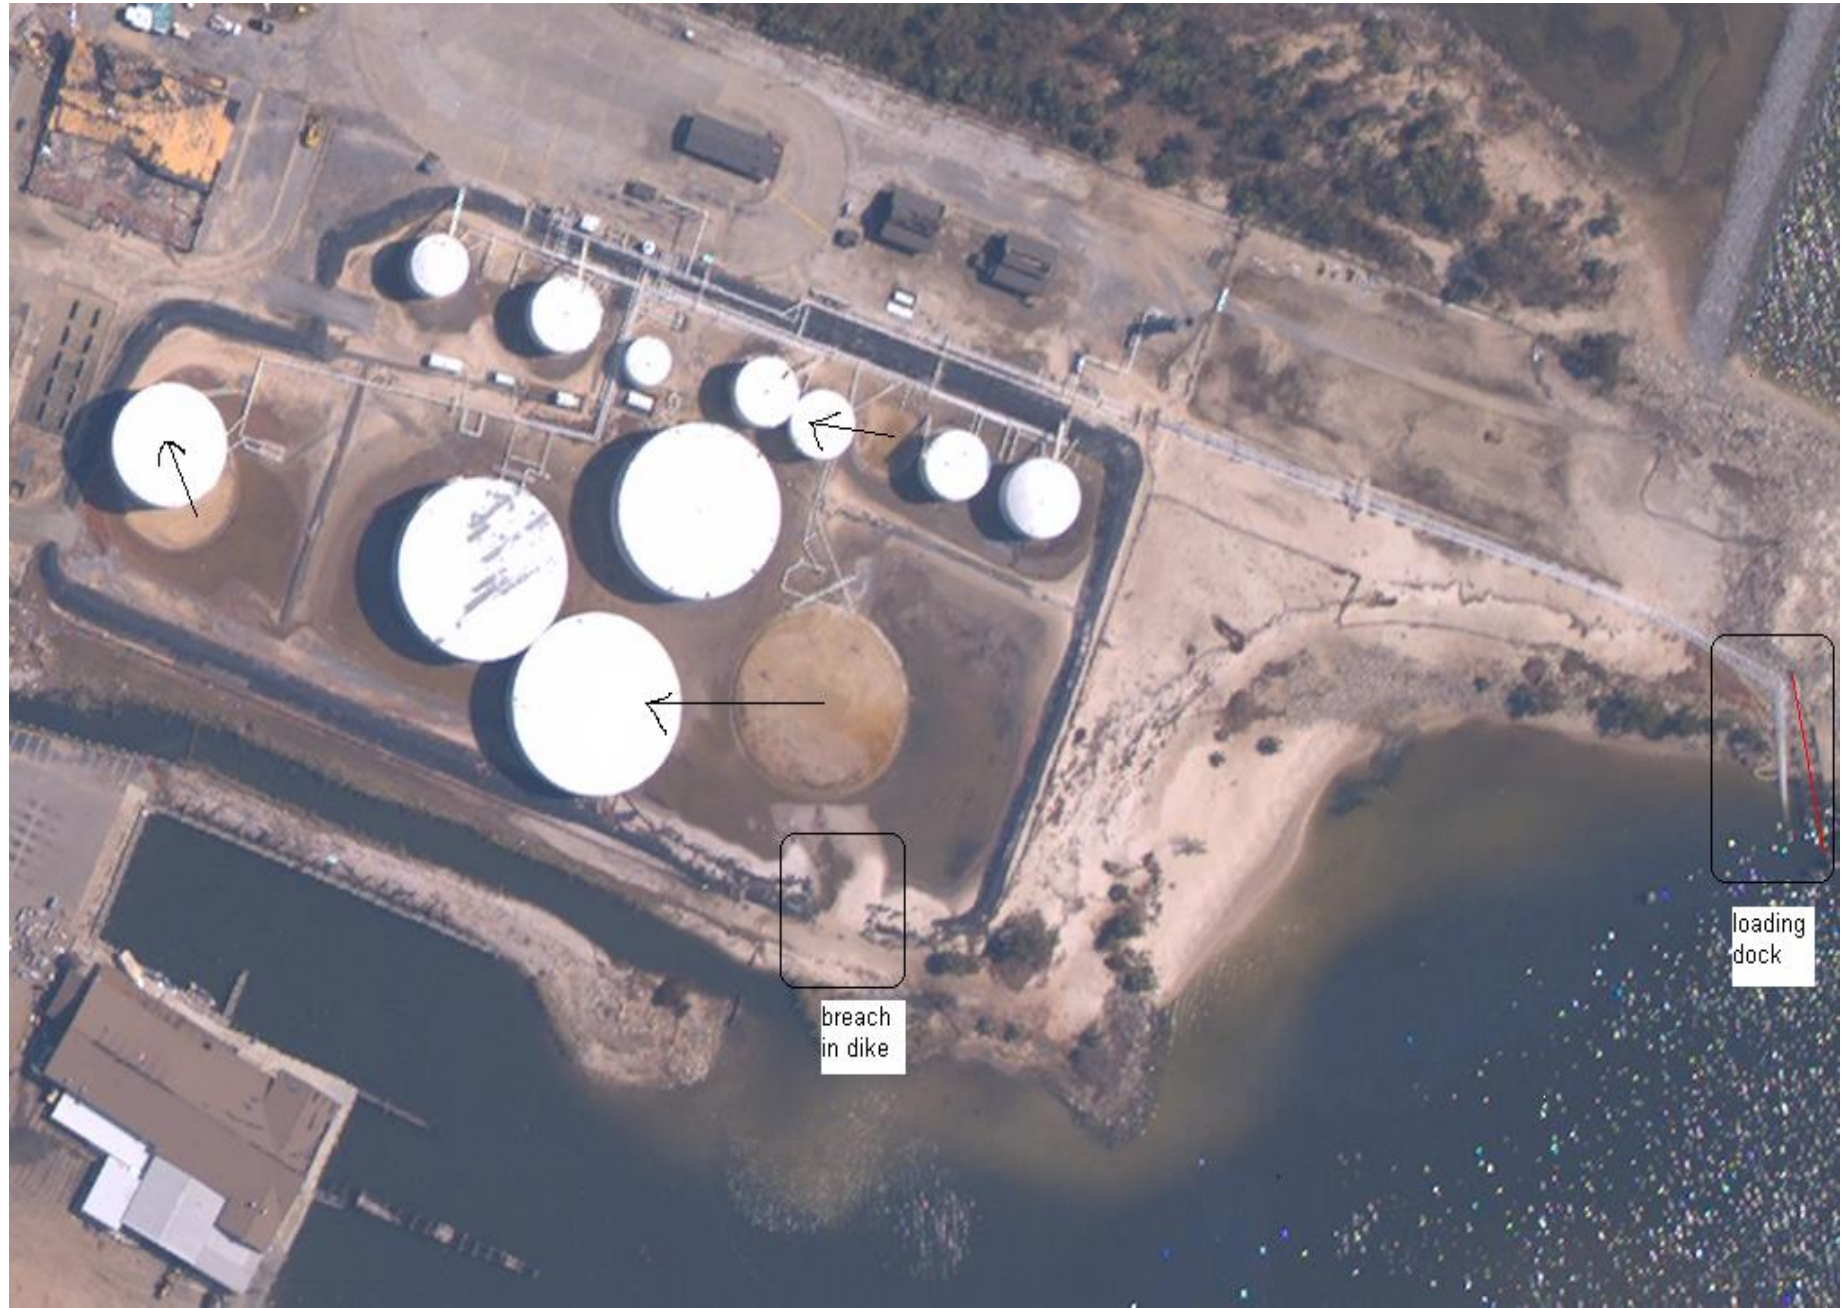
# ASTs Displaced by Flooding

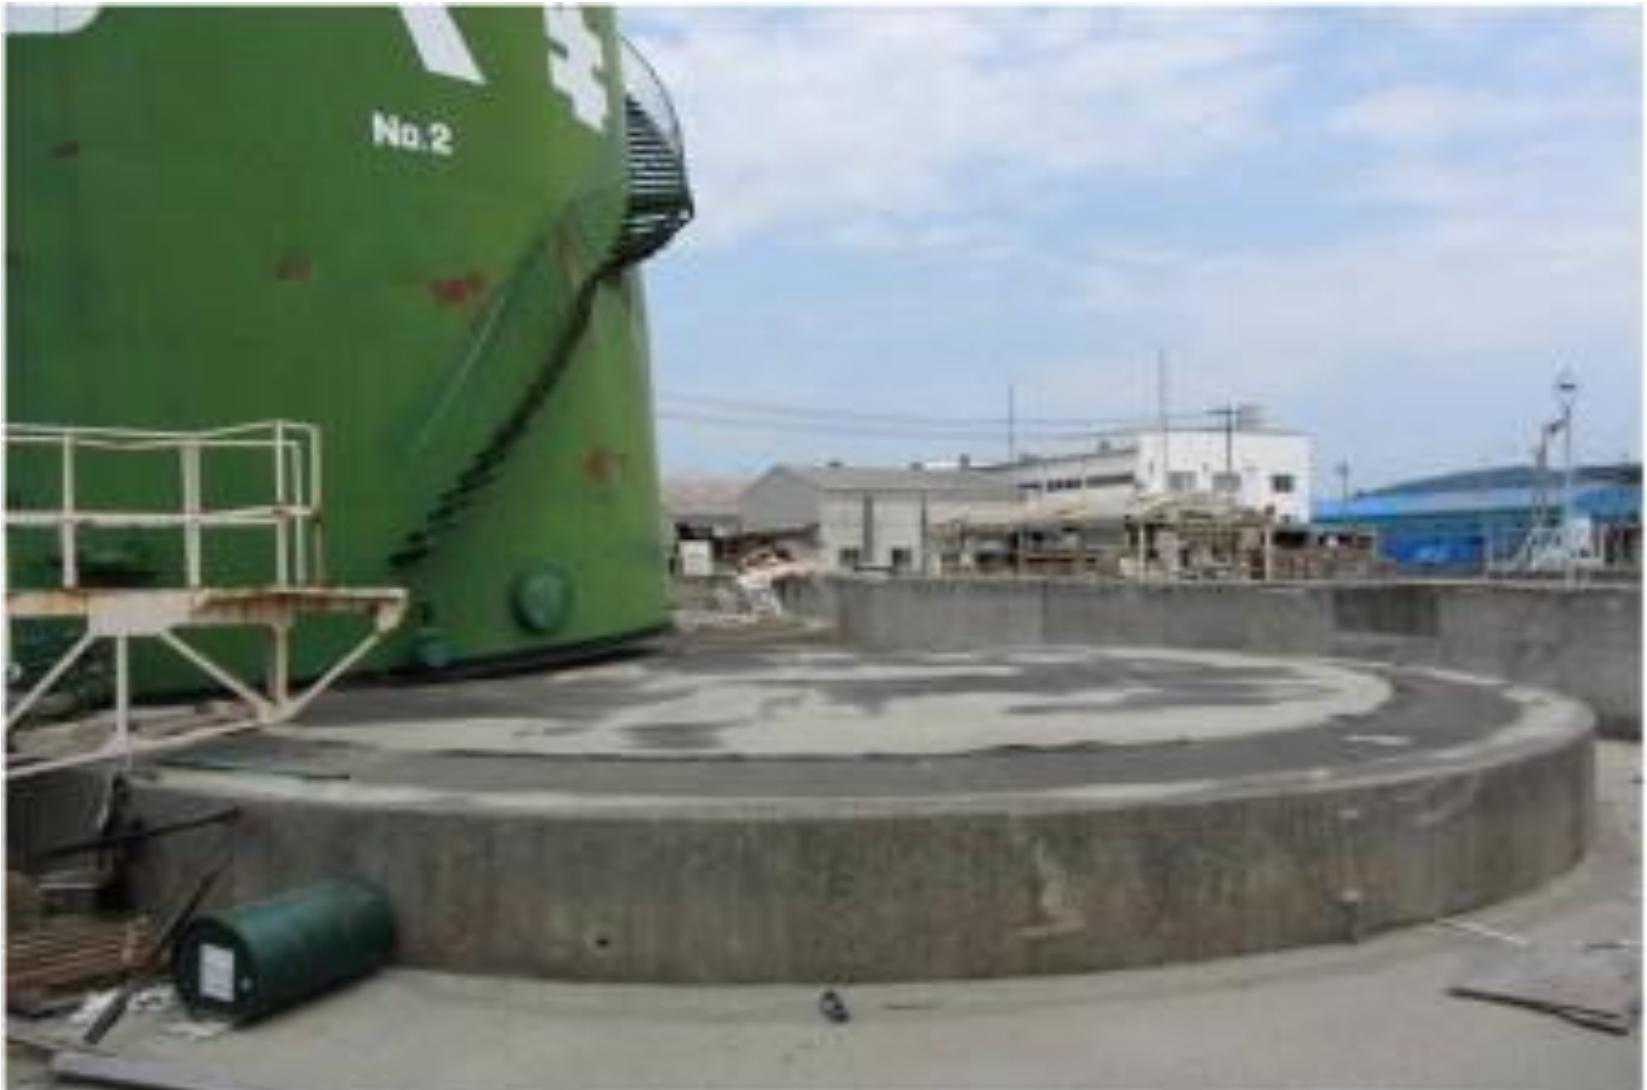
# Hazard Prevention - Seismic

API 650 Requirements for Seismic Ground Motion -  
Goal – Protect life and prevent catastrophic collapse

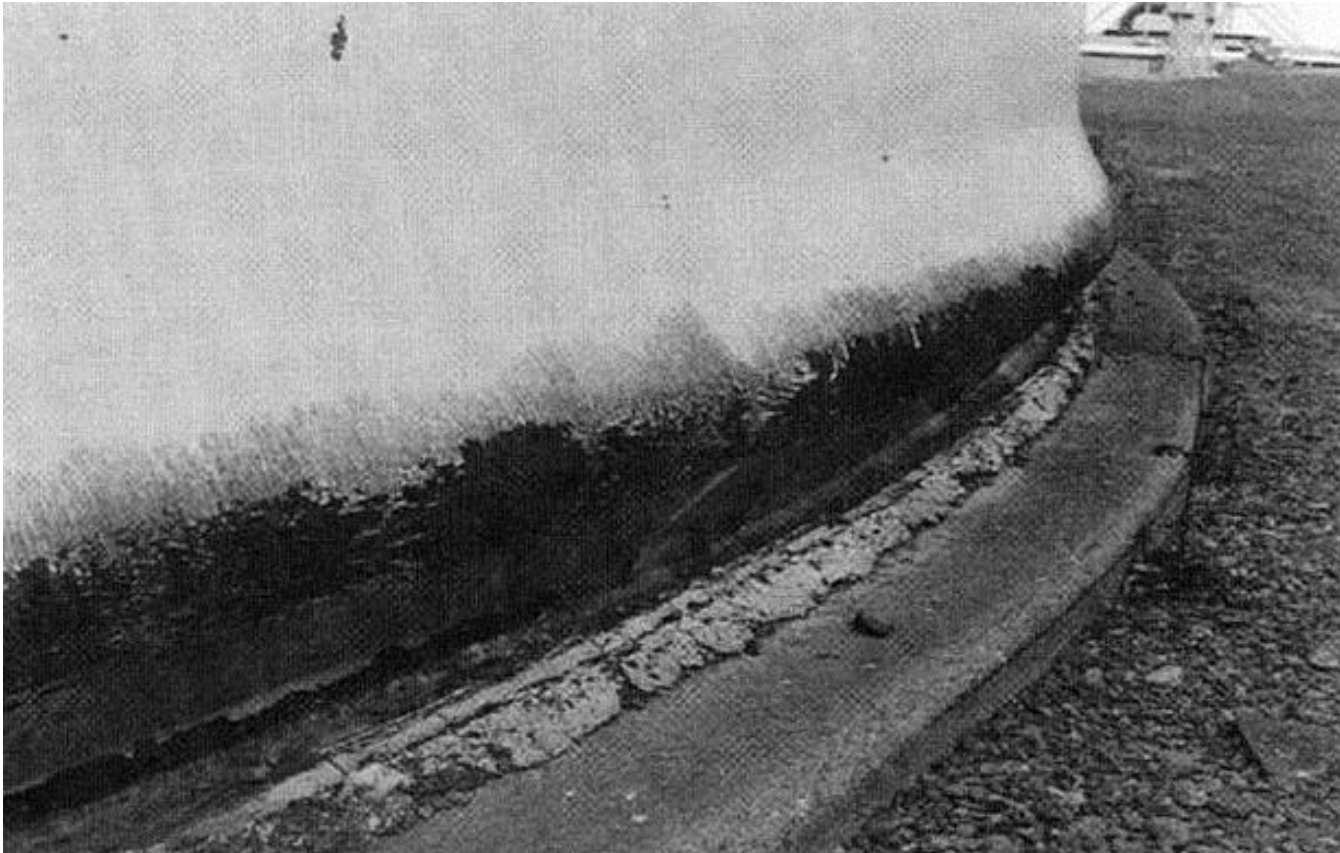
# API 650 Appendix E Seismic Design

Control methods use an equivalent lateral force analysis that applies equivalent static lateral forces to a linear mathematical model of the tank based on a rigid wall, fixed based model.

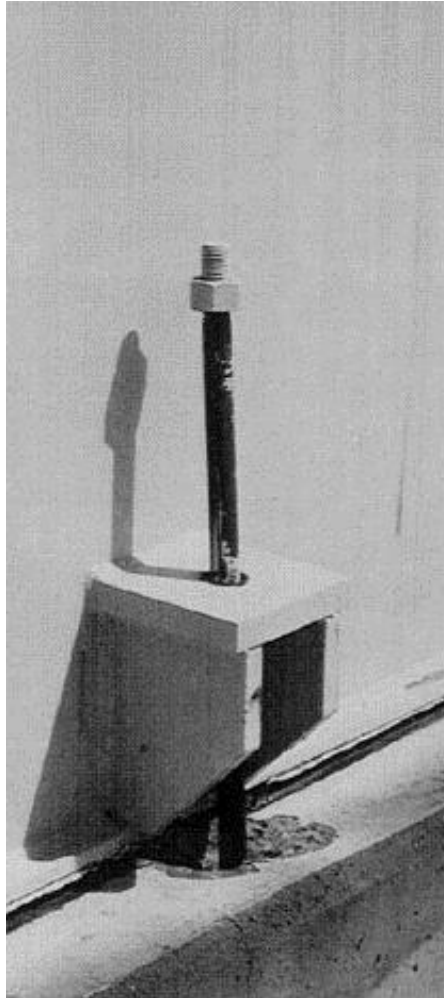
Traditional Anchor

# API 650 Appendix E Seismic Anchor Design

- Mechanically-anchored tanks have anchor bolts, straps or other mechanical devices to anchor the tank to the foundation.
- Self-anchored tanks use the inherent stability of the self-weight of the tank and the stored product to resist overturning forces.

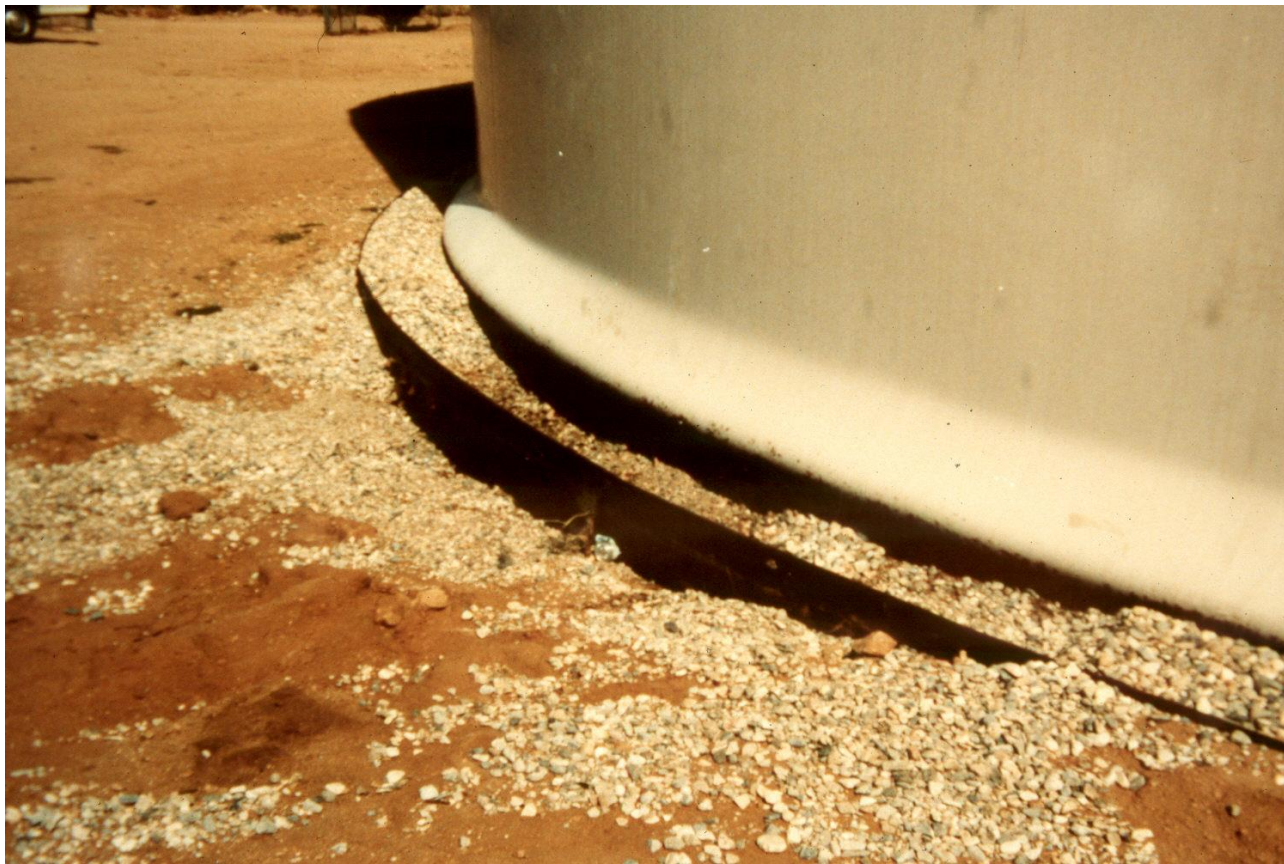
# API 650 Appendix E Seismic Design

Site-specific design is needed when the tank is located within 10 km of a known active fault or when the structure is designed using base isolation or energy dissipation systems.

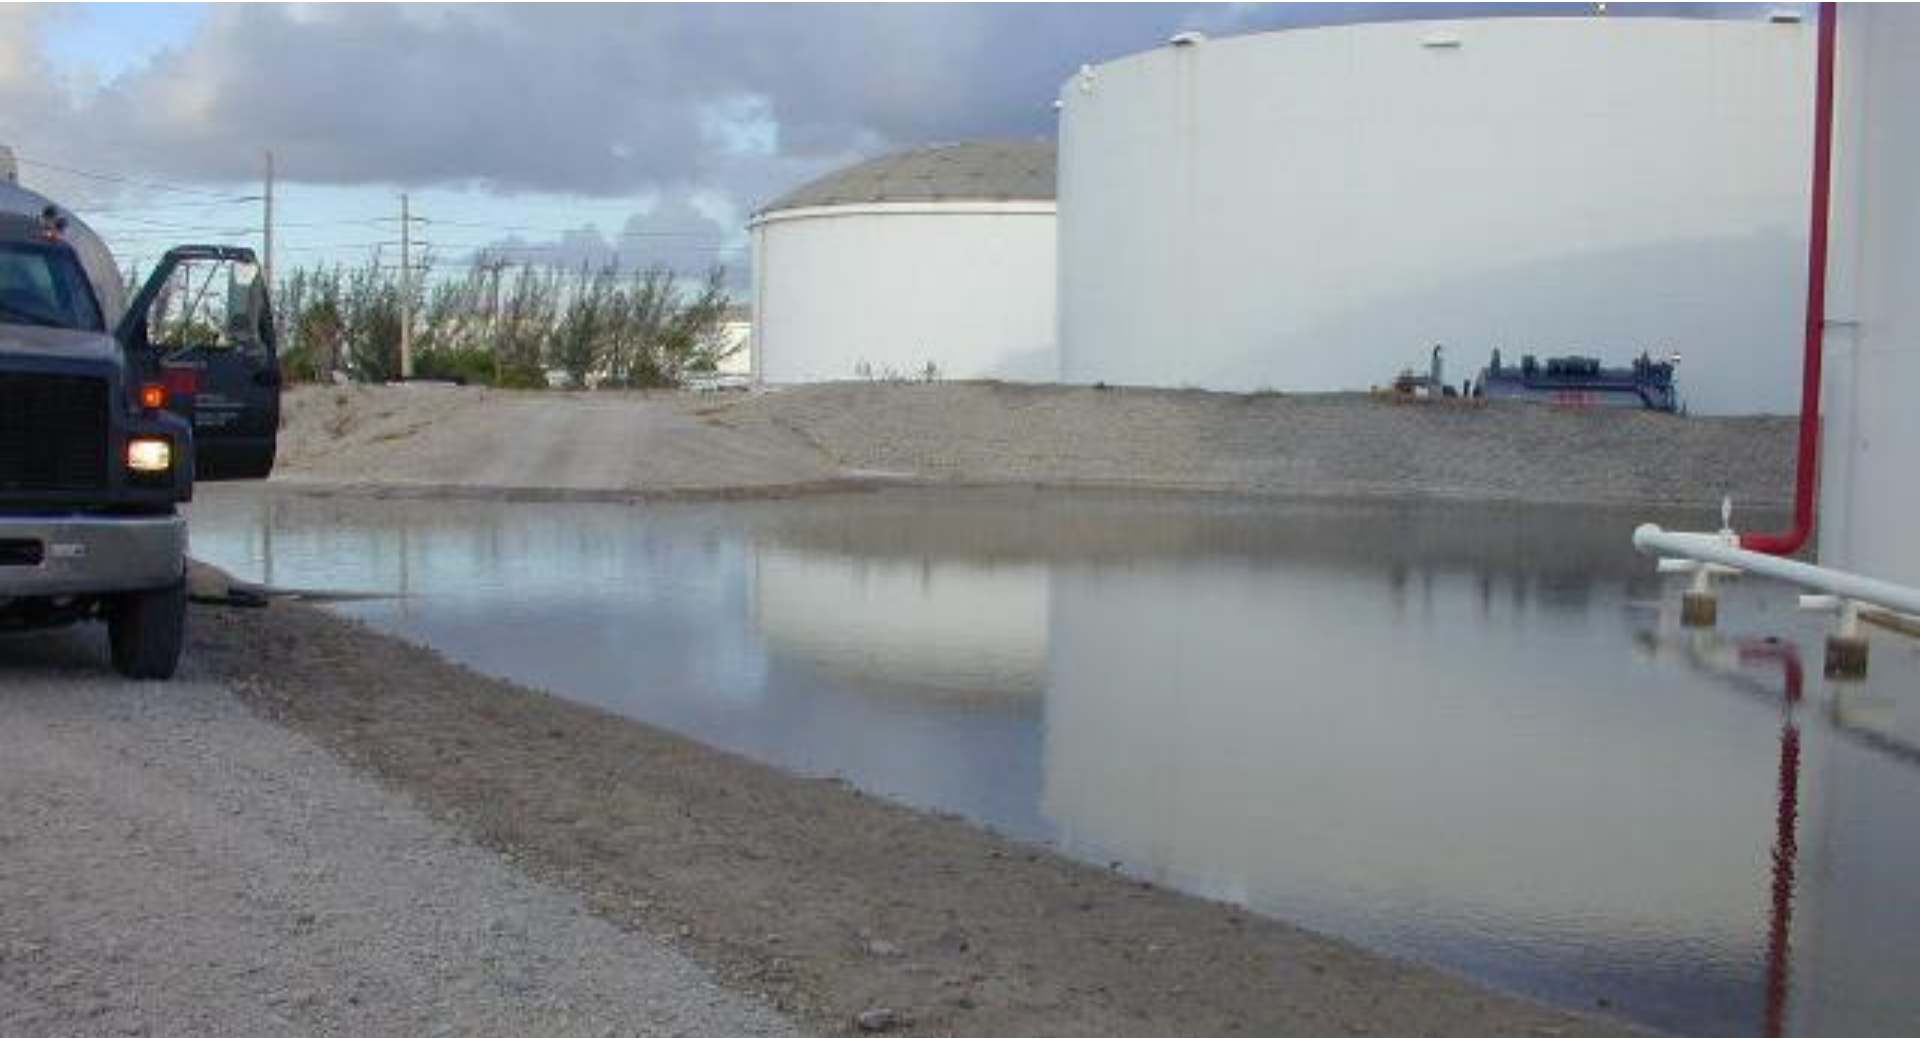
# Port Everglades, Florida - Jet Fuel Overfill – Approximately 378,540 Liters

2400 Barrels (2004)

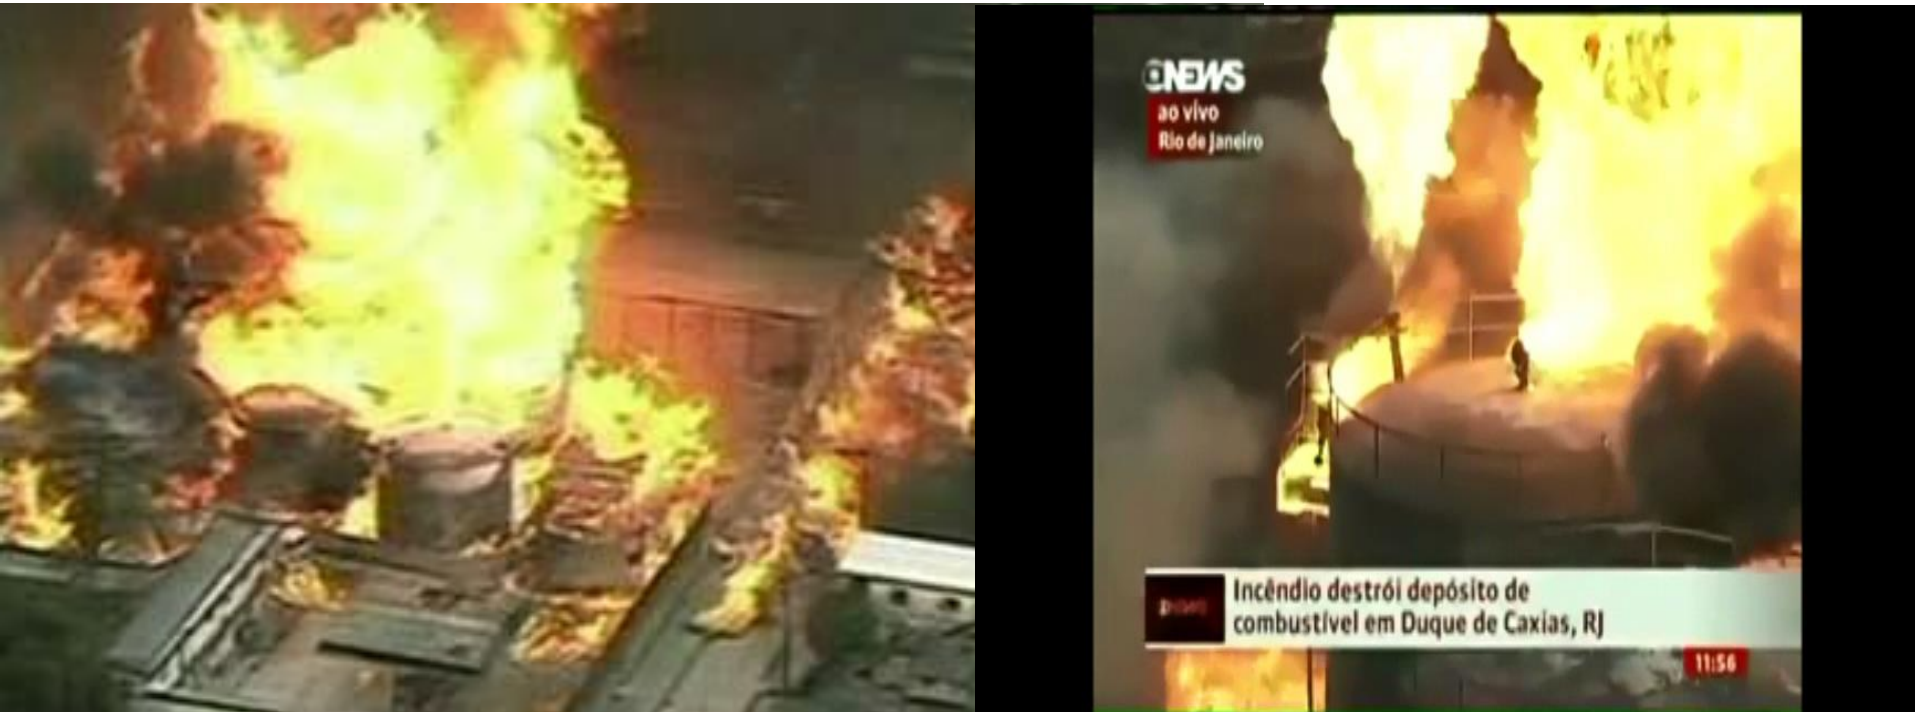
# Rio de Janeiro - May 2013

- One dead from inhalation of vapors, 7 injured
- 6 tanks at terminal, spread to administration buildings
- Site did not have environmental license to operate
