# Hazards Management for ASTs

# Hazard Events that can Affect Your Facility

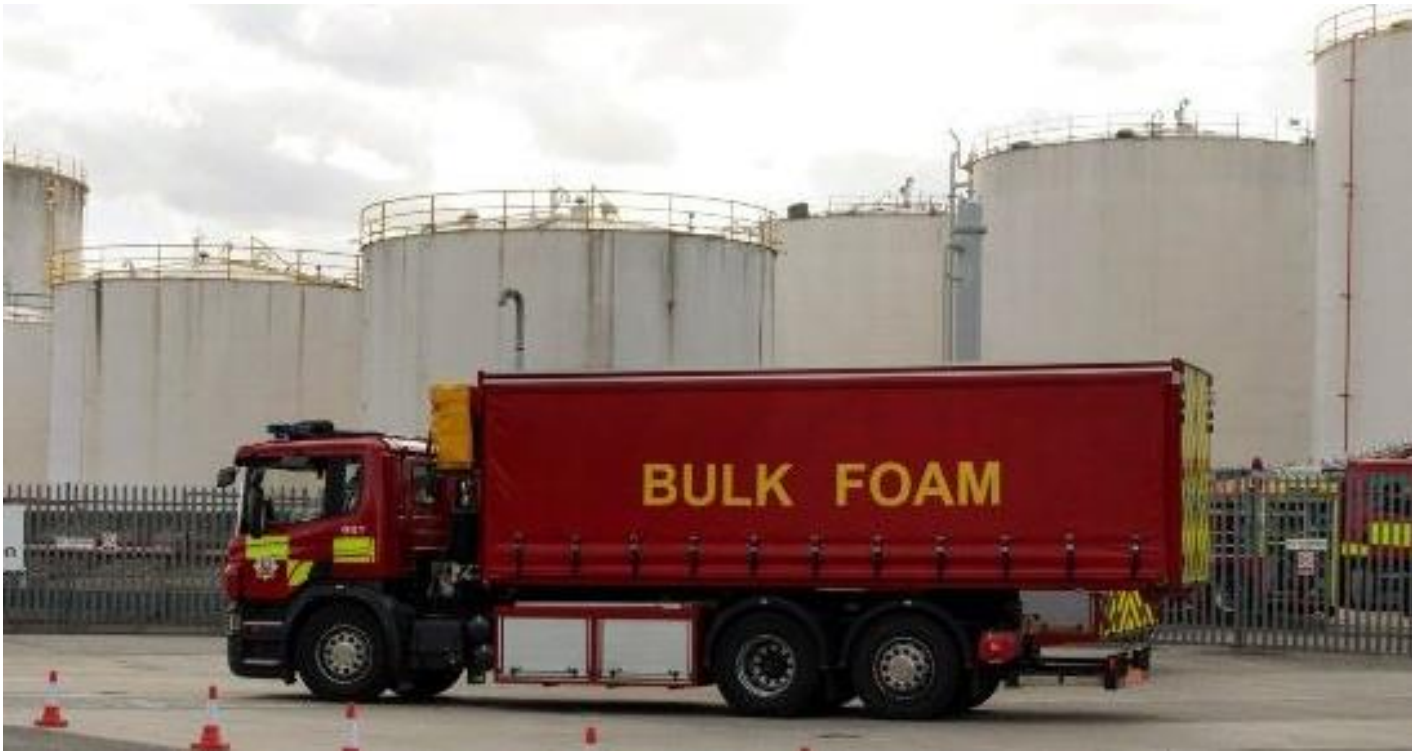
# West Thurrock, Essex, UK, April, 2013

Fire in the rim seal of one of the empty tanks had automatically set off Terminal's foam fire extinguishers. Sixty fire fighters extinguished the fire, no injuries

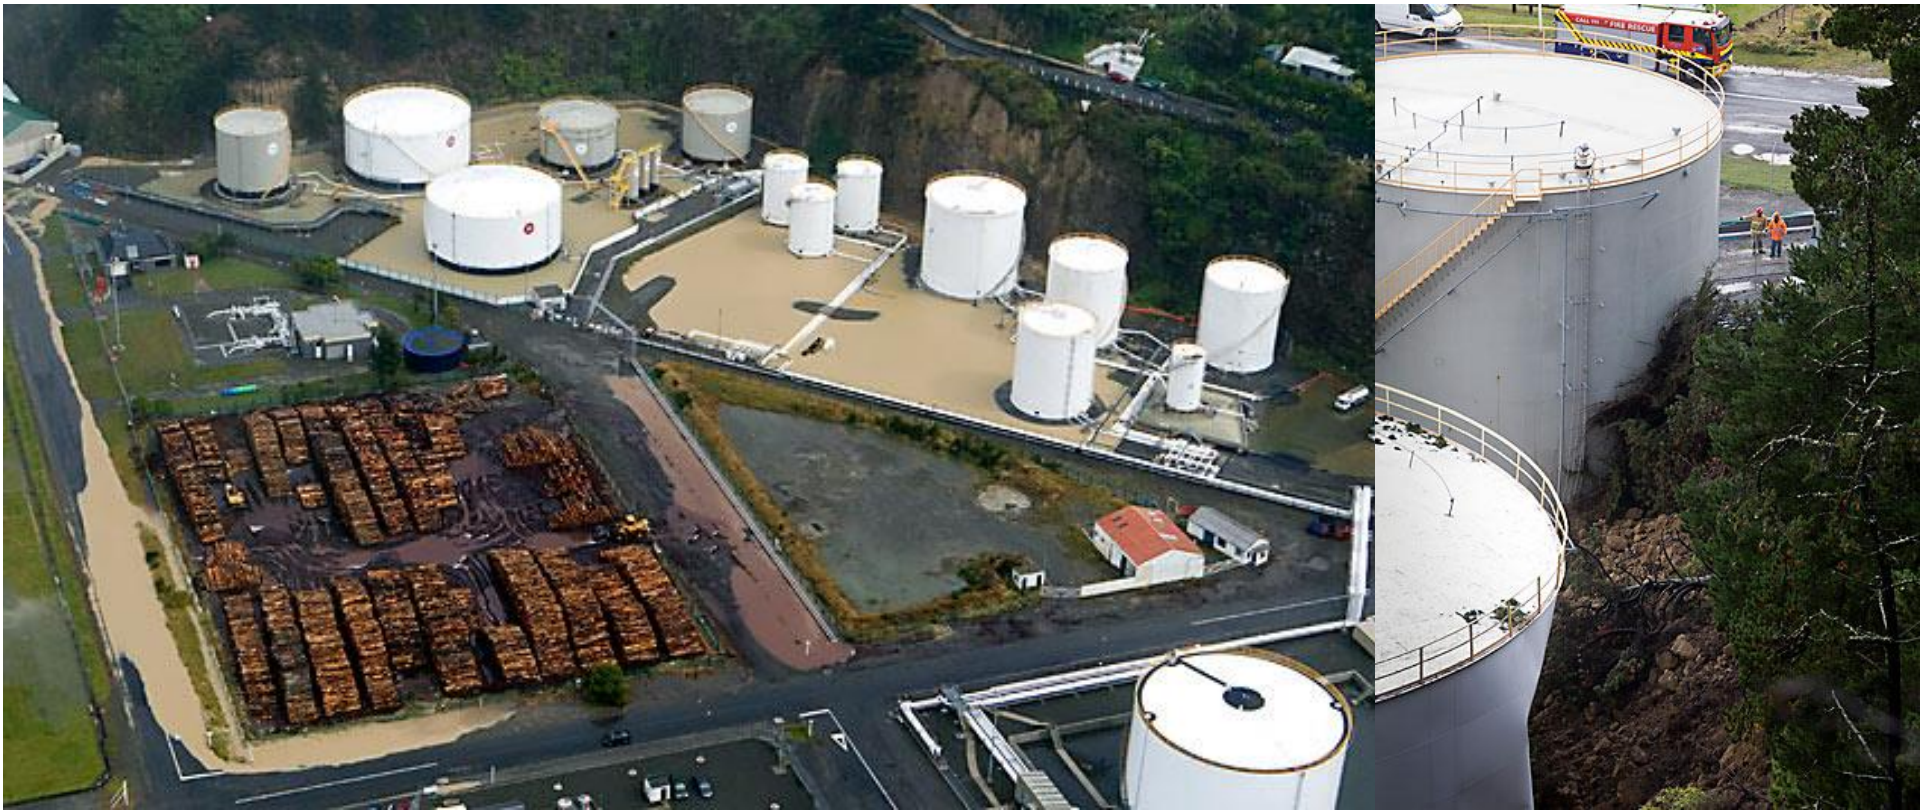
# Lyttleton, New Zealand, March, 2014.

A landslide during a major storm damaged 2 tanks and caused 1.2 million liters of jet fuel to spill from a tank at Mobil Oil New Zealand's tank farm at Naval Point. About 1500 liters of fuel went into Lyttelton Harbor through a drainage system before sandbags were put in place.
