Tanknology

Sump Testing and Repair

Sump and Dispenser Pan Testing and Repair

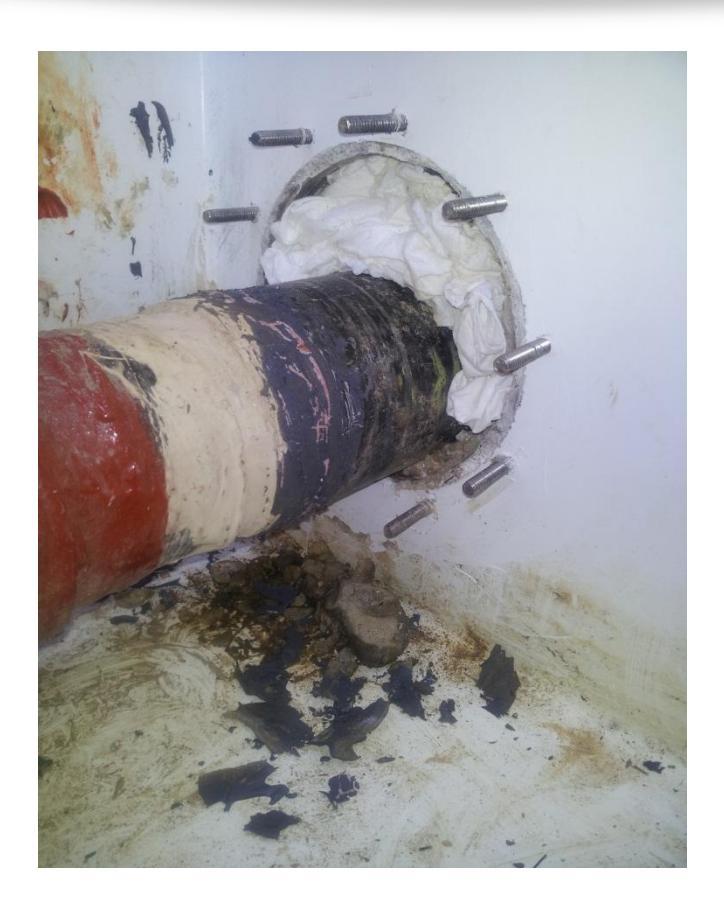
Pic # 001: Before repair view of a 3.75" DW Ameron LCX vent line as it enters a fiberglass vent sump, beneath the vent riser location. Our surprise was the pipe's position after scraping away tons of sump-tite that was added during the original installation. We had ordered a boot configuration with an insert sized to the pipe. Once we saw this, we realized what we ordered wasn't going to work.

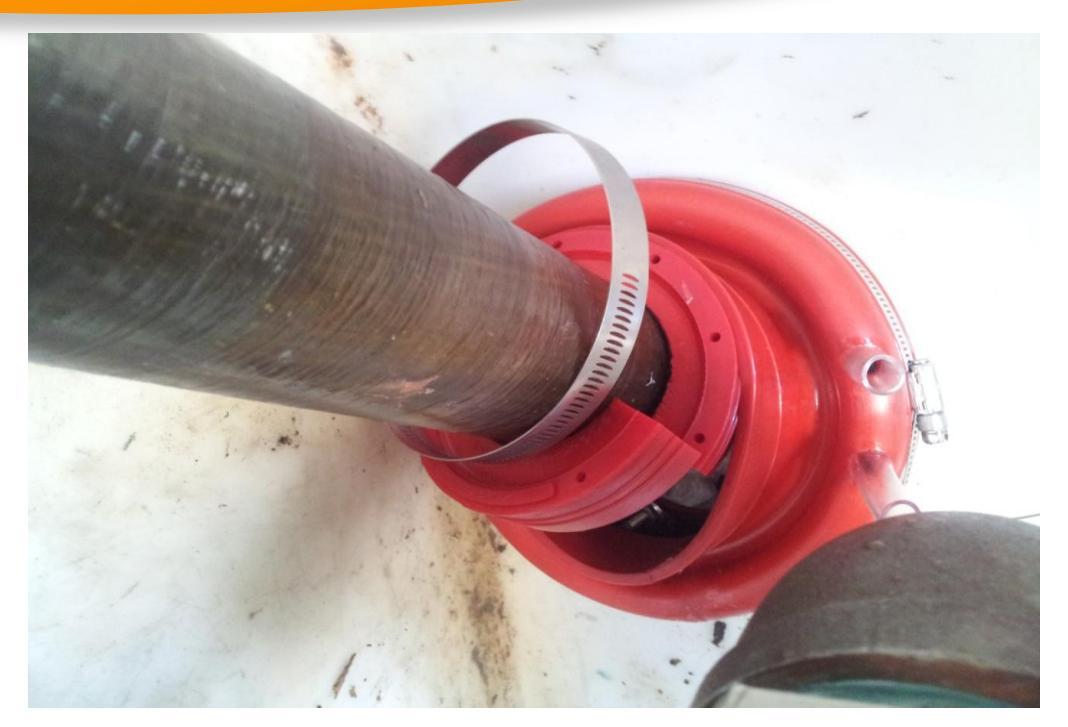
Pic # 002: This is what we ended up with when trying to get the parts we ordered to work. There was just no way to get that insert into the boot as it caused too much distortion to the boot. We realized that we were going to need a CUSTOM boot.

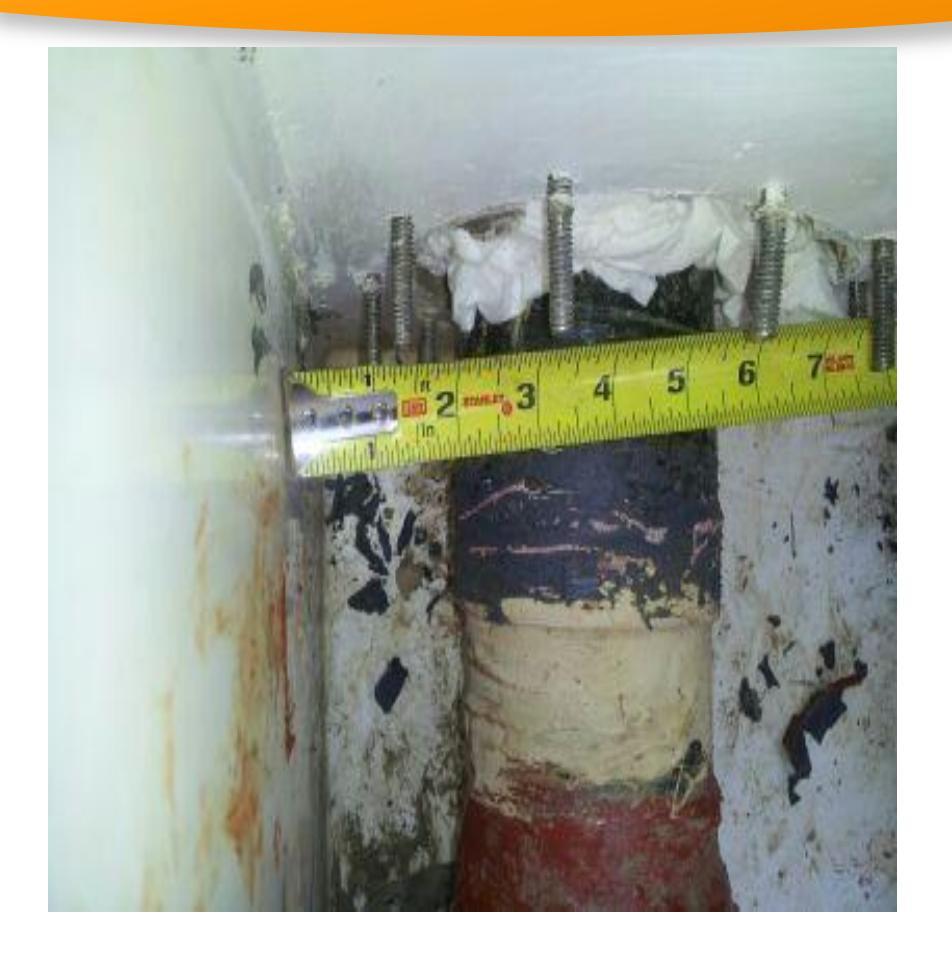
Pic # 003: Contacted Manufacturer and began describing the issues. Measurements were taken to verify clearances. Cell phone pictures were sent to show the challenges

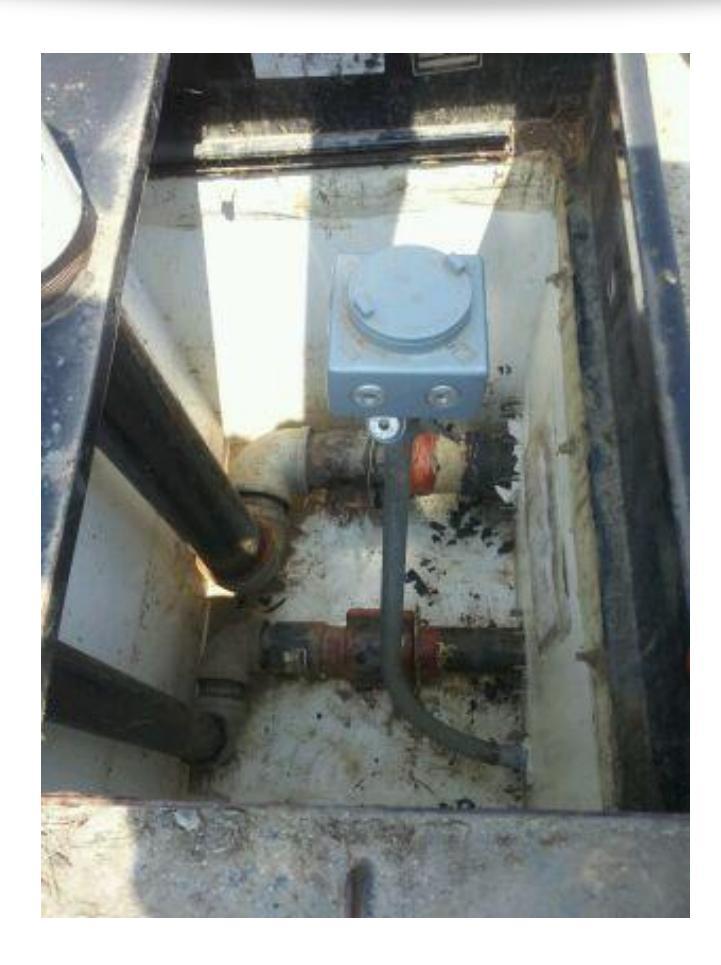
Pic 004: Just to illustrate the difficulties presented here, that penetration is the one closer to the side of the sump. And that conduit and j-box kept us from having ideal access to the area to repair.

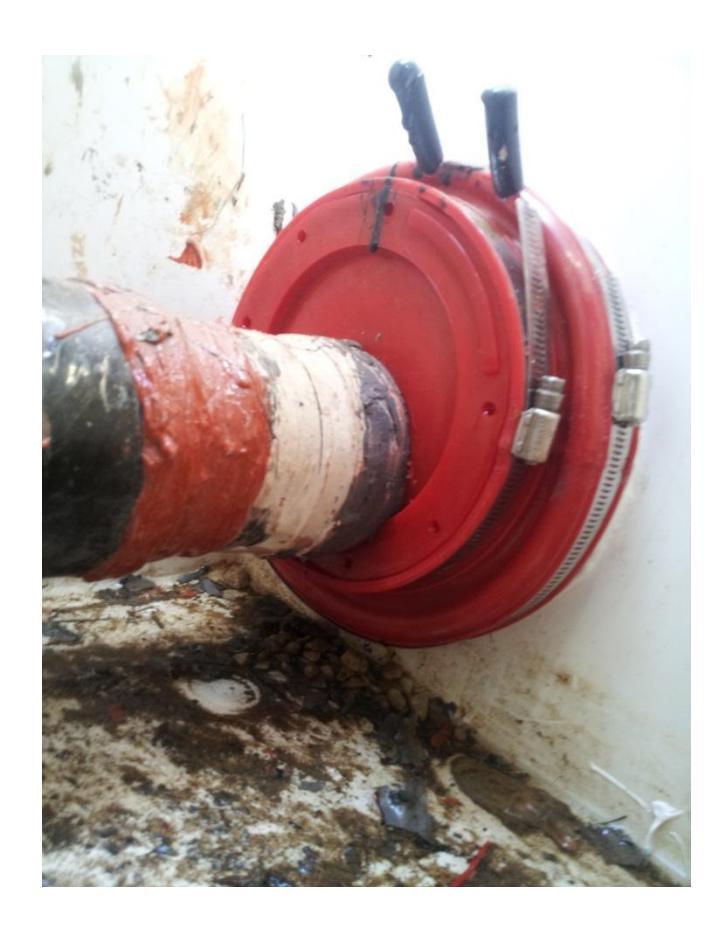
Pic 005: The next morning, UPS delivered the custom-drilled insert that ICON was able to create in their shop for us. As you can tell by the appearance of the outer ring of the boot, the insert Fit perfect! The boot was filled and then a test was run with passing results. Job Complete.

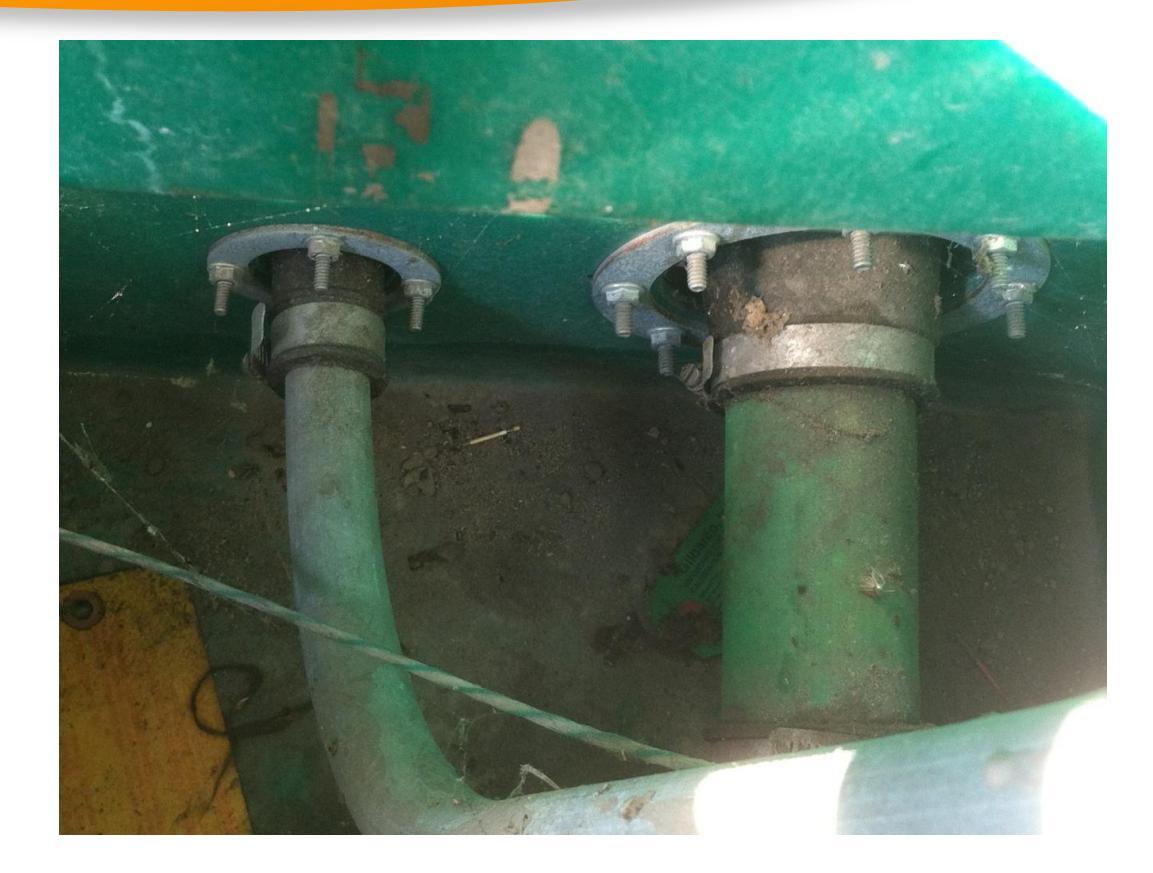
Pic # 001: Before repair view of a 2.5" Environ product line and the smaller 1.0" conduit penetrations.

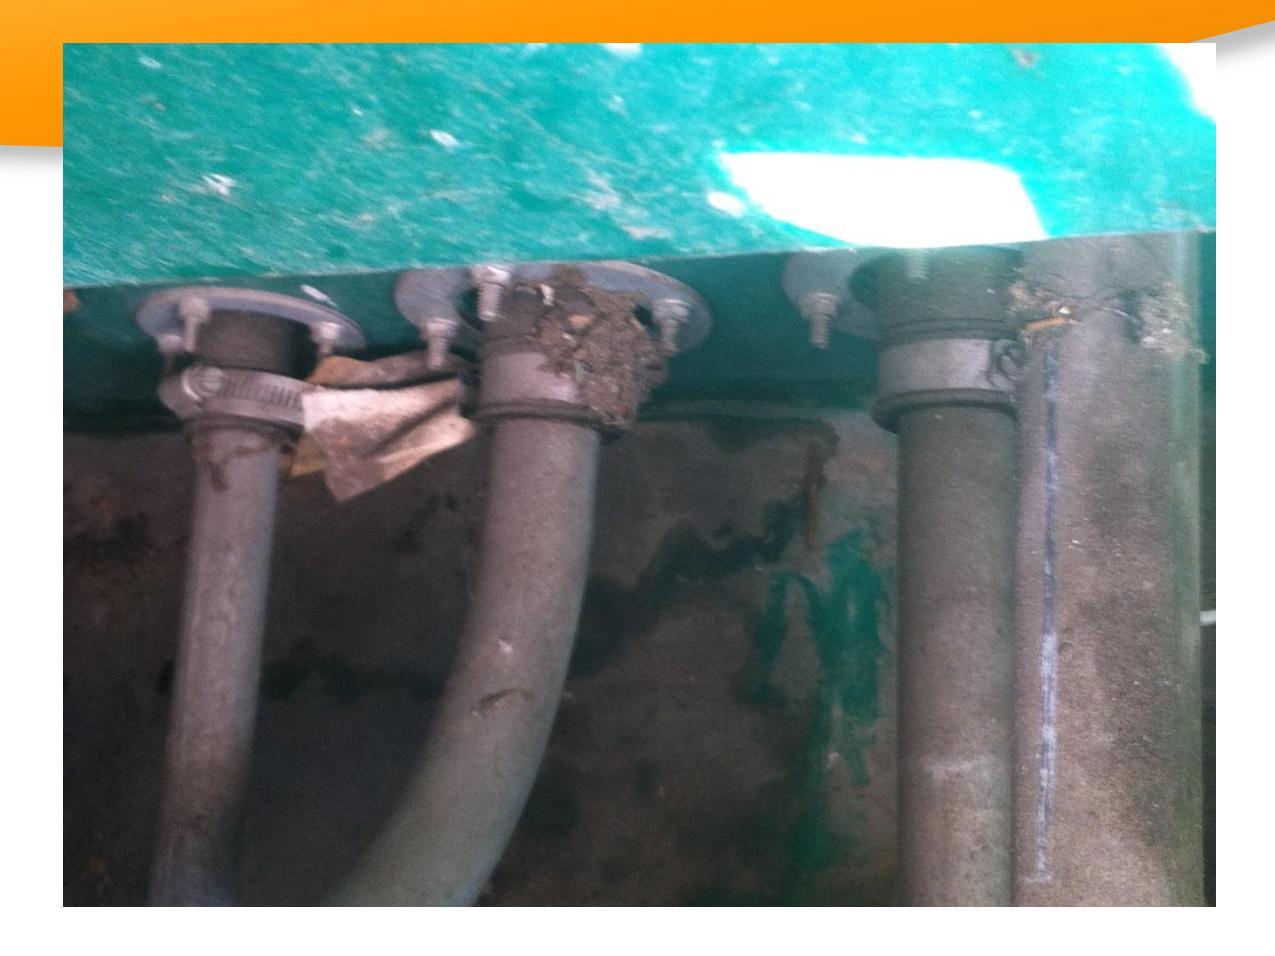
Pic # 002: Before repair view of a 2.5" Environ product line, 1.4" conduit and the smaller 1.0" conduit penetrations.

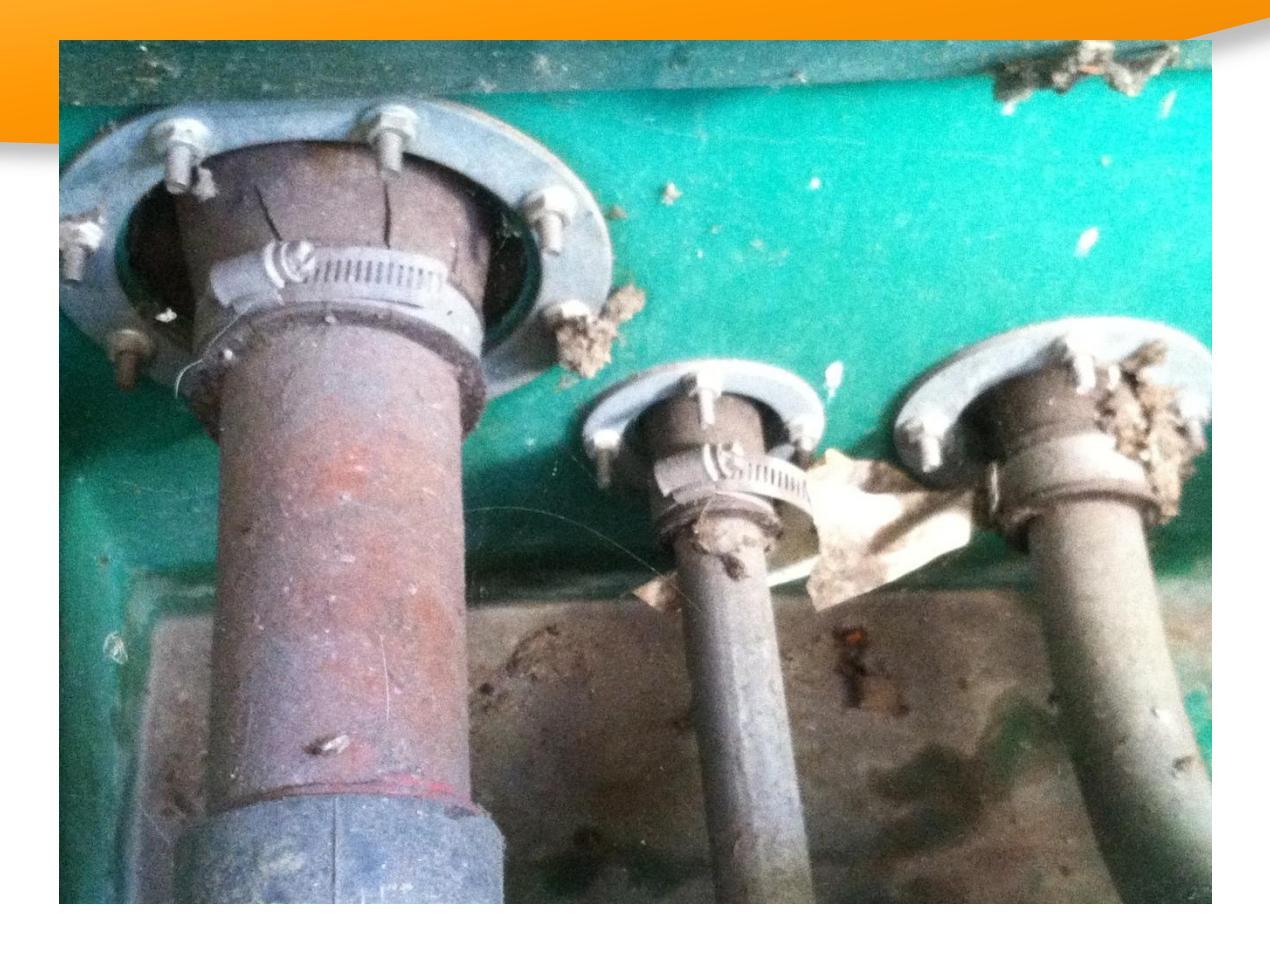
Pic # 003: Before repair view of a 2.5" vapor line, 1.4" conduit and the smaller 1.0" conduit penetrations.

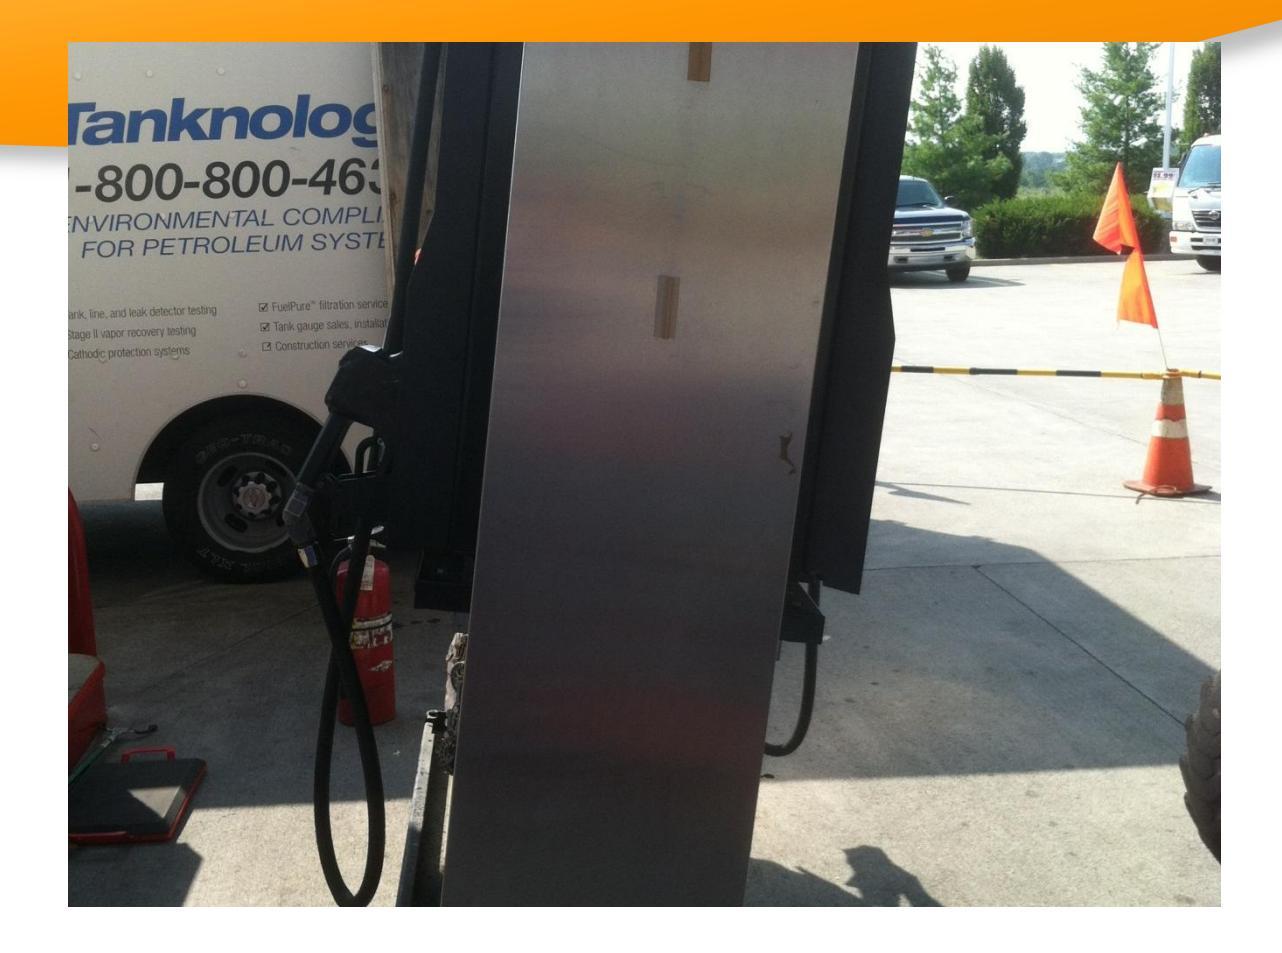
Setting Dispenser 3/4 down onto the ground with spill towels under the base.

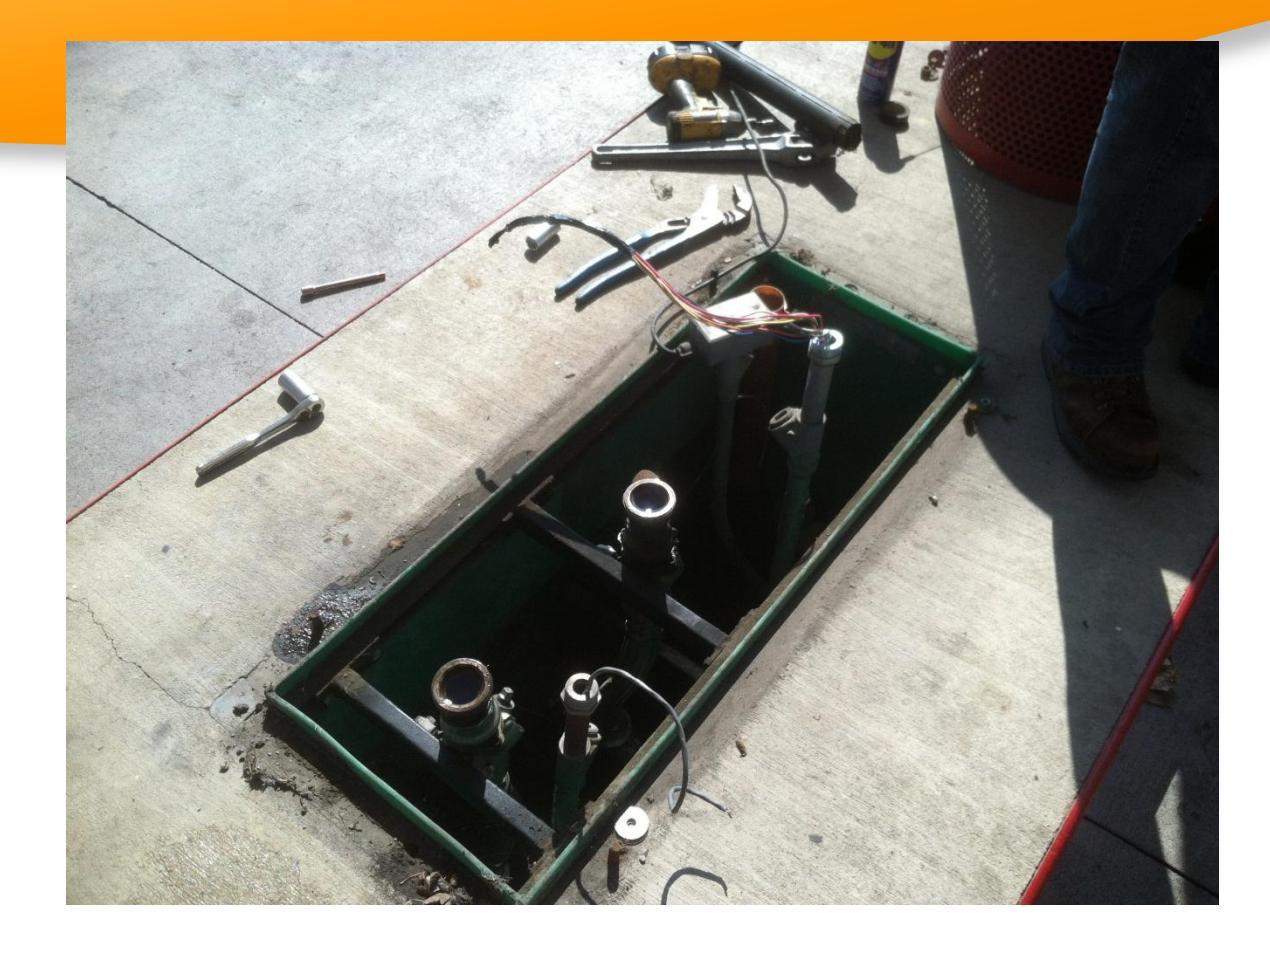
Dispenser sump 3/4 before capping the impact valves and removing center cross brace for clearance.

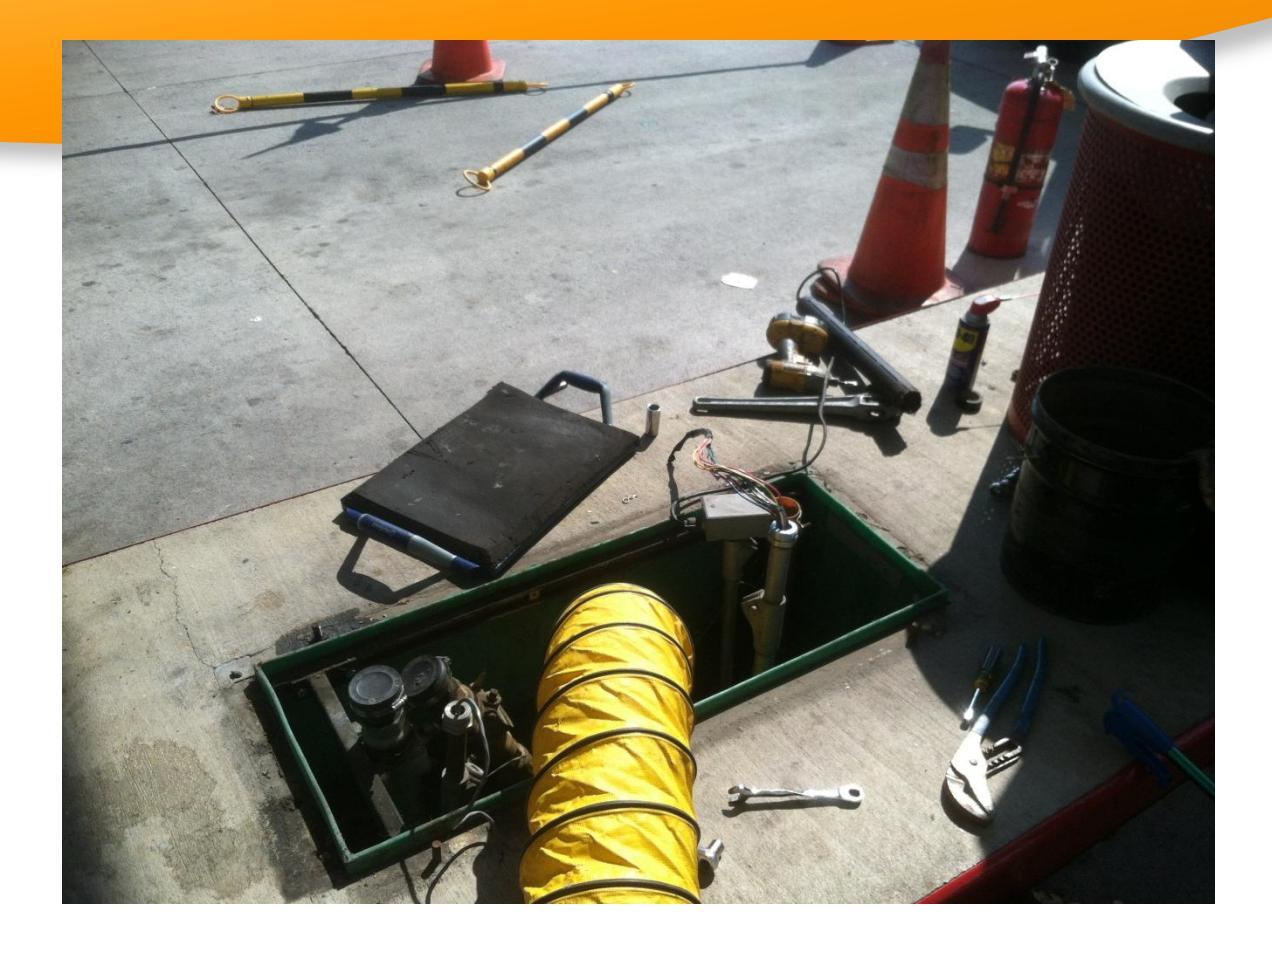
Running Ventilator prior to beginning work inside the sump. This helps to dissipate any residual vapors from the sump.

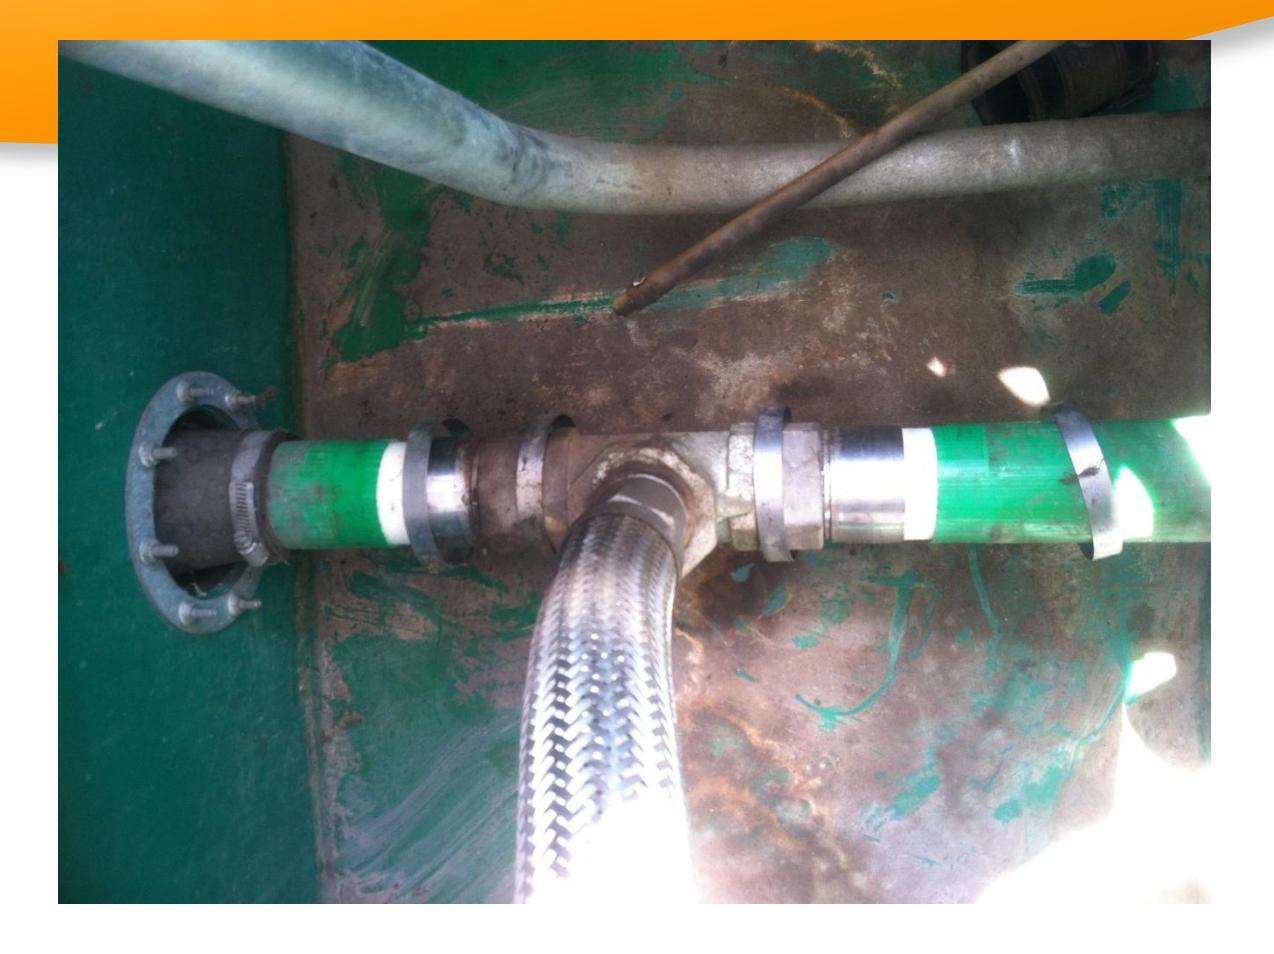
Beginning the removal of the old Environ test boots and penetration fittings in the dispenser 3/4 UDC.

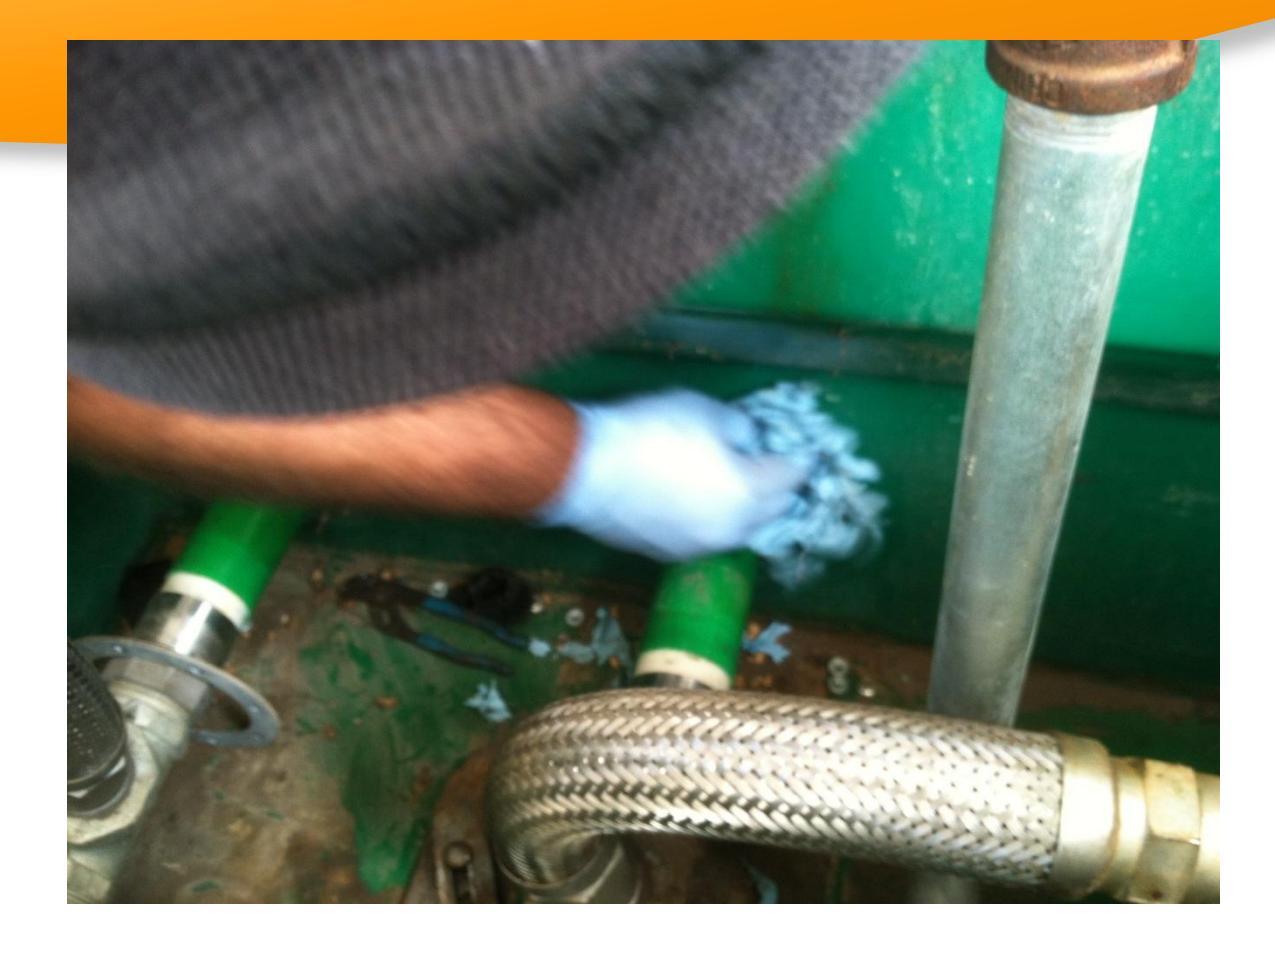
Wiping-down the surfaces of the sump walls with Acetone as a cleaning-prep before applying PetrolSeal to bond the flanged portion of the new split repair boots to the Poly sump wall.

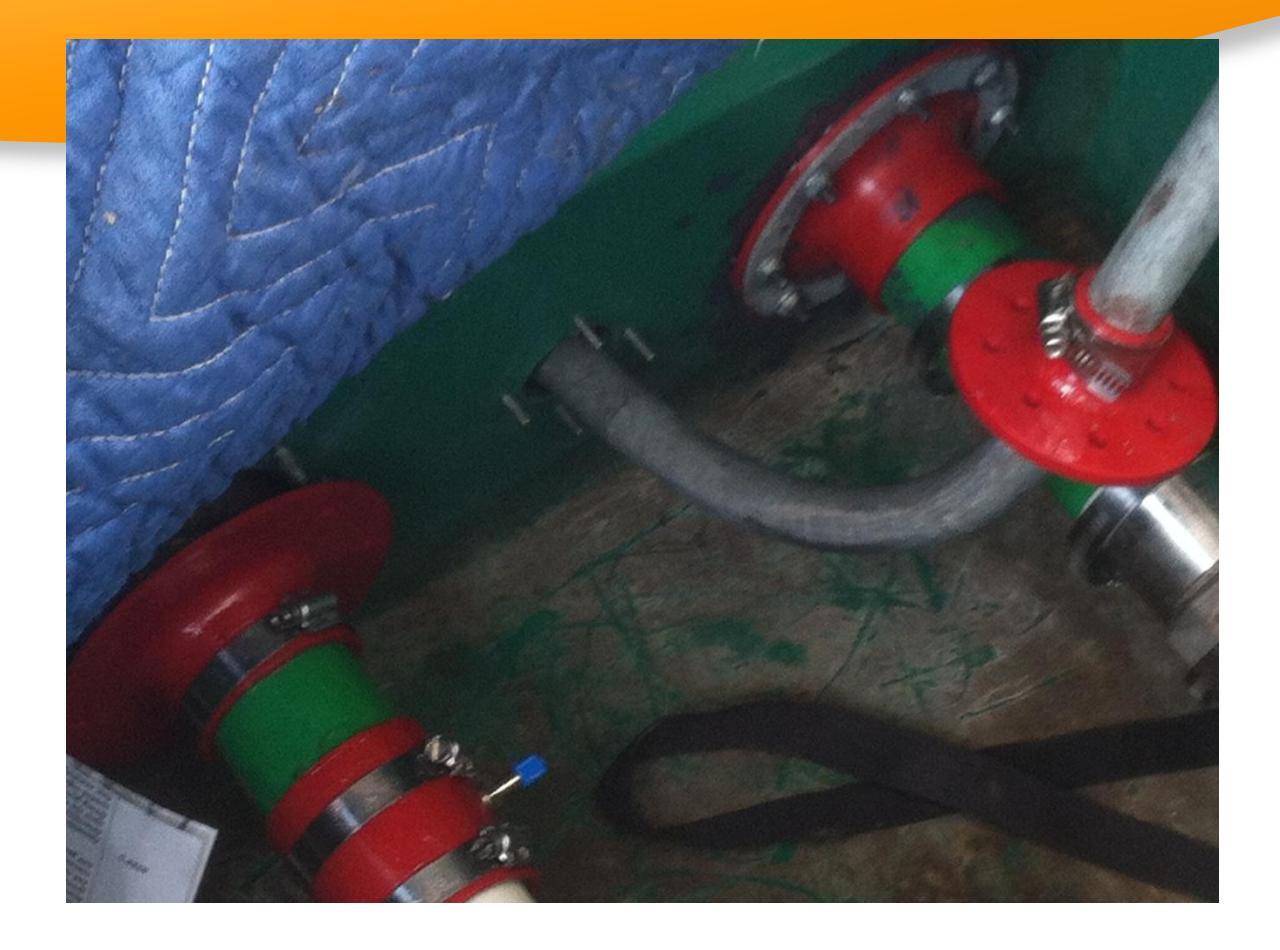
Making progress with split repair boot installation. The smaller 1.0" conduit penetration boot is drying after being bonded-together with FastFuse. Note the new Icon test boot with air-test fitting already on the product line.

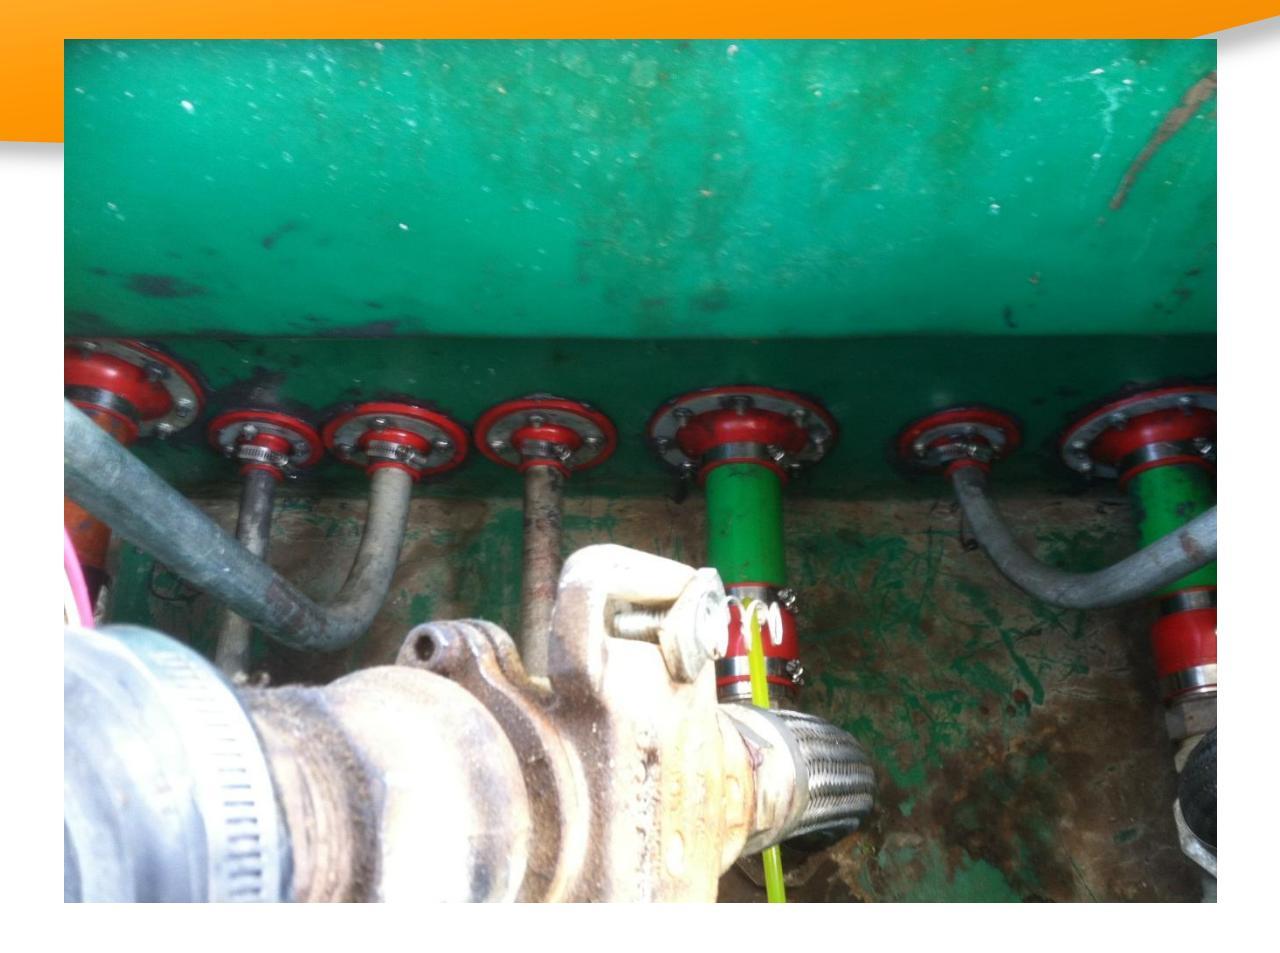
Finished installation in UDC ³/₄. From left-to-right: 2.5" Vapor, 1.0" conduit, 1.4" conduit, 1.0" conduit, 2.5" Environ product line, 1.0" conduit, 2.5" Environ product line.

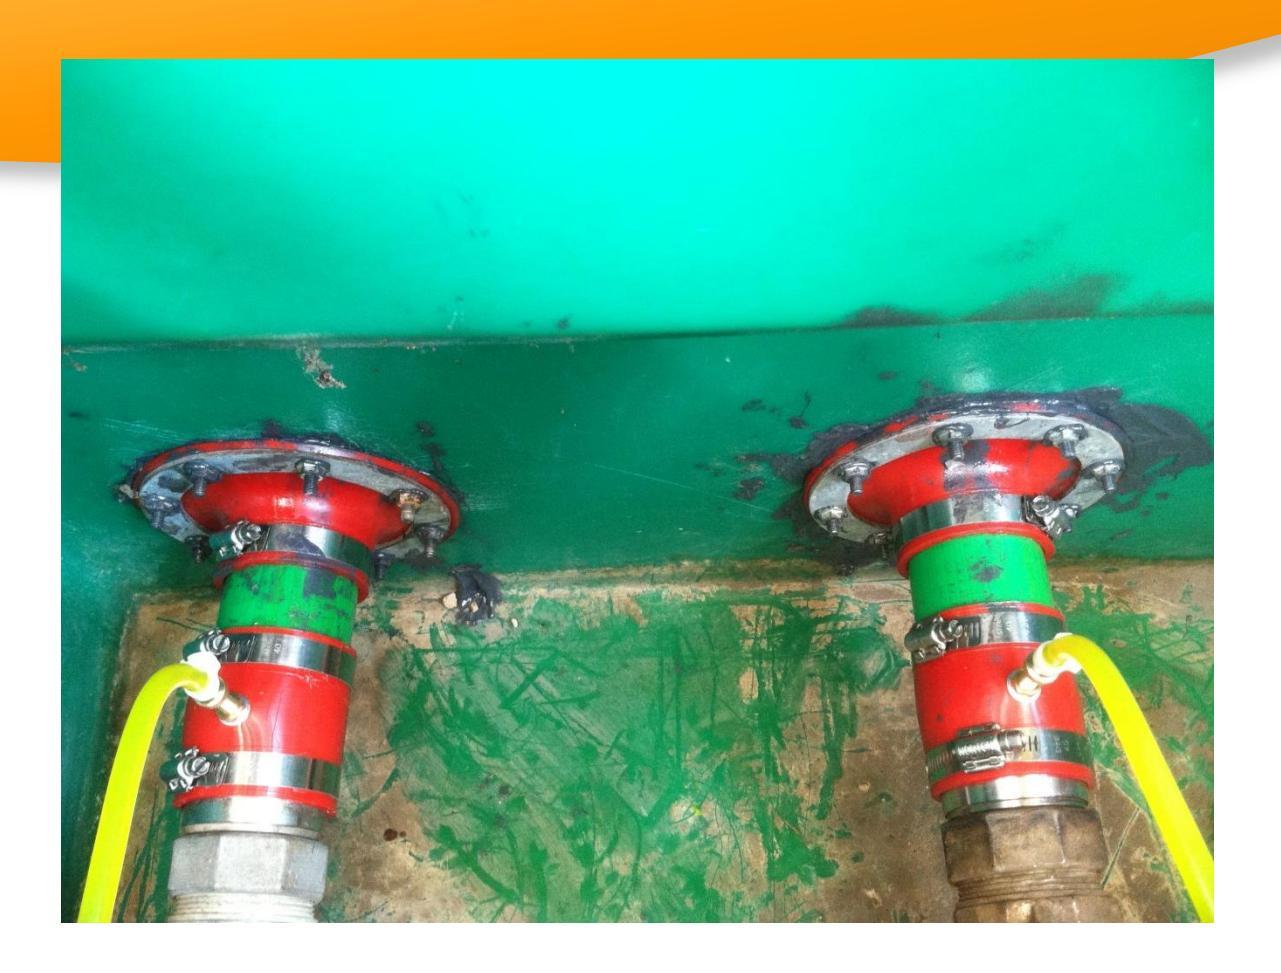
Finished installation in UDC $\frac{3}{4}$. From left-to-right: 2.5" Environ product line (2) with new Icon 2.5" x 2.5" Test Boots w/Air Test fittings and new Air-Test Jumper hoses installed.

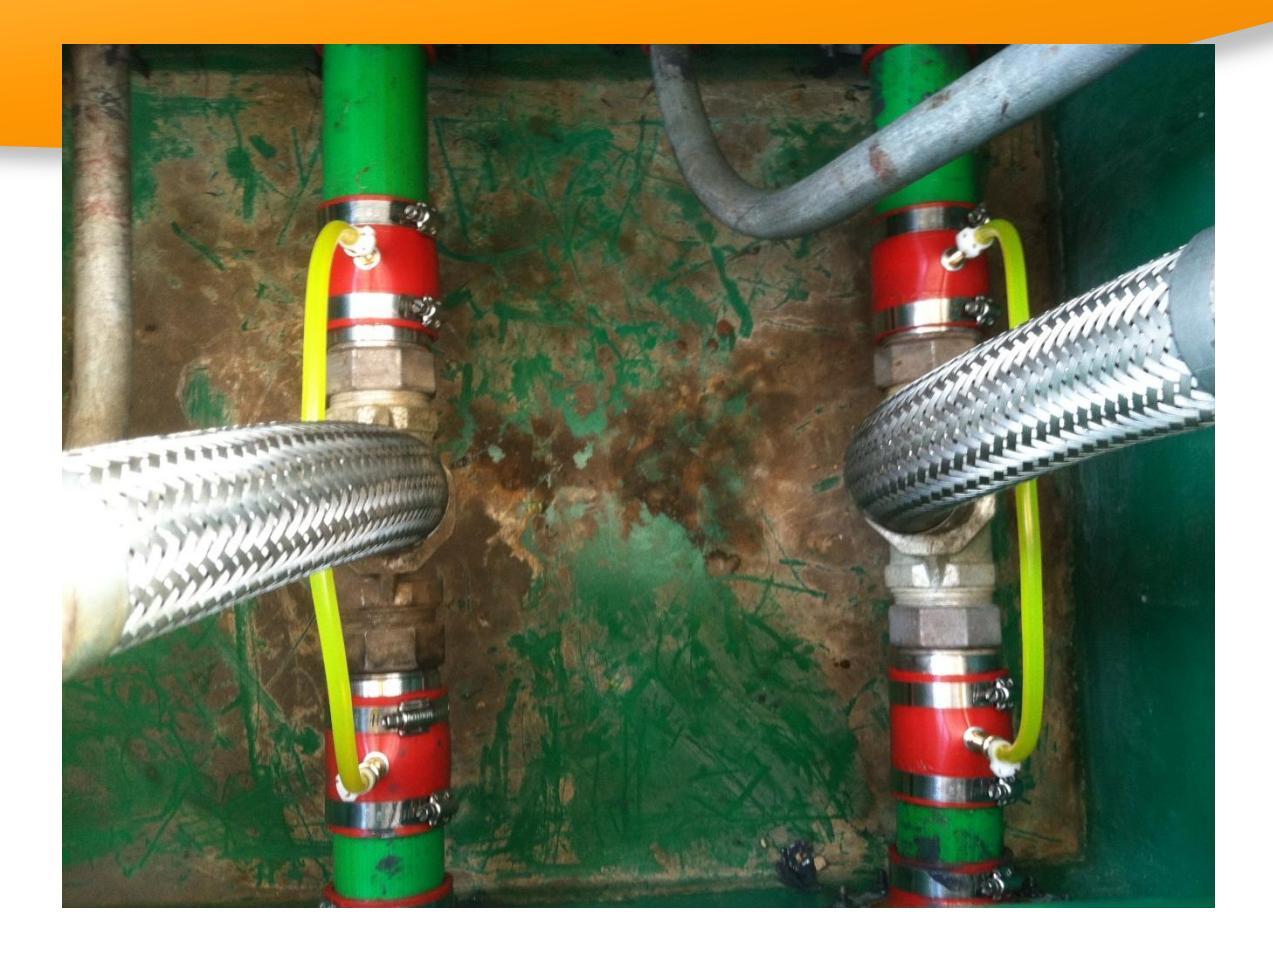
Straight-down view into UDC ³/₄ showing the Secondary Piping Test Boots and Air-Test Jumper hoses installed. Note: The jumper hoses were shortened to prevent excess sagging and placing a pull on the ends wit h the excess hanging-down. **DISCONNECT AFTERWARDS**

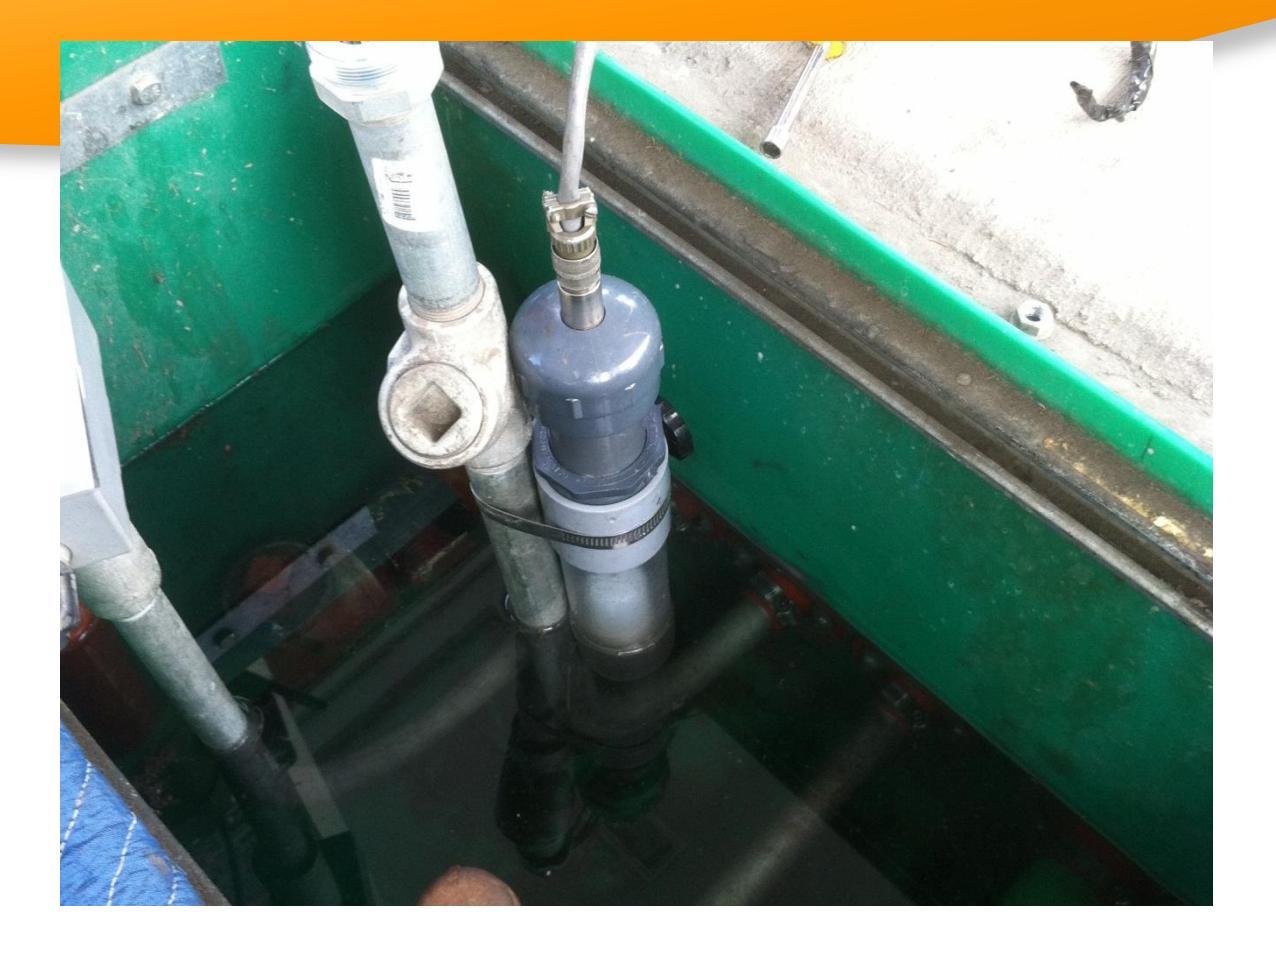
Conducting the final Hydro-Test with Tanknology's VPLT® probe. No problems were encountered and we achieved a passing result. All water was removed after the test.

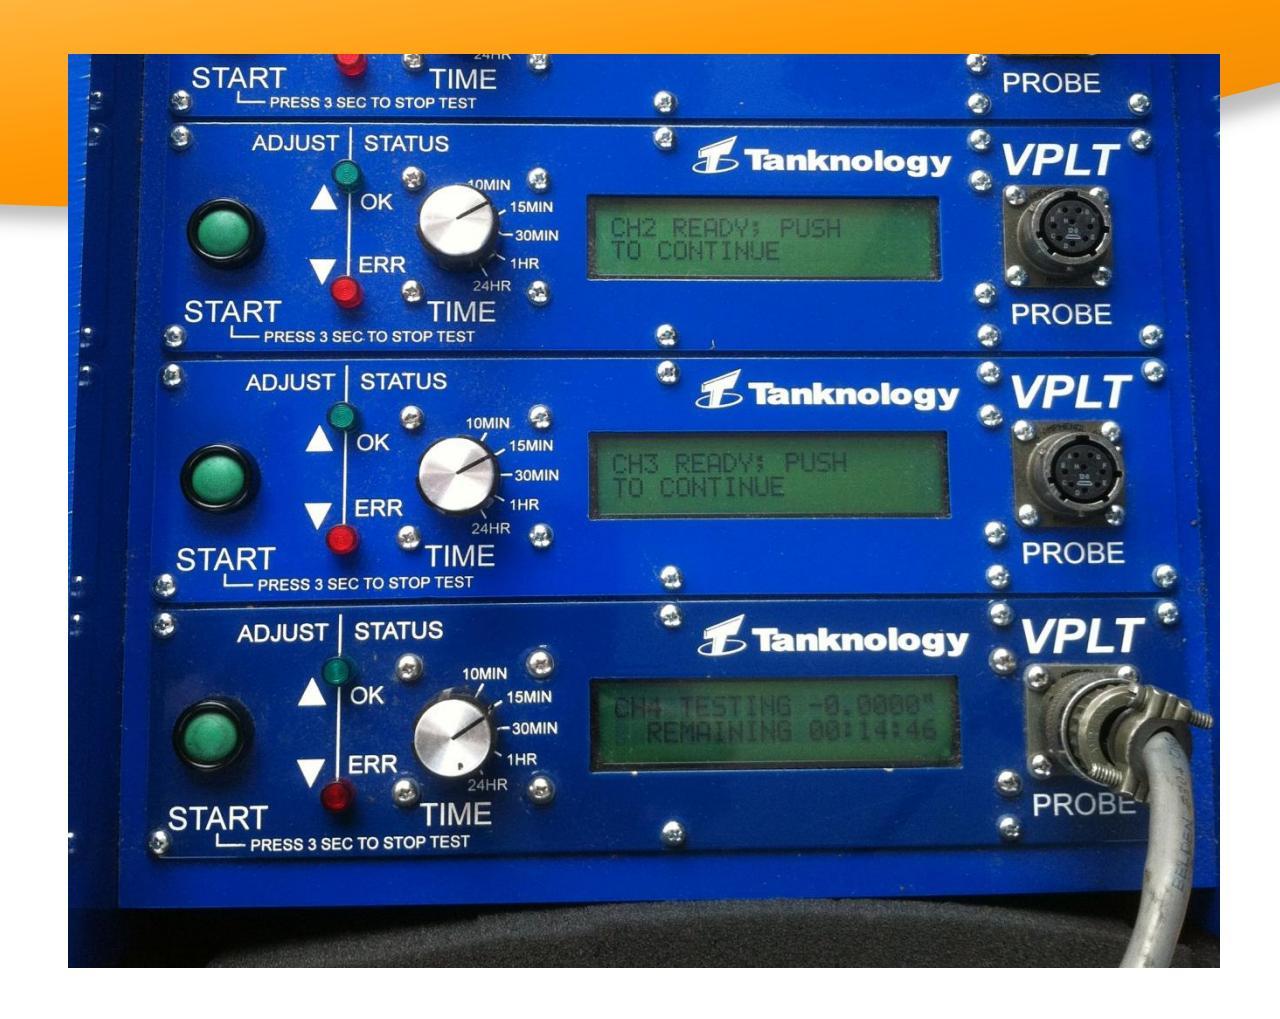
Close-Up view of the VPLT® testing system console.
