What's Going On Inside Today's Storage Tanks?

Lorri Grainawi, STI/SPFA NISTM October 4, 2013 Albany, NY

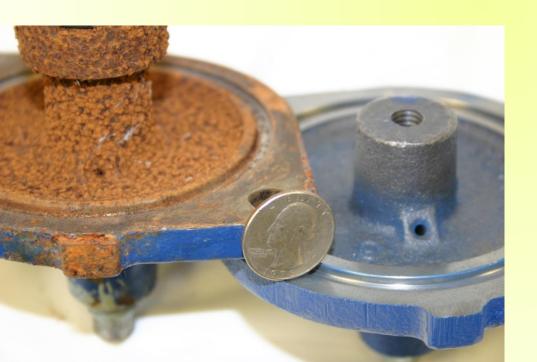
Corrosion of metal components within tanks storing ULSD

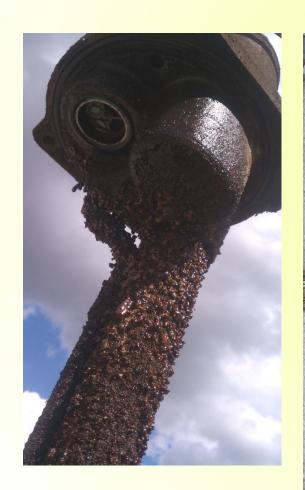
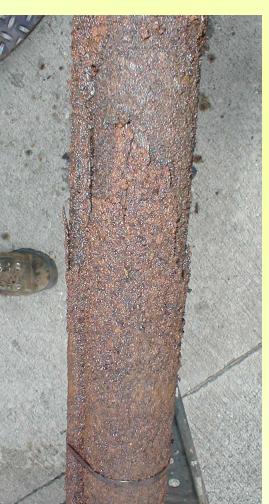
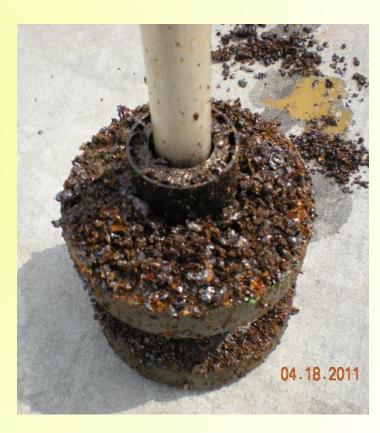
Corrosion Occurring in all 3 Areas

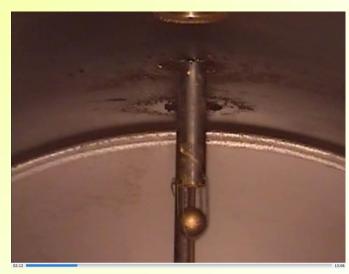
- Fuel samples extracted and tested
- Example Las Vegas service station tanks under same owner
- FRP tank vapor control fitting – top right photo
- Steel tank vapor control fitting – bottom right photo

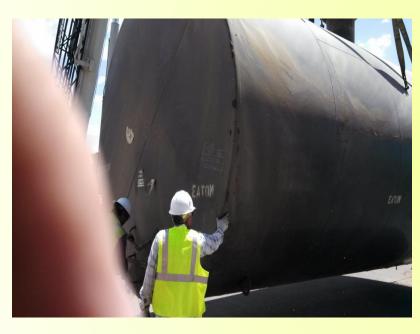
1986 Sti-P3 E85 Tank Removed in 2013 – No Leaks
